Comparative Analysis of seismic performance between step-back frame structure and common frame structure

Keywords: step-back frame structure, seismic performance, deformation characteristic, damage mechanisms

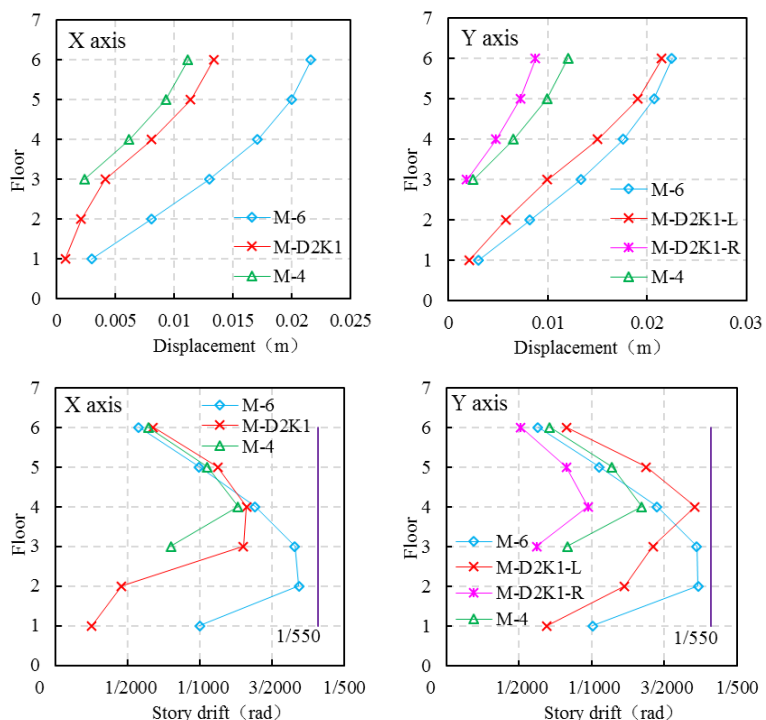
Fig. 5 – Displacement and story drift of frame structure models by response spectrum analysis

Fig. 5 shows the displacement and story drift of frame structure models under frequent earthquake by response spectrum analysis, in which M-D2K1-L represents the side of columns connected with lower embedding end and M-D2K1-R represents the side of columns connected with upper embedding end. The displacement of M-D2K1 is between that of M-4 and M-6 at the direction along the slope, and the deformed shape is different from common frame structure, which is limited to some extent at floors below upper embedding end. Because of torsion effect, the displacement of M-D2K1 is different on both sides across the slope. The displacement across the slope is less than that of common frame with same height.

The maximum story drifts of the investigated structures are less than the limit value 1/550 defined by Chinese code GB 50011-2010. In the along-slope direction, the story drift of M-D2K1 is close to that of common frame from 4th floor to 6th floor, and less than that of common frame from 1st floor to 3rd floor, which is consistent with the limitation of displacement at these floors. In the across-slope direction, except for the story drift of M-D2K1-L from 4th floor to 6th floor, the story drift of step-back frame structure is evidently less than that of common structure. The maximum story drift of M-D2K1 along the slope is obviously less than that of M-6, and the values of two models across the slope are approximate to each other. The floor on which the maximum story drift is located is 4th floor in M-D2K1, which is different from M-6.

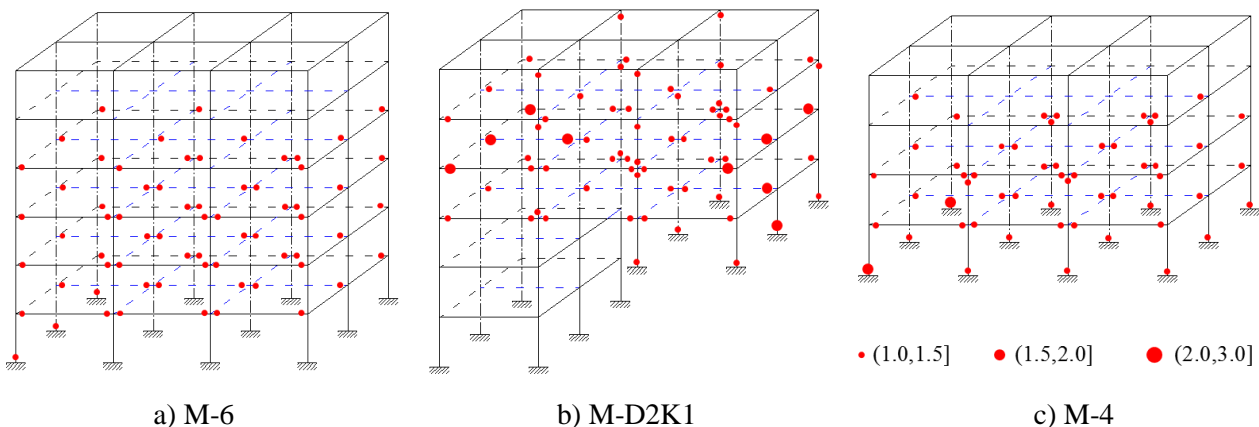
Fig. 7 – Plastic hinges of frame structure models under the action of ground motion record 13 with intensity of 0.40g along X axis

Plastic hinges of frame structure models under rare earthquake with intensity of 0.40g along X axis are displayed in Fig. 7, and the degree of plastic hinge is divided into three levels. It can be observed that plastic hinges are mainly at the end of columns and beams along X axis, and the distribution is basically symmetric about the X axis. In common frame structure M-6, the majority of plastic hinges are located at beams ends, and there are plastic hinges at the bottom of small part columns at 1st floor. In M-4, the bottom of columns at 1st floor are all hinged, and some plastic hinges occur at the top of columns at 2nd floor. Common frame structures show typical beam hinge mechanisms. In step-back frame structure M-D2K1, there is no plastic hinge at components' end at floors below upper embedding end. The bottom of columns connected with upper embedding end are all hinged, and plastic hinges develop at the top of more than half of columns at 5th floor. The damage degree of beams in M-D2K1 is greater than that in M-4 and M-6.

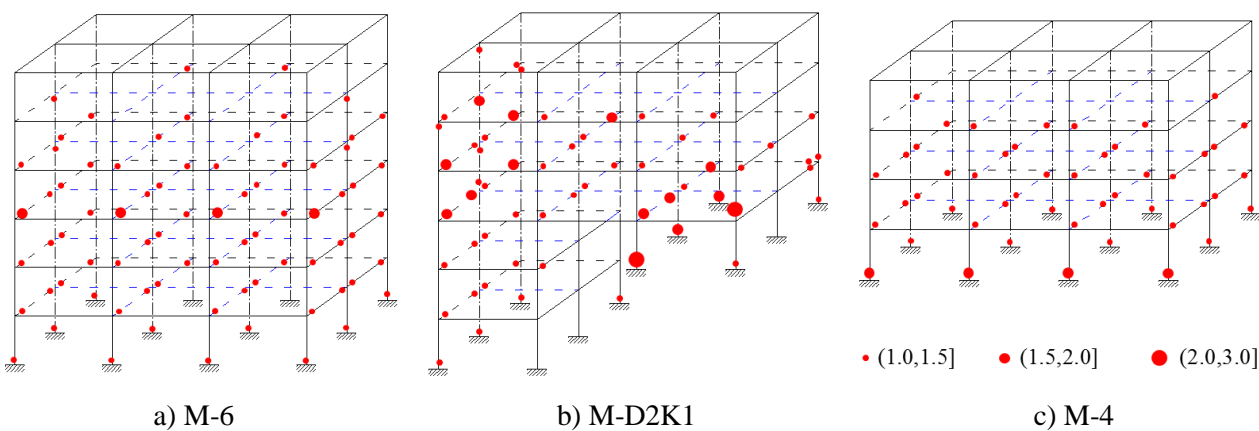
Fig. 8 – Plastic hinges of frame structure models under the action of ground motion record 13 with intensity of 0.40g along Y axis

Fig. 8 shows plastic hinges of frame structure models under rare earthquake with intensity of 0.40g along Y axis. Plastic hinges are mainly at the end of columns and beams along Y axis except one beam at 3rd floor along X axis. In common frame structure M-4 and M-6, the bottom of columns at 1st floor are all hinged, and the rest plastic hinges are mainly located at beams ends. In step-back frame structure M-D2K1, there are plastic hinges at bottom of columns connected with lower embedding end and columns connected with upper embedding end, and the damage at bottom of columns connected with upper embedding end is worse. The damage degree of beam ends on higher floors at side of columns connected with lower embedding end is greater.
