## The shaking table test of strengthen / retrofitting with gabion mesh as jacketing method

Toward improvement of earthquake safety of non-engineered building in Nepal

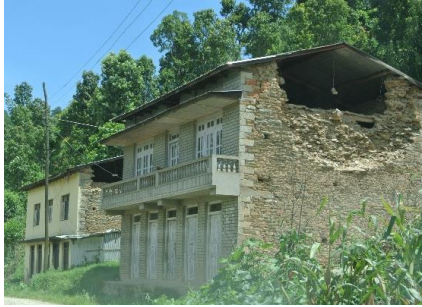
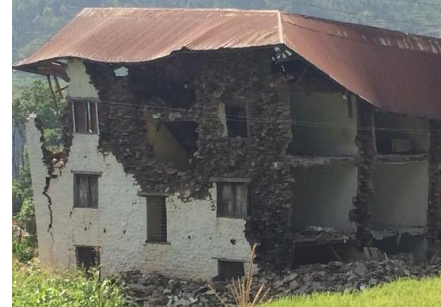
Fig. 1-1 Typical failure pattern of 2015 Nepal earthquake

found. Such houses are destroyed because of the weakness of the mortar used, and absence of bond stones across the thickness of the stone wall resulting in delamination of the inner and outer walls along with separation of the walls at the corners. These finally result in the total collapse of the buildings. Figure 1-1 shows typical failure pattern in this earthquake.

Gable wall failure

Delamination of the inner and outer walls

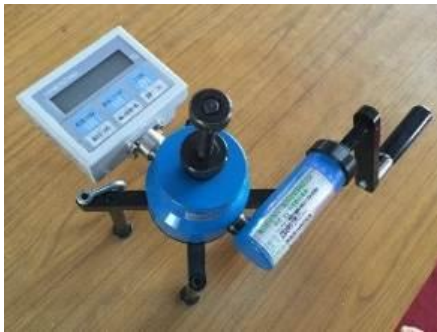
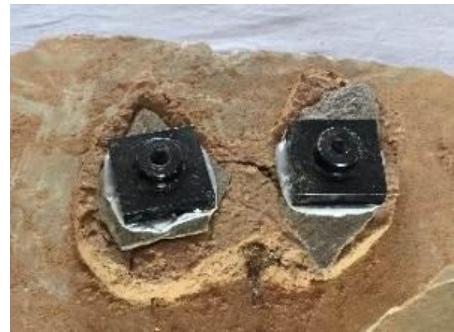
Fig. 2-2 Typical failure pattern of 2015 Nepal earthquake

To know the strength of the masonry in mud mortar, tensile strength test between stone and mud were conducted in Nepal. The results and photos of the test are shown in Fig.1-2 and Table 1-2. The strength was about 12% compared with the average value as 0.65N/mm<sup>2</sup> of the result of previous tensile test of cement mortar and bricks.

Portable tensile test machine

Specimens of tensile test

Specimens	Max(N)	Area(mm <sup>2</sup> )	Tensile strength (N/mm <sup>2</sup> )
1	238.00	2619.90	0.0908
2	252.00	3437.71	0.0733
Ave.			0.0821

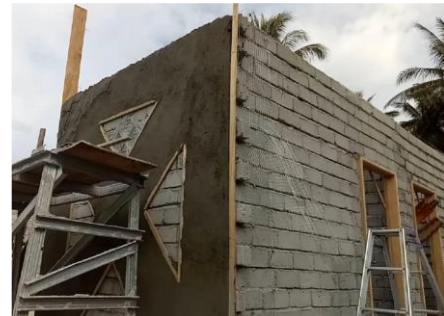
Fig.2-2 Reconstruction house in Sulawesi

used in masonry in Indonesia and other countries and it has used reconstruction project in the 2019 Sulawesi and Lombok earthquakes. (Fig. 2-2)

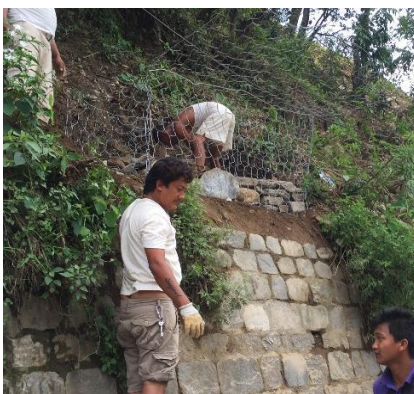
Fig.2-3 Gabion baskets

As a Strengthening / Retrofitting method for masonry structure, a full jacketing method using Gabion mesh without cement mortar finishing is proposed. In Nepal, cement is quite expensive and is not easy to obtain by the people living in mountain regions. Therefore, to make mud mortar stone masonry houses earthquake safer, a simple, affordable, adaptable and economical method should be found. The method must also be familiar to local masons. Generally, Gabions for civil work are, packed with stones in baskets about 1m<sup>3</sup>, and are widely used in Nepal as slope strengthening for road embankment. (Fig.2-3)

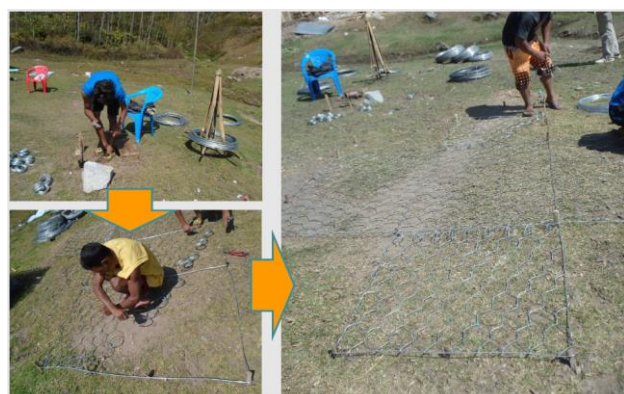
Fig.2-4 Installing gabion mesh on site

This wire is commercially available in the form of a rolls. Therefore, it can be carried into mountainous areas by man power. And then, preparing mesh from roll wires is performed near the building site. As shown in Fig.2-4, in Nepal, gabions for civil engineering are commonly used mountainous regions on site as molding technique. Installing is technically not difficult, it is considered that residents be able to learn the mesh forming technique by training for several hours.

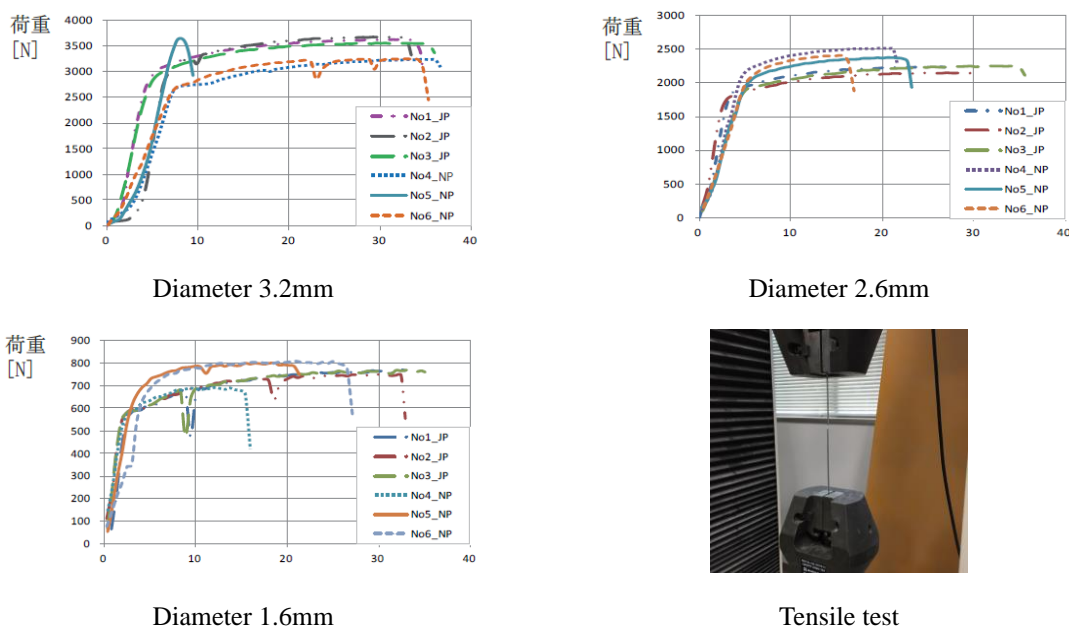
Fig. 2-6 Result and photo of the tensile test

For shaking table test, Japanese wire mesh is used. Therefore, comparison study between Nepal wire and Japanese wire were conducted. A total of 18 tensile tests consists three wire types which diameter are 3.2mm, 2.6mm, 1.6mm made in Japan (J) and Nepal (N). The photos of the test and results shown in fig. 2-6. Nepal product were 10% lower than Japan made averagely. In addition, some of products Nepal made are remarkably low strength and it has variation in quality.

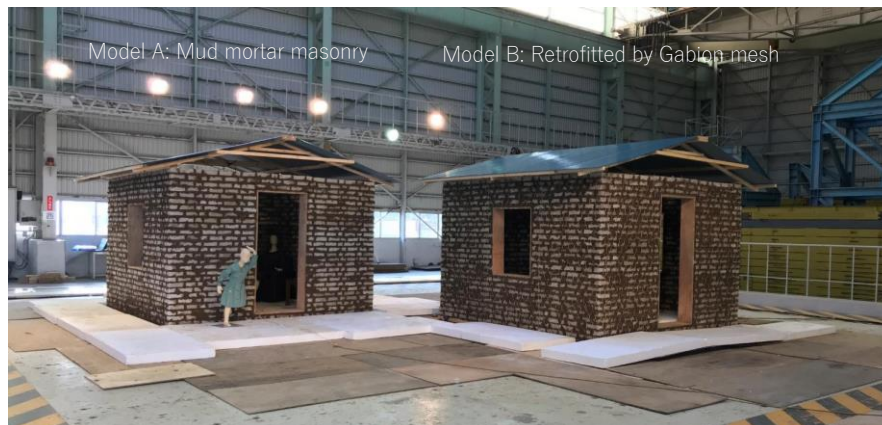
Fig.3-1 Two models on shaking table

Two model structures were built on the shaking table on Feb. 2019. Both models were of the same size and built as unreinforced mud mortar masonry houses. Model A is the original unreinforced mud mortar masonry house without plaster. And model B is the same masonry structure strengthened by wrapping 2mm gabion wire mesh on both sides of the walls, shown in Fig.3-1.

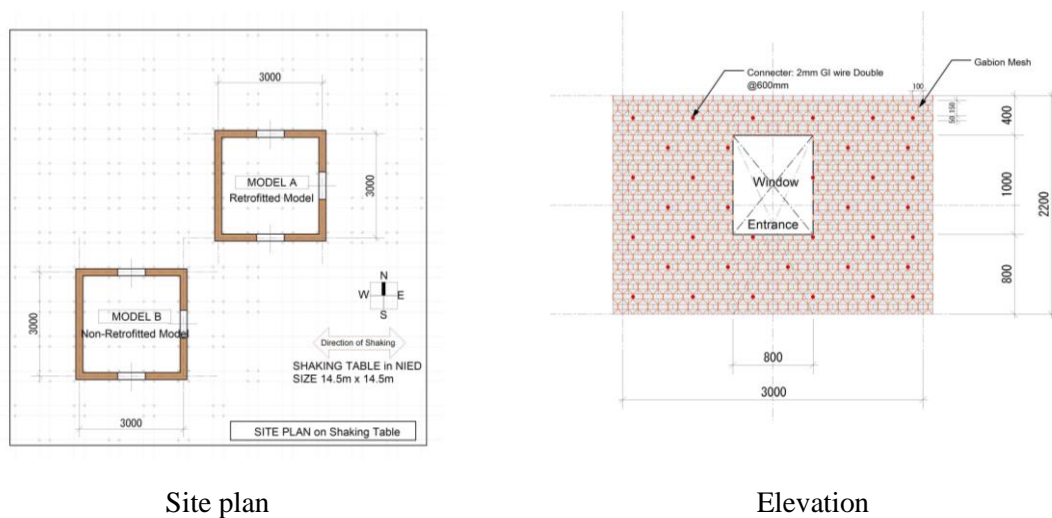
Fig.3-2 Drawings of shaking table test

Each model consisted of four walls with size 3200mm x 2200mm with galvanized corrugated sheet roof. The wall thickness is 210mm. Figure 3-2 shows the drawings of masonry walls. The west wall is without opening, perpendicular to the direction of the shaking.

Site plan

Elevation

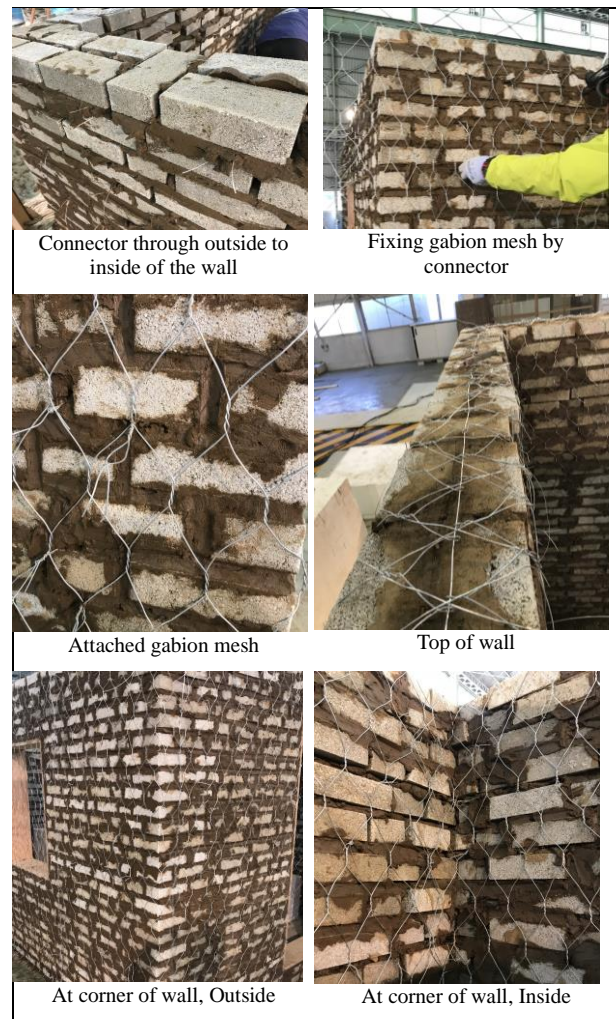
Fig.3-4 Installing gabion mesh

This connector uses two pieces of about 400mm in length and wall thickness + 100mm x 2(both sides), and is arranged at intervals of 600mm in width and 300mm in height.

In addition, Gabion meshes which size is 2400mm x1100mm were used vertically. Its hangs down from the upper part of the wall, and the inside and outside meshes are tied together by connectors from the upper part. The workability is improved by using bending wire when temporarily fixing. The meshes are joined together by knitting same dimension of wires without overlapping.
