Structural Behavior of Bolted Joints in Metal Exterior Wall

Keywords: Metal exterior wall, Cyclic loading test, Bolted joint, Slotted hole

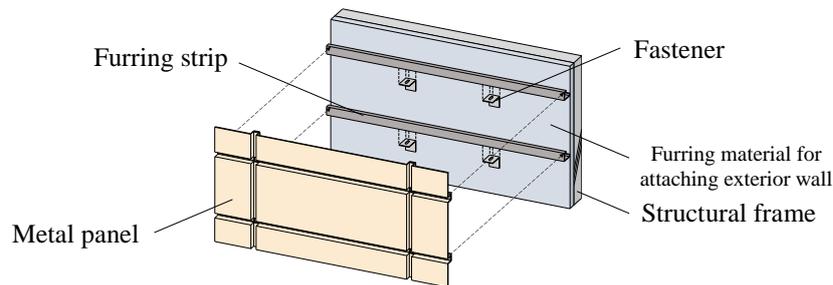
Fig. 1 – Metal exterior wall

The metal exterior wall is composed of metal panels and steel components called furring strip and fastener. The panels are formed by bending the metal plates with a thickness of about 0.8 to 5.0 mm into a box shape, and the height and width can be arbitrarily manufactured. One panel is supported at the upper and lower parts by the furring strips. Fasteners are attached to each furring strip at regular intervals.

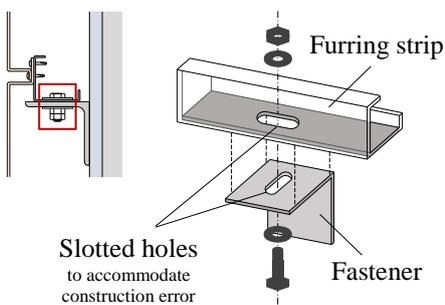
Fig. 2 – Bolted joint

The joints on the metal exterior wall include a bolted joint between the fastener and furring strip (Fig. 2) and a screw joint between the furring strip and the panel (Fig. 3). For the bolted joints, the fastener has a slotted hole in the out-of-plane direction and similarly, the furring strip has in-plane slotted holes to accommodate construction errors in the structural frame. In order to prevent the panel from slipping out of the plane after construction, bolted joints were generally fixed by spot welding. However, in recent years, the non-welding method has been promoted due to fire risk^[1]. The panel is fixed to the furring strip using drill screws in the order of the upper part of the lower-layer-side panel and then the lower part of the upper-layer-side panel. Specifically, after fixing the upper part of the lower-layer-side panel at only two points, the lower part of the upper-layer-side panel is overlapped there and fixed completely. Each screw joint has slotted holes to cope with expansion and contraction due to thermal stress. Only the lower part of the panel where all screw joints are slotted holes can be moved in the in-plane direction.

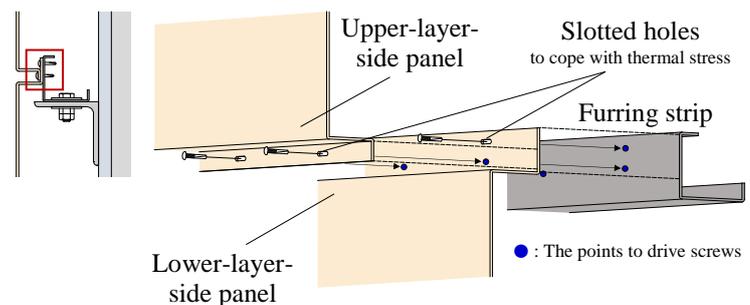
Fig. 3 – Screw joint

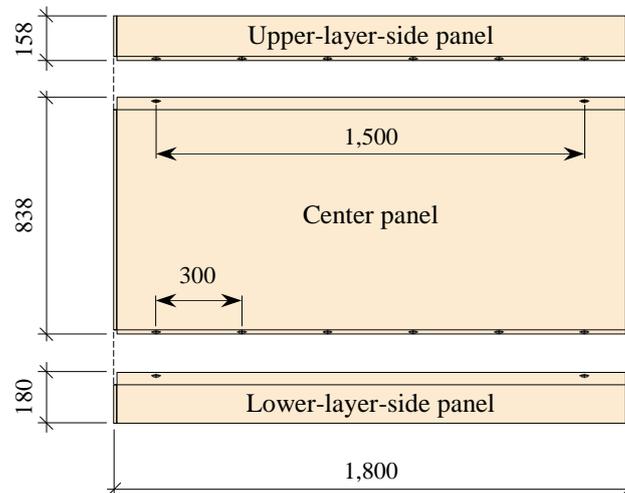
Fig. 4 – Dimensions of metal panels

The specimen represents a metal exterior wall intended for construction in a middle-rise building. The panel to be tested is an aluminum panel (A1100; $F_y=95 \text{ N/mm}^2$) with a height of 838 mm and a width of 1,800 mm (center panel (Fig. 4)). In order to reproduce the actual screw joints, panels to be attached to the upper and lower part of the center panel are partially manufactured and joined together. Fig. 4 shows the dimensions of metal panels. These panels do not include the opening, the outside corner, and the inside corner. Steel components for mounting the panels are two furring strips (Angles with lip: L-60x60x15x15x2.3) and four fasteners (Angle: L-90x90x7). The steel grade for general steel structure (SS400; $F_y = 235 \text{ N/mm}^2$) is used. The dimensions of these steel components are shown in Fig. 5. Austenitic stainless steel bolts with a nominal diameter of 12 mm (M12, A2-70; $F_y = 450 \text{ N/mm}^2$) and martensitic stainless steel drill screws with a nominal diameter of 4.2 mm (ST4.2, C1-70; $F_y = 410 \text{ N/mm}^2$) are used in this test.

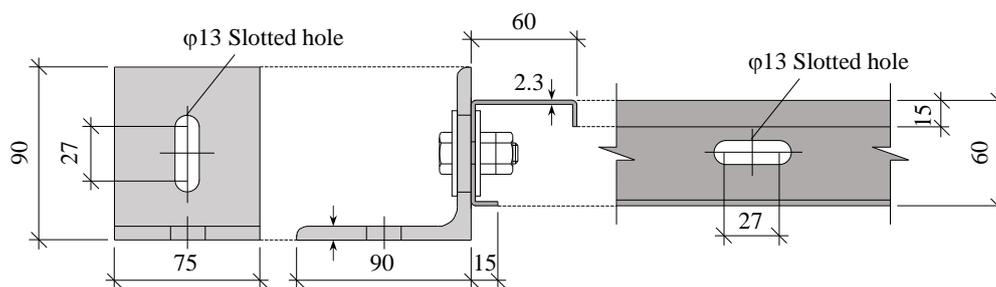
Fig. 5 – Dimensions of steel components

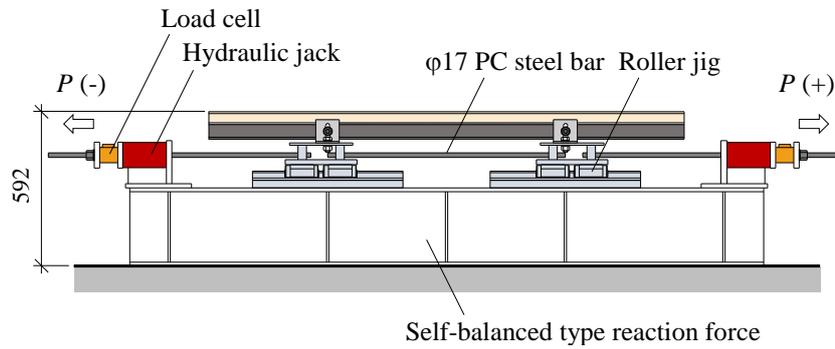
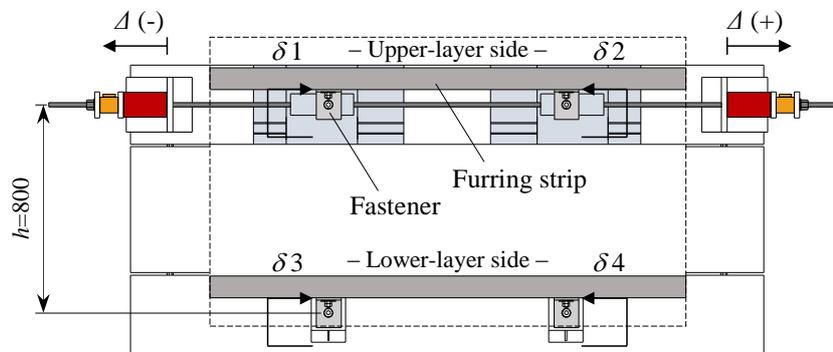
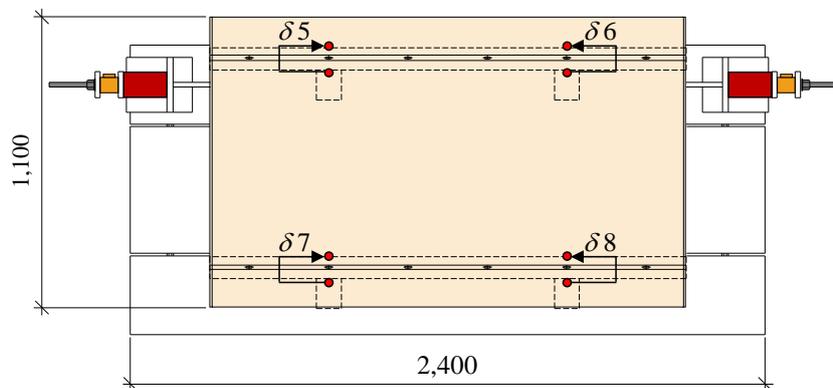
(a) Elevation view

(b) Measurement of story drift

(c) Plan view

Fig. 6 – Setup

The overview of the setup is shown in Fig. 6. First, four fasteners are fixed to a self-balanced type frame jig. Then, two furring strips, which are called the upper-layer-side and the lower-layer-side, are attached horizontally and parallel to the fasteners. One furring strip is bolted to two fasteners. At this time, the bolts are tightened to 20kN, which is about 60% of the yield strength of M12 stainless steel bolt. After attaching the furring strips, the panels are fixed to them with drill screws. The upper-layer-side connection of fasteners is a horizontal roller. In the experiment, the forced displacement is generated by hydraulic jacks connected to the left and right of the rollers via PC steel bars to reproduce the story drift.

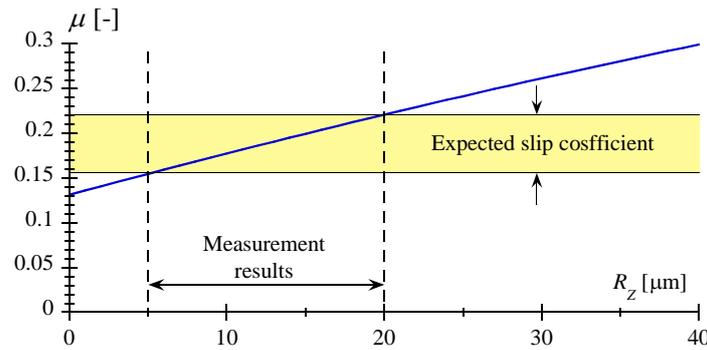
Fig. 7 – Slip coefficient and surface roughness relationship

Using Eq. (1) and surface roughness of this specimen, the slip coefficient can be estimated to be between 0.15 and 0.22 as shown in Fig. 7. Furthermore, slip strength (P_s) can be calculated by the following equation.

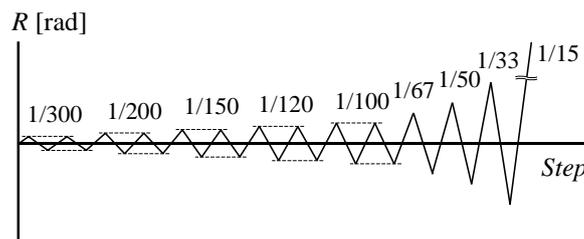
Fig. 8 – Loading history

The loading history in this experiment is shown in Fig. 8. The loading history is a cyclic loading controlled by the amplitude of the story drift angle (R). Until $R = 1/100$ rad, each cycle (determined according to the performance grade of the curtain wall^[2]) is performed for two cycles. Then each amplitude of $1/67$ rad, $1/50$ rad, and $1/33$ rad, which are 1.5 times, 2 times, and 3 times of $1/100$ rad, are performed for one cycle in order to confirm the failure condition of the metal exterior wall. Ultimately, the specimen is completely failed by deforming to $R = 1/15$ rad.

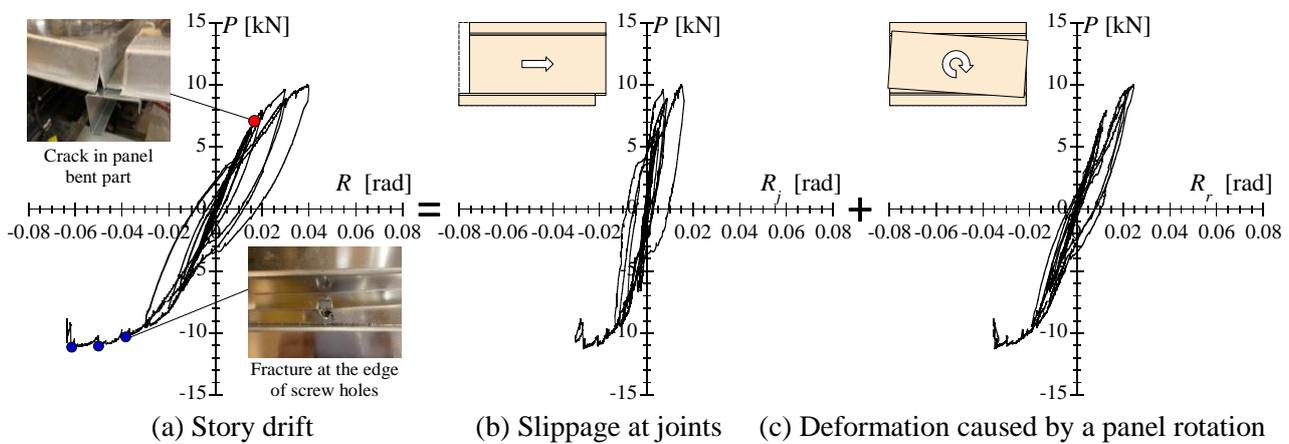
Fig. 9 – Load-deformation angle relationship

Fig. 9 shows the hysteresis behavior obtained from the experiment. The vertical axis of the figure is the in-plane load applied to the metal exterior wall (P) and the horizontal axis is (a) story drift angle (R), (b) angle of slippage in the horizontal direction at joints (R_j), and (c) angle of horizontal deformation caused by a panel rotation (R_r). Up to story drift angle $R = 1/100$ rad, there is a roughly linear relationship between the load and story drift angle, indicating that the metal exterior wall almost elastically follows the deformation of the structural frame. On the other hand, when the positive side $R = 1/67$ rad was loaded, a crack was observed in the bent part of the panel, the stiffness was decreased, and the residual deformation under unloading condition became remarkable. Furthermore, fracture was confirmed at the edge of screw holes at the lower part of the center panel at $R = 1/25$ rad.

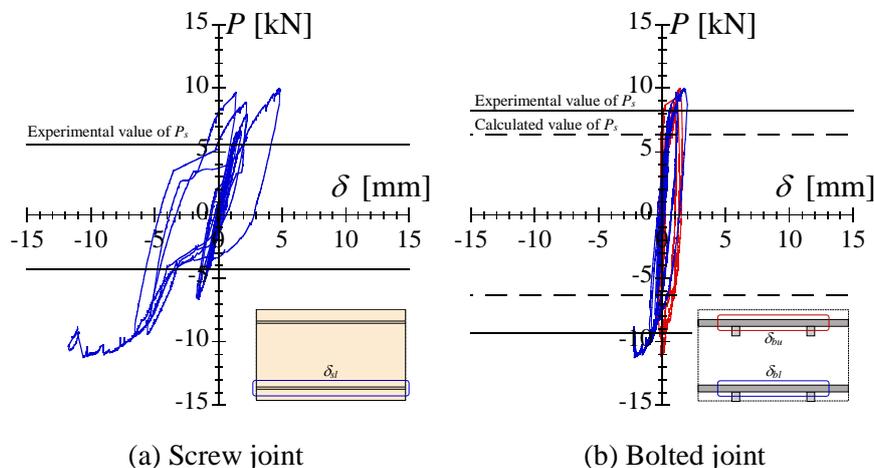
Fig. 10 – Slippage in the horizontal direction at joints (Fig. 9 (b))

The breakdown of the misalignment in the horizontal direction at joints in the overall behavior is discussed in this section. The hysteresis behavior at the screw joint and the bolted joint are shown in Fig. 10. The vertical axis of the figure is the in-plane load (P) and the horizontal axis is the deformation of each joint δ_{sl} , δ_{bu} , and δ_{bl} . At the screw joint, a clear slip behavior is seen at $R = 1/50$ rad. Meanwhile, at the bolted joint, although the hysteresis curve became slightly nonlinear, and the deformation by about ± 1.0 mm was generated, the deformation was smaller than that of the screw joint.

Here, it is assumed that most of the initial stiffness of the entire hysteresis curve is due to the stiffness of the furring strip and the fastener. Thus, the evaluation range of the slip strength is defined as the point at which the 0.2 mm offset straight line of the initial stiffness intersects with the hysteresis curve^[3]. The calculated values of slip strength are shown by broken lines and the experimental values are shown by solid lines in Fig. 10. From the figure, it can be seen that the deformation did not progress even when the load reached the calculated value of the slip strength. When the slip strength of the screw joint is calculated using the same method, the calculated value of the slip strength is about 4.2kN. Then, by assuming the same slip coefficient as the bolted joint, the initial tension of the drill screw can be calculated which is about 3.4kN. Therefore, it can be concluded that by controlling the tension of the bolted joint during the setup (the bolts are tightened to about 60% of its yield strength in this experiment), it is possible to suppress the deformation of the bolted joint and to force the slip of the screw joint to advance.

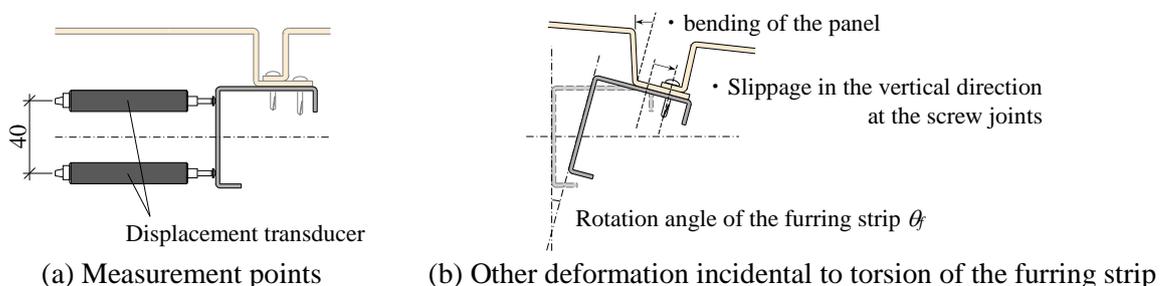
Fig. 11 – Measurement of torsion of the furring strip

In this section, the breakdown of the horizontal deformation caused by a panel rotation is described. With the deformation of the structural frame, torsion around the material axis of the furring strip occurs. From the rotation angle of the furring strip (θ_f) obtained by the measurement method shown in Fig. 11, the deformation of the furring strip in the upper and lower direction of the panel can be calculated. The value obtained by dividing this deformation by the distance between the measurement points is defined as the deformation angle due to the torsion of the furring strip (R_f). In addition, the deformation angle obtained by subtracting R_f from the horizontal deformation angle caused by a panel rotation (R_r) is defined as the other deformation angle (R_o). This includes the deformation incidental to the torsion of the furring strip, such as bending of the panel and misalignment in the vertical direction at the screw joints. The respective hysteresis curves are shown in Fig. 12. The vertical axis of the figure is the in-plane load (P) and the horizontal axis is the respective deformation angle R_f and R_o . The deformation due to the torsion of the furring strip is almost elastic. On the other hand, it can be seen that the history of other deformation shows an increase in deformation and a decrease in load due to the fracture at the screw joint.

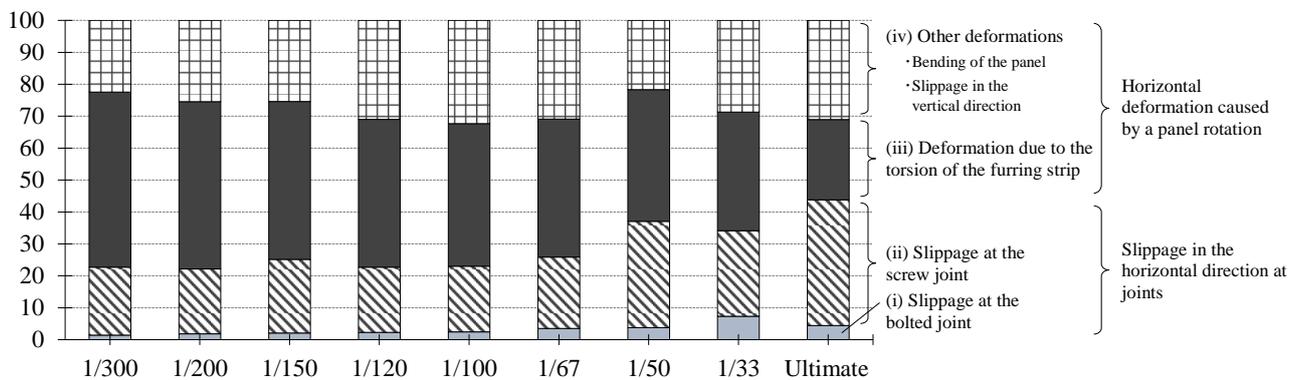
Fig. 13 – Percentage of each deformation at every story drift angle

The deformations described in previous sections are shown in Fig. 13 in percentage at every story drift angle. The vertical axis of the figure is the ratio of each deformation to the overall deformation, and the horizontal axis is the story drift angle (R). The deformations are (i) slippage at the bolted joint, (ii) slippage at the screw joint, (iii) deformation due to the torsion of the furring strip, and (iv) other deformations incidental to the torsion of the furring strip. Where, (i) and (ii) are classified into slippage in the horizontal direction at joints, and (iii) and (iv) are classified into horizontal deformation caused by a panel rotation. Similarly, Fig. 14 shows the transition of residual deformation for each story drift angle. The story drift angle at the unloading of the first cycle of each loading amplitude is plotted on the vertical axis. In addition, the ratio of each deformation to the residual deformation angle is shown using the bar graph.

Up to $R = 1/100$ rad, the residual deformation angle is as small as $1/500$ rad at most, and the specimen is almost in the elastic range. Until then, the ratio of the slippage at the bolted joint to the total deformation was extremely small. Slippage at the screw joint accounts for 30% and deformation due to the torsion of the furring strip accounts for nearly 60%. It can be seen that the deformation due to the torsion of the furring strip plays a major role as the deformation mechanism of the metal exterior wall.

The percentage of deformation at the bolted joint and screw joint have increased since $R = 1/67$ rad, where the panel cracked. On the other hand, the percentage of deformation due to the torsion of the furring strip, which had maintained the elastic state, decreased and eventually dropped to less than 20%. This is because the damage to the screw joint determines the strength and ultimate state of the metal exterior wall, and eventually, the damage to the screw joint progresses to follow the story drift.

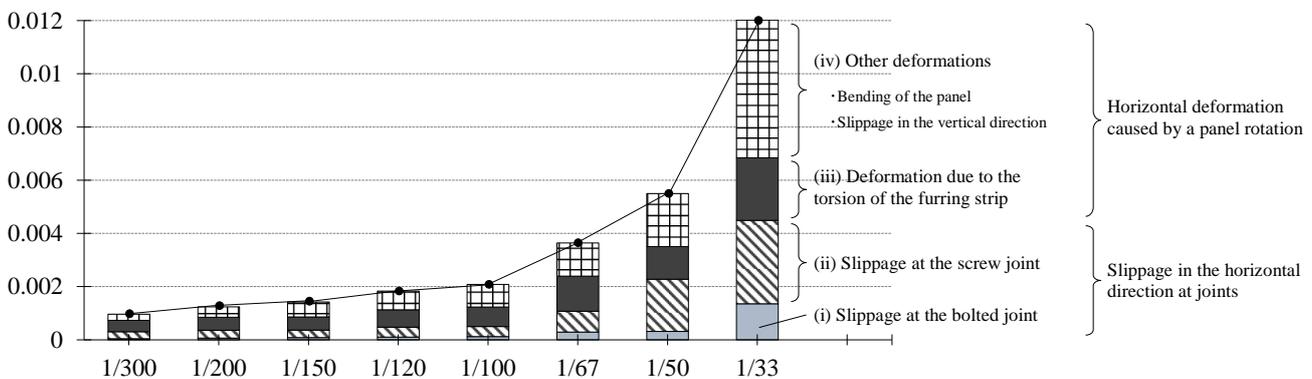
Fig. 14 – Residual deformation and its breakdown
