Structural Behavior of Bolted Joints in Metal Exterior Wall

In this study, a in-plane cyclic-loading test of a metal exterior wall was conducted to evaluate the allowable story drift and deformation mechanism of the metal exterior wall.

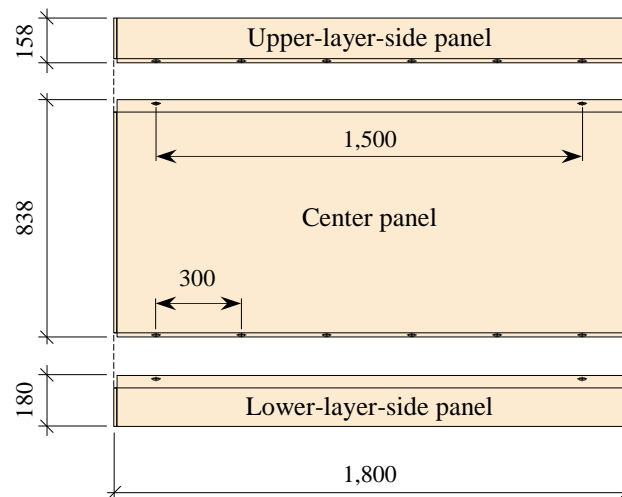
Fig. 4 – Dimensions of metal panels

The specimen represents a metal exterior wall intended for construction in a middle-rise building. The panel to be tested is an aluminum panel (A1100; $F_y=95 \text{ N/mm}^2$) with a height of 838 mm and a width of 1,800 mm (center panel (Fig. 4)). In order to reproduce the actual screw joints, panels to be attached to the upper and lower part of the center panel are partially manufactured and joined together. Fig. 4 shows the dimensions of metal panels. These panels do not include the opening, the outside corner, and the inside corner. Steel components for mounting the panels are two furring strips (Angles with lip: L-60x60x15x15x2.3) and four fasteners (Angle: L-90x90x7). The steel grade for general steel structure (SS400; $F_y = 235 \text{ N/mm}^2$) is used. The dimensions of these steel components are shown in Fig. 5. Austenitic stainless steel bolts with a nominal diameter of 12 mm (M12, A2-70; $F_y = 450 \text{ N/mm}^2$) and martensitic stainless steel drill screws with a nominal diameter of 4.2 mm (ST4.2, C1-70; $F_y = 410 \text{ N/mm}^2$) are used in this test.

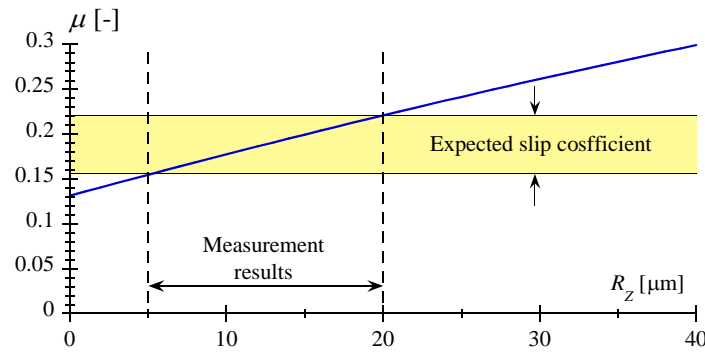
Fig. 7 – Slip coefficient and surface roughness relationship

Using Eq. (1) and surface roughness of this specimen, the slip coefficient can be estimated to be between 0.15 and 0.22 as shown in Fig. 7. Furthermore, slip strength (P_s) can be calculated by the following equation.

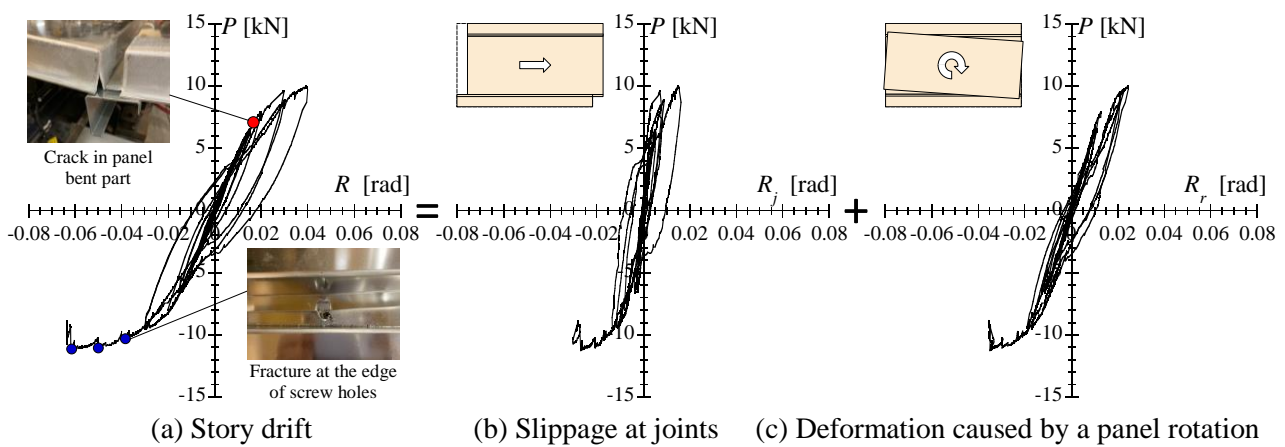
Fig. 9 – Load-deformation angle relationship

Fig. 9 shows the hysteresis behavior obtained from the experiment. The vertical axis of the figure is the in-plane load applied to the metal exterior wall (P) and the horizontal axis is (a) story drift angle (R), (b) angle of slippage in the horizontal direction at joints (R_j), and (c) angle of horizontal deformation caused by a panel rotation (R_r). Up to story drift angle $R = 1/100$ rad, there is a roughly linear relationship between the load and story drift angle, indicating that the metal exterior wall almost elastically follows the deformation of the structural frame. On the other hand, when the positive side $R = 1/67$ rad was loaded, a crack was observed in the bent part of the panel, the stiffness was decreased, and the residual deformation under unloading condition became remarkable. Furthermore, fracture was confirmed at the edge of screw holes at the lower part of the center panel at $R = 1/25$ rad.

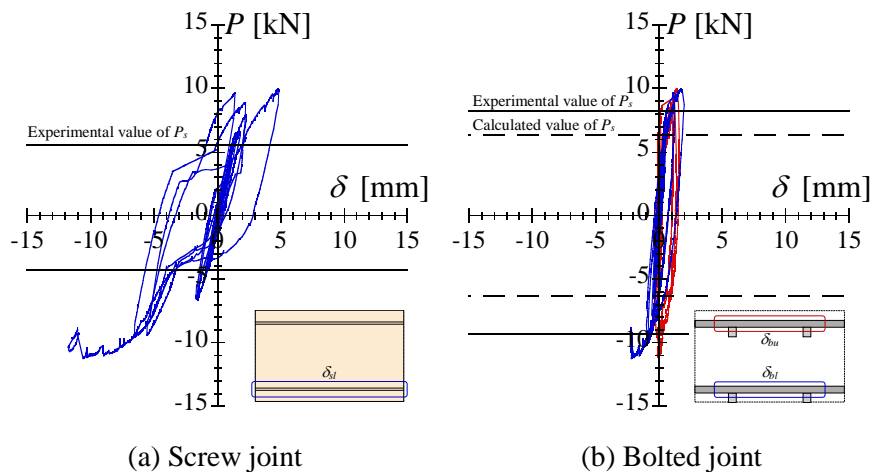
Fig. 10 – Slippage in the horizontal direction at joints (Fig. 9 (b))

The breakdown of the misalignment in the horizontal direction at joints in the overall behavior is discussed in this section. The hysteresis behavior at the screw joint and the bolted joint are shown in Fig. 10. The vertical axis of the figure is the in-plane load (P) and the horizontal axis is the deformation of each joint δ_{sl} , δ_{bu} , and δ_{bl} . At the screw joint, a clear slip behavior is seen at $R = 1/50$ rad. Meanwhile, at the bolted joint, although the hysteresis curve became slightly nonlinear, and the deformation by about ± 1.0 mm was generated, the deformation was smaller than that of the screw joint.

Here, it is assumed that most of the initial stiffness of the entire hysteresis curve is due to the stiffness of the furring strip and the fastener. Thus, the evaluation range of the slip strength is defined as the point at which the 0.2 mm offset straight line of the initial stiffness intersects with the hysteresis curve^[3]. The calculated values of slip strength are shown by broken lines and the experimental values are shown by solid lines in Fig. 10. From the figure, it can be seen that the deformation did not progress even when the load reached the calculated value of the slip strength. When the slip strength of the screw joint is calculated using the same method, the calculated value of the slip strength is about 4.2kN. Then, by assuming the same slip coefficient as the bolted joint, the initial tension of the drill screw can be calculated which is about 3.4kN. Therefore, it can be concluded that by controlling the tension of the bolted joint during the setup (the bolts are tightened to about 60% of its yield strength in this experiment), it is possible to suppress the deformation of the bolted joint and to force the slip of the screw joint to advance.

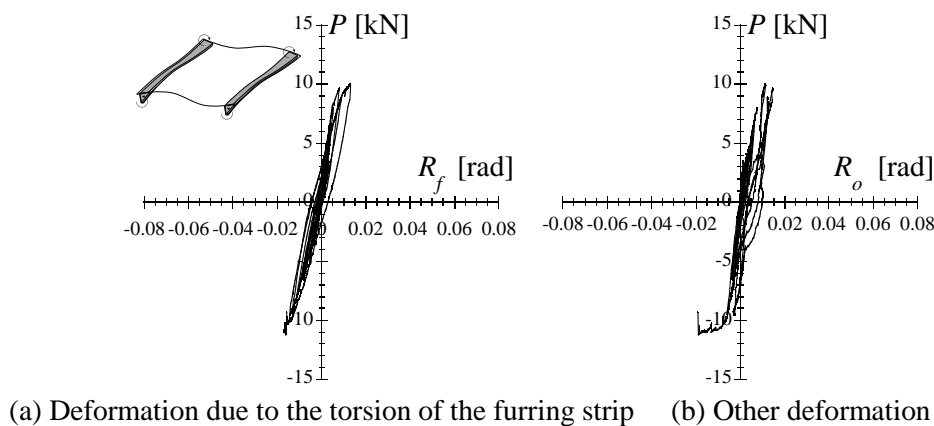
Fig. 12 – Horizontal deformation caused by panel rotation

In this section, the breakdown of the horizontal deformation caused by a panel rotation is described. With the deformation of the structural frame, torsion around the material axis of the furring strip occurs. From the rotation angle of the furring strip (θ_f) obtained by the measurement method shown in Fig. 11, the deformation of the furring strip in the upper and lower direction of the panel can be calculated. The value obtained by dividing this deformation by the distance between the measurement points is defined as the deformation angle due to the torsion of the furring strip (R_f). In addition, the deformation angle obtained by subtracting R_f from the horizontal deformation angle caused by a panel rotation (R_r) is defined as the other deformation angle (R_o). This includes the deformation incidental to the torsion of the furring strip, such as bending of the panel and misalignment in the vertical direction at the screw joints. The respective hysteresis curves are shown in Fig. 12. The vertical axis of the figure is the in-plane load (P) and the horizontal axis is the respective deformation angle R_f and R_o . The deformation due to the torsion of the furring strip is almost elastic. On the other hand, it can be seen that the history of other deformation shows an increase in deformation and a decrease in load due to the fracture at the screw joint.
