STUDY ON THE SEISMIC PERFORMANCE OF TRADITIONAL JAPANESE BUILDING WITH THE THICK EARTHEN WALL

H. Yokouchi⁽¹⁾, Y. Ohashi⁽²⁾

Keywords: Traditional Japanese building, Box-shaped wall structure, Mud wall, Horizontal loading test

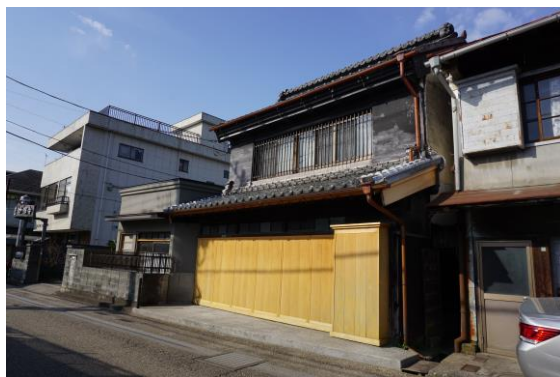
(a) Misegura

Fig. 1 – Examples of dozo structures

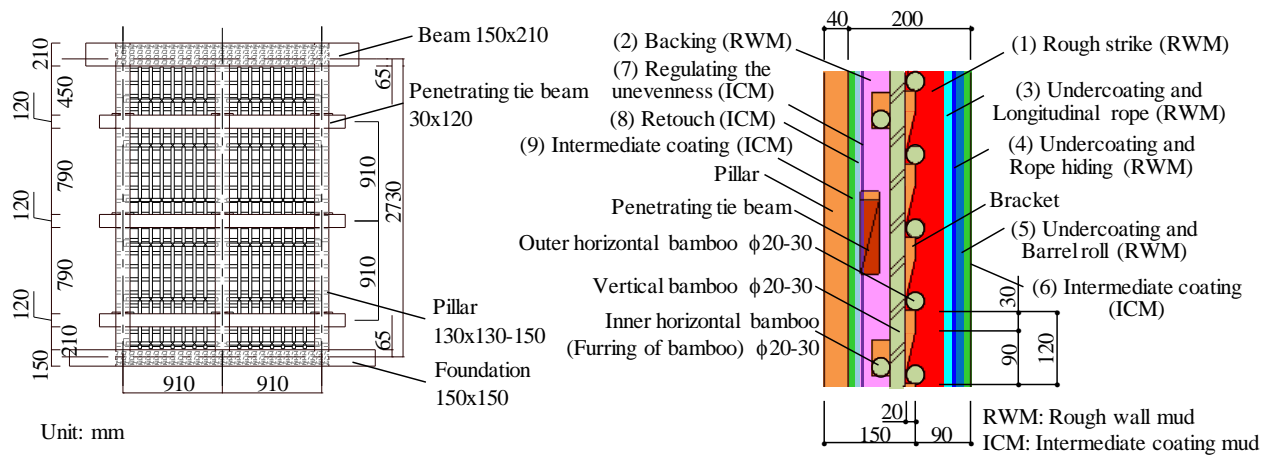
Fig. 5 – Shapes and dimensions of Type B

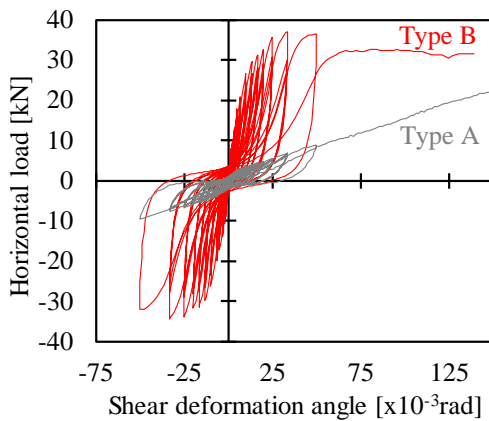
Fig. 7 – Relationship between the horizontal load and the shear deformation angle

The relationship between the horizontal load and the shear deformation angle of Types A and B (as obtained from loading tests) are described in Fig. 7. The strength of Type A specimen was significantly less than that of the Type B. However, as deformation increased, because the resistance caused by the penetrating tie beams sinking into the pillars became larger, the proof strength—which continued to rise in proportion to deformation—was confirmed even if the deformation reached 1/7 rad or more. The maximum proof strength of Type B was 37.1 kN; the deformation angle at that time was 1/30 rad. Fig. 8 shows the skeleton curves during positive loading of Types A and B. This figure also shows the restoring force of only the mud wall panel subtracted Type A from Type B at the same deformation. After the maximum proof strength, the resistance strength of the mud wall panel decreased, but—as with Type A, described above—the resistance

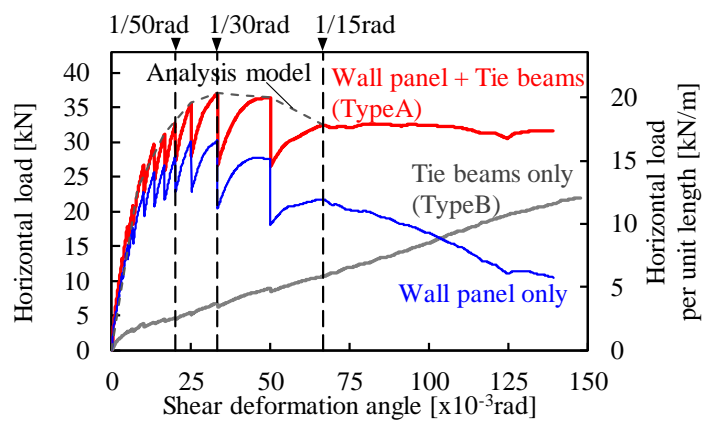
Fig. 8 – Skeleton curve comparison during positive loading

strength of the penetrating tie beams increased with the horizontal deformation. Maintaining a proof strength of 84% or more of the maximum up to the final deformation by balancing the mud wall panel resistance and the penetrating tie beams resistance, we confirmed the toughness of the thick earthen walls.

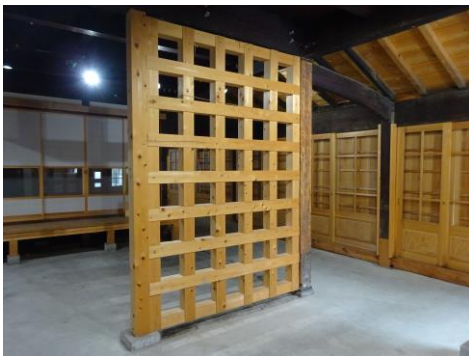
Fig. 12 – Installation example of the timber grid wall

In order to accurately evaluate the restoring strength characteristics of the building, it is necessary to add that of all horizontal strength resistance elements; examples of the horizontal strength resistance element of the target building include the earthen walls and the hanging walls, the bearing of penetrating beam and timber connection, etc. However, due to contribute of the strength of the full surface earthen walls arranged so as to surround the outer periphery of the building is very dominant; in this study, the restoring strength characteristic of the building was simply evaluated considering only the full surface walls. By the way, the X direction has a large opening and the wall quantity is extremely small. Especially, the story shear strength of the 1st story is low. Therefore, we also verified for the seismic performance of Retrofit Model, attached the timber grid walls to the position of blue line shown in the plan view of 1st floor in Fig. 10. The timber grid walls were installed in the positions where there were no shear walls on the lower floor; the example of the installation of this wall is shown in Fig. 12. By arranging the walls this position, the arrangement balance between the height direction and the plane of the horizontal strength resistance elements is improved. Fig. 13 shows the skeleton curves used for the restoring strength evaluation. The restoring strength characteristics of the inner earthen wall and the timber grid wall shown in the Figure were modeled using the test results of References [12,13]. The restoring strength characteristic of the target building was evaluated by multiplying the horizontal strength per unit length, calculated by dividing the horizontal strength of the test result by the specimen width of 1.82 m, by the wall length for each floor and each direction. Fig. 14 shows restoring strength characteristics of each story and the equivalent single degree of freedom (SDOF) model in each direction. The base shear coefficients at the maximum proof strength were 0.15 (Retrofit Model: 0.33) at the X direction and 0.53 at the Y direction.

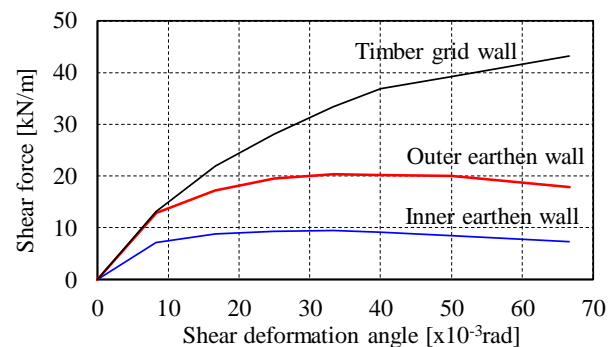
Fig. 13 – The horizontal strength per unit length used in the evaluation
