SEISMIC STRENGTHENING AND UPLIFT OF THE 1904 WELLINGTON TOWN HALL

S.J. Oliver⁽¹⁾, L.A. Whitehurst⁽²⁾, H.S. McKenzie⁽³⁾ & A.E. Philpott⁽⁴⁾

Keywords: heritage, unreinforced masonry, retrofit, base isolation

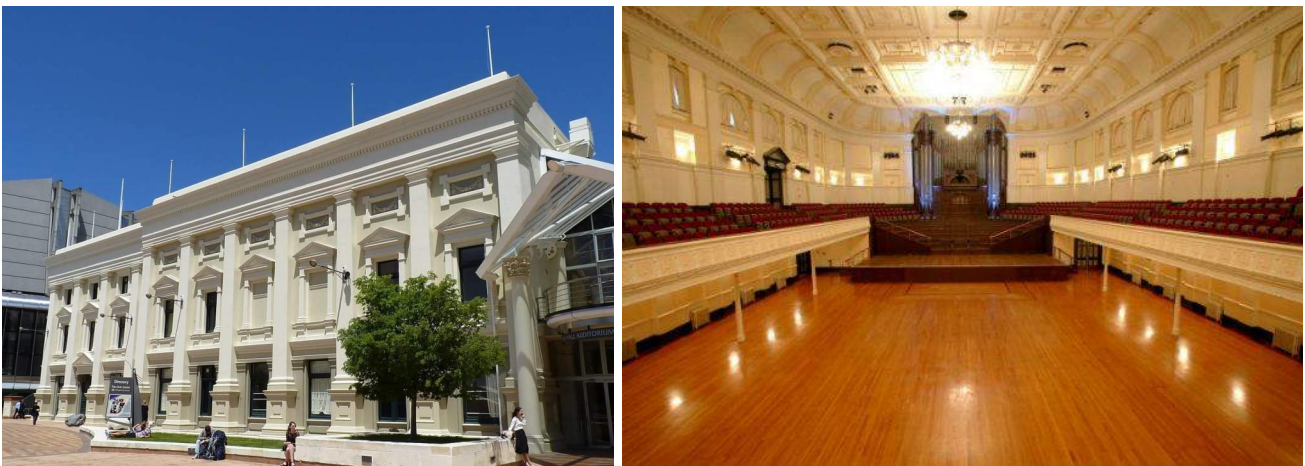
Fig. 1 – Photograph illustrating the Wellington Town Hall northern façade as it currently stands (left) and auditorium - courtesy Wellington City Council (right)

The Wellington Town Hall is a large unreinforced masonry building constructed circa 1904 in Wellington, New Zealand. Figure 1 illustrates the northern (Civic Square) façade of building. The building features a large auditorium as well as the offices of the Mayor and a Debating Chamber for the City Council, and forms part of the Wellington City municipal complex. Heritage New Zealand has designated the building a Category I rating, the highest possible rating in New Zealand, recognising the building's outstanding historical and cultural significance. The main auditorium has been described as having world-class acoustics and was the home of the New Zealand Symphony Orchestra (NZSO) until the Town Hall was closed in 2013 (refer Figure 1). In addition, the Town Hall has been used to record several soundtracks for major films as part of Wellington's burgeoning film industry.

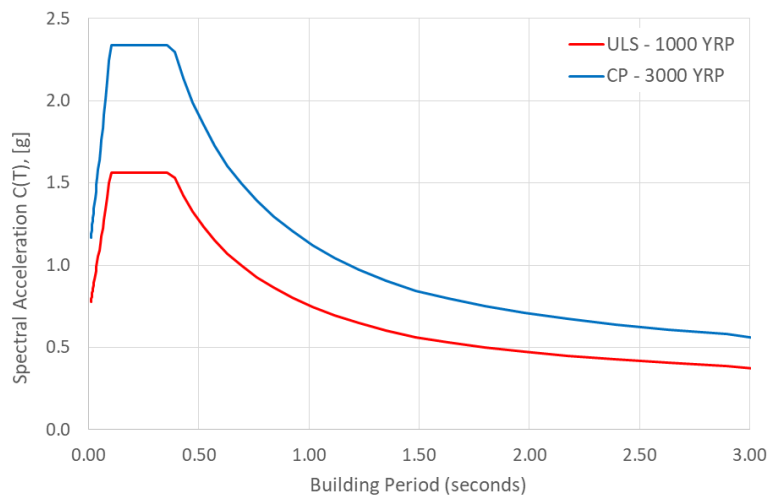
Fig. 4 – NZS1170.5 hazard spectra for Wellington Town Hall site

Seismic loads for the project were determined using NZS 1170.5 [2] in accordance with the project performance objectives (refer Table 1). The Wellington Town Hall site was categorized as subsoil class D with a site period of 0.7s. Interpolated subsoil Class C-D spectra were determined in accordance with the procedure detailed in NZS 1170.5 for the 1,000 and 3,000 year return period earthquakes (refer Figure 4).

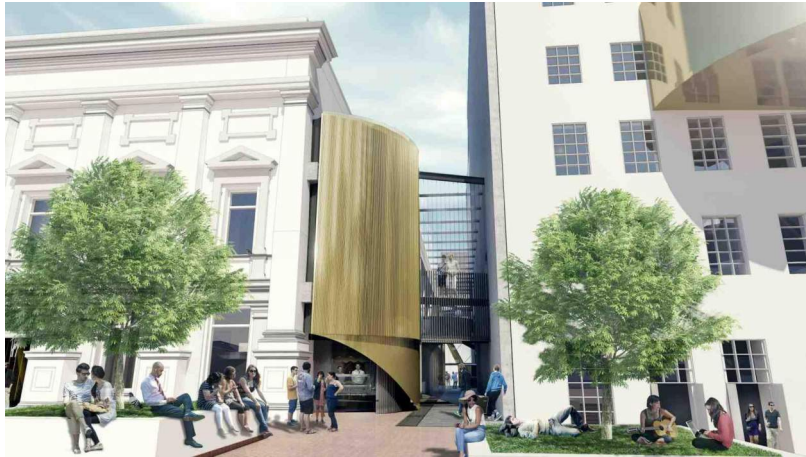
Fig. 9 – Proposed West Hall rendering (courtesy Athfield Architects)

The West Hall, located between the Town Hall and the MOB, will be completely rebuilt. The new structure consists of in situ reinforced concrete slabs supported on a reinforced concrete moment frames (the latter provided to brace the auditorium walls). A new glass atrium roof will be provided over the seismic joint formed between Town Hall and the MOB. The new glass roof will be supported on a steel structure that will cantilever laterally from the MOB and be supported vertically on both the MOB and the Town Hall (the latter consists of sliding joint to accommodate anticipated seismic movements). As shown in Fig. 9, a modern glass, brass, and aluminium façade will enclose the West Hall on each end, creating a laneway between Wakefield Street on the south end and the Civic Square on the north end.
