DAMAGE LIMIT STATES FOR ARTISTIC ASSETS FROM CYCLIC AND DYNAMIC TESTS ON PLASTERED MASONRY WALLS

Keywords: cultural heritage assets, damage limit states, in-plane cyclic shear test, plaster, stone masonry

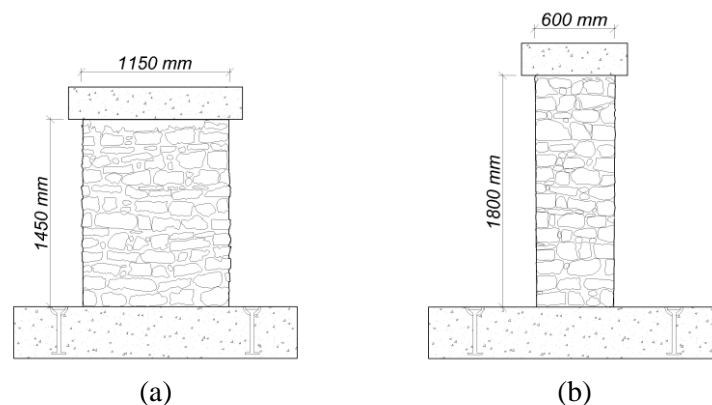
Fig. 1 – In-plane cyclic shear-compression test specimens: (a) squat piers CT01 and CT02; (b) slender piers CS01 and CS02.

Four masonry piers were built during construction of the shake-table prototype for in-plane cyclic shear-compression tests, using the same materials, construction techniques, and scaling factors adopted for the half-scale building prototype [7]. A nominal thickness of about 300 mm was selected, which is the average thickness of the walls of the shake-table prototype. Walls were constructed in double-leaf undressed stone masonry (stone dimensions of about 100÷400 mm) with a 10%÷15% volume of river pebbles (diameter of about 50 mm). Stones were arranged in almost horizontal courses, although not perfectly regular given the variable dimensions of blocks and pebbles. Double-curvature conditions were imposed to the specimens, and two aspect ratios h/ℓ (i.e. ratio of pier height h to length ℓ) were selected: 1.26 for two squat piers CT02 and CT01 (Fig. 1a) and 3.0 for two slender piers CS01 and CS02 (Fig. 1b). For each aspect ratio, two axial compression levels σ_0/f_c (i.e. ratio of uniform normal stress σ_0 at the base to masonry compressive strength f_c) at the pier base were targeted: 0.2 and 0.3 for CT02 and CT01, and 0.3 and 0.45 for CS01 and CS02, respectively. One face of each pier was plastered, with a first leveling layer made of the same mortar used for the masonry (without EPS beads) and a 2-mm-thick skim coat [5].

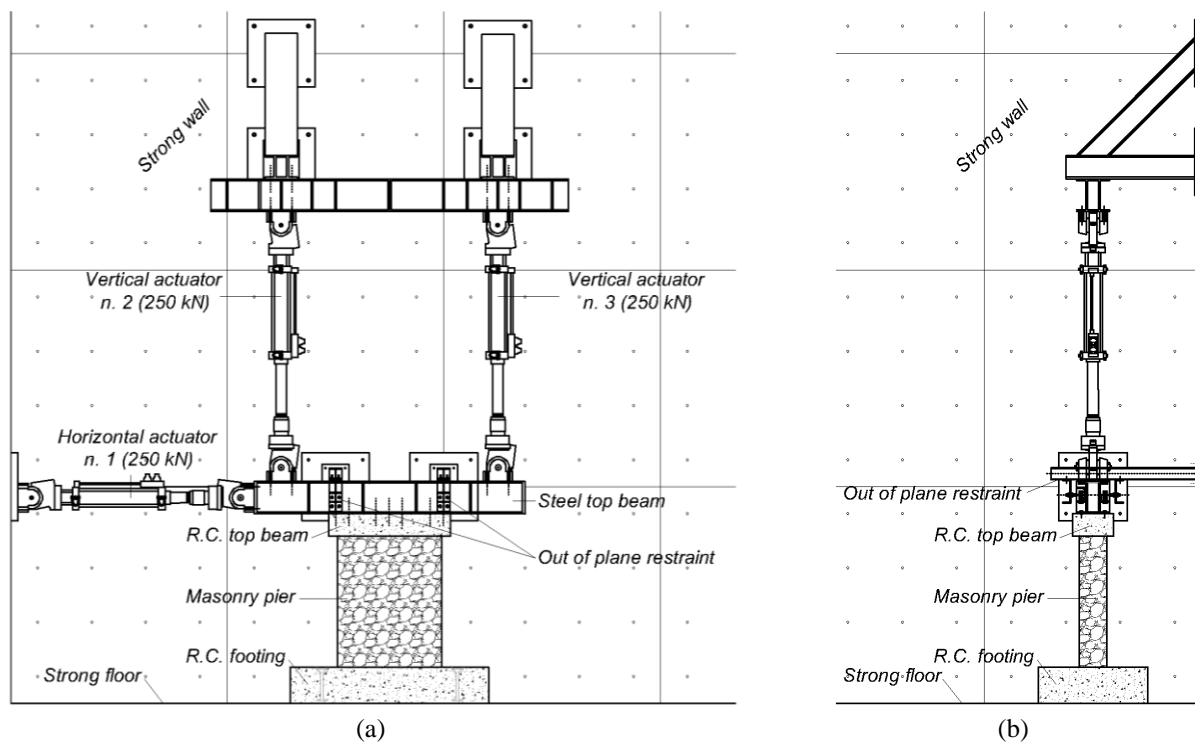
Fig. 2 – In-plane cyclic shear-compression test setup: (a) front view; (b) side view.

The experimental setup for in-plane cyclic tests took advantage of the three-dimensional strong-walls/strong-floor configuration of the EUCENTRE laboratory [9][11]. Fundamental parts of this system were three servo-hydraulic actuators, with a maximum force capacity of 250 kN each and a stroke of 0.76 m. Two actuators applied an axial load to the specimen, while the third one imposed horizontal displacements to the top of the piers in the North-South direction (Fig. 2). Since a double-curvature configuration was chosen for the tests, vertical rotation of the pier top was prevented by the implementation of a hybrid control of the vertical actuators: they were forced to apply a constant total axial load and to maintain the same vertical displacement. Out-of-plane displacements of the pier top were prevented by specific restraints, allowing longitudinal translation only.

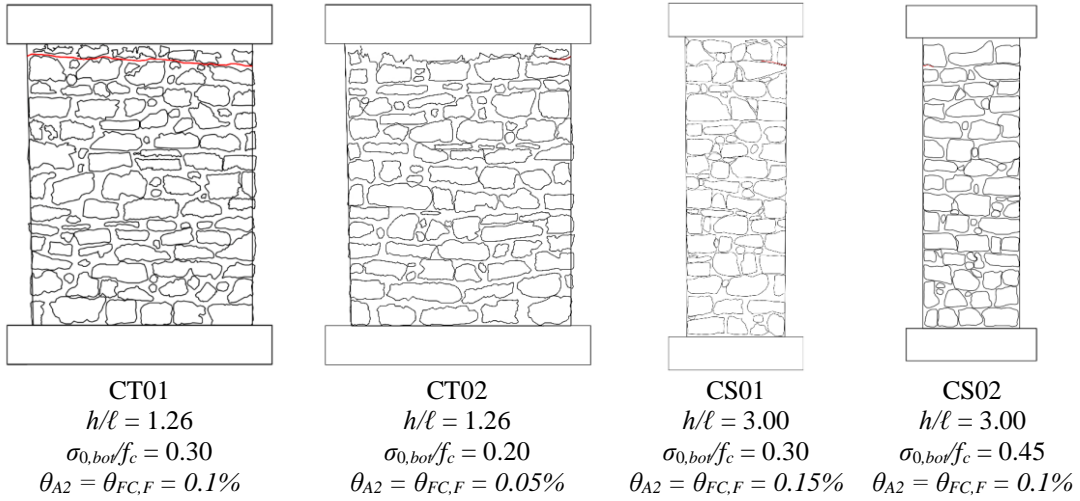
Fig. 3 – Damage conditions the four specimens at first cracking for flexural rocking.

Non-structural damage state A2 was attained in all specimens simultaneously with structural damage state FC due to flexure. First cracks appeared in the plastered surface of squat specimen CT01 at $\theta_{A2} = \theta_{FC,F} = 0.10\%$, with a horizontal crack extending for the entire length below the top stone course. For the other specimens, cracks originated at a corner below the top stone course at $\theta_{A2} = \theta_{FC,F} = 0.05\%$ for CT02, at $\theta_{A2} = \theta_{FC,F} = 0.15\%$ for CS01, and at $\theta_{A2} = \theta_{FC,F} = 0.10\%$ in the case of CS02. Fig. 3 depicts the crack pattern of each pier at A2 damage state.

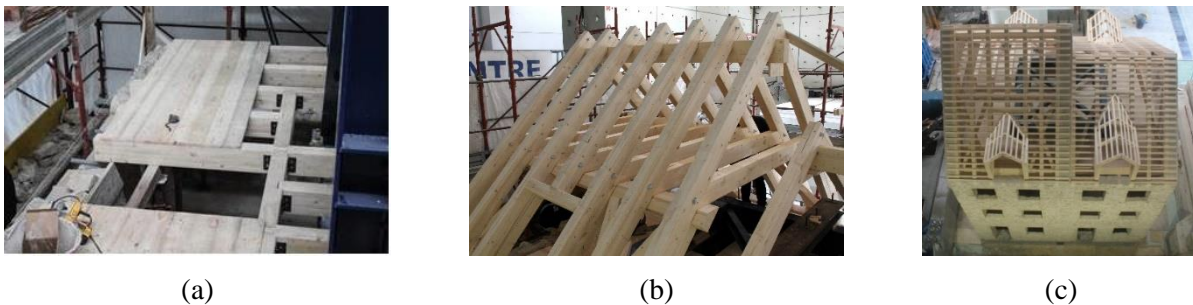
Fig. 7 – Building aggregate prototype: (a) timber floor framing; (b) timber roof trusses with 45° slope; (c) tile battens and dormers.

Timber floor and roof framing provided flexible diaphragm to the building aggregate [5][6]. The timber floors of the prototype consisted of timber joists (typical section of 100x160 mm) and 20-mm-thick planks, nailed to the joists (Fig. 7a). The joists of the first and the second floors were oriented along the longitudinal shaking direction. Roof timber trusses (Fig. 7b) were oriented in the transverse direction and rested on 100x200-mm timber spreader beams, located atop the East and the West walls and embedded into the masonry thickness. Tile battens supporting clay tiles were directly nailed above the rafters, without any planks (Fig. 7c). The roof structures were characterized by slopes of 34° and 45° for the North and South units, respectively, and consequently by two different truss configurations. The shortest truss had a simple layout, without any king post or webs, while the steepest one was more complex with a collar tie beam and a supporting secondary structure. Diagonal braces were provided to increase the in-plane stiffness of the roof pitches.

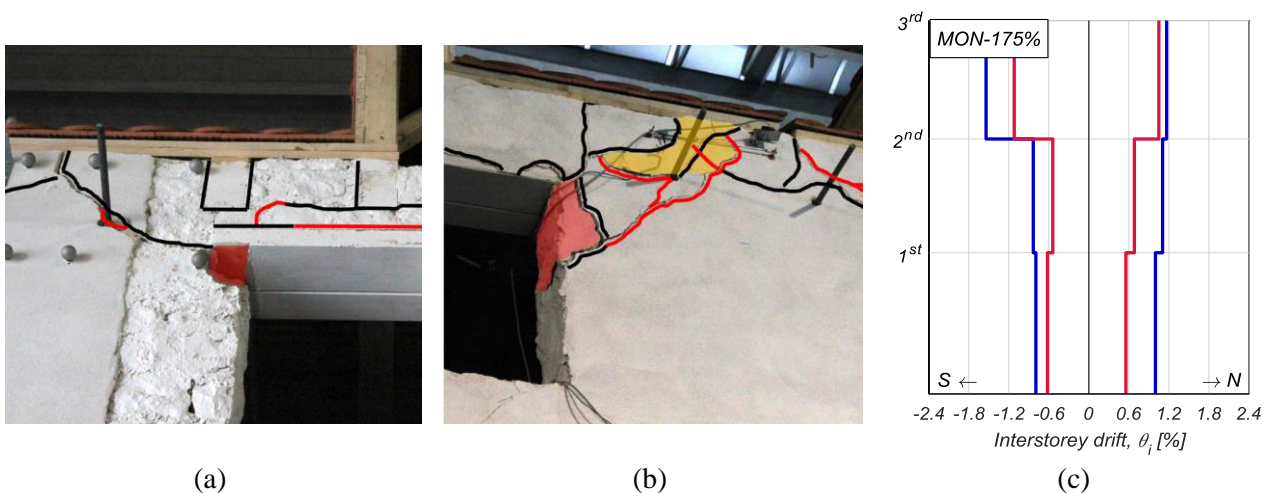
Fig. 10 – Test results after MON-175% with PGA of 0.347 g: (a) West wall fallen stone; (b) East wall completely detached stones and plaster; (c) interstorey drift envelopes, West wall in blue and East wall in red.

During test MON-175% (PGA = 0.347 g) the building specimen reached a severe level of damage and was deemed approaching near-collapse conditions (damage state NC [3][4]), with interstorey drift ratios θ_{NC} between 0.62% and 1.54%. Significant residual crack widths and activation of out-of-plane overturning mechanisms of the North and South walls were observed. Floor joists pulled out from the North and South walls by a maximum of approximately 2.9 mm and 5.9 mm at the first and second floors, respectively, with residuals of about 2.2 mm and 4.6 mm. Flexural-rocking mechanisms occurred at the base of the piers of the East and West longitudinal façades, with elongation and widening of pre-existing cracks. At this stage of testing, portions of plaster and some stones completely detached from the masonry, at the top of the structural joint of the East façade, and were kept from falling only by instruments and cables: this meant that non-structural damage state A4 [3][4] had been reached, with a local interstorey drift ratio $\theta_{A4} = 1.12\%$.
