STUDY ON IMAGE DIAGNOSIS OF TIMBER HOUSES AFFECTED BY THE EARTHQUAKE UTILIZING DEEP LEARNING

Abstract

Keywords: Image diagnosis; Deep learning; Image processing; Timber house; Damage assessment

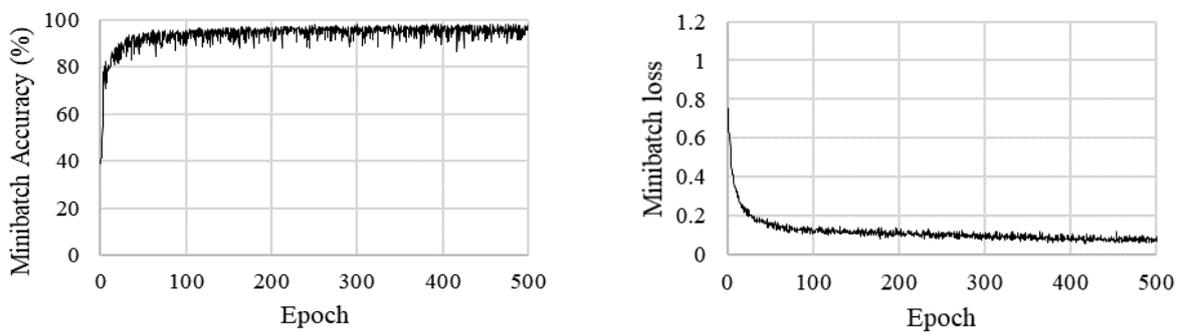
Fig. 1 – Examples evaluation with learning accuracy and loss (Case of SV19/RMC)

In this verification, six image databases for each kind of damage such as real mortar cracks (RMC), chromakeying/pseudo mortar cracks (CMC), real mortar spalling (RMS), chromakeying/pseudo mortar spalling (CMS), real siding board cracks (RBC), and chromakeying/pseudo siding board cracks (CBC) were used for each CNN model cases. Therefore, forty-two cases which consist of seven CNN models and six image databases were examined. These cases were evaluated by indication of learning accuracy and loss. Fig. 1 shows an example of results of learning accuracy and loss. The higher learning accuracy, the more successful deep learning, and the closer the learning loss is to zero, the more successful deep learning. Thus, all cases were evaluated by the indicator, and it was confirmed that the all cases had enough learning accuracy.

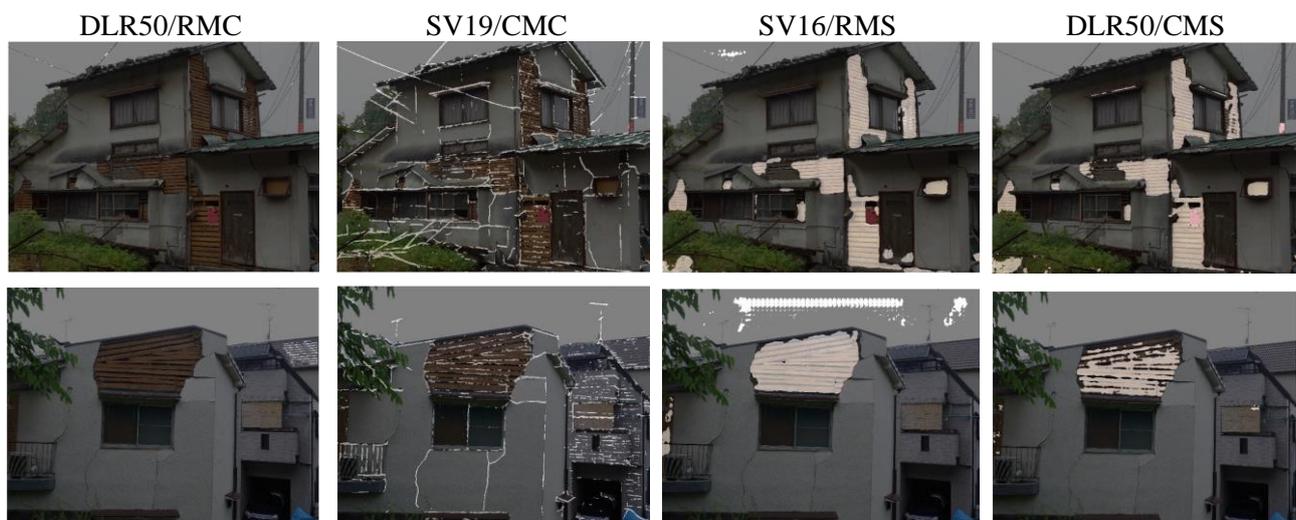
Fig. 2 – Comparison of damage extraction results

Based on the damage extraction results of each CNN models which applied to the photos of Kumamoto earthquake reconnaissance in 2016, each CNN models were evaluated and compared. Fig. 2 shows the comparison of damage extraction results for each CNN models.

CNN models for chromakeying/pseudo damage image database can extract the damage more accurate rather the CNN models for real damage image database. Thus, SV19/CMC, DLR50/CMS, and DLR50/CBC were adopted for damage extractors in the following discussion.

Before damage evaluation, the noises such as plants and wires in the damage extraction results shown in Fig. 2 were removed by using pre- and post-image processing algorithm. Then, the damage rate calculated based on the damage extraction results.

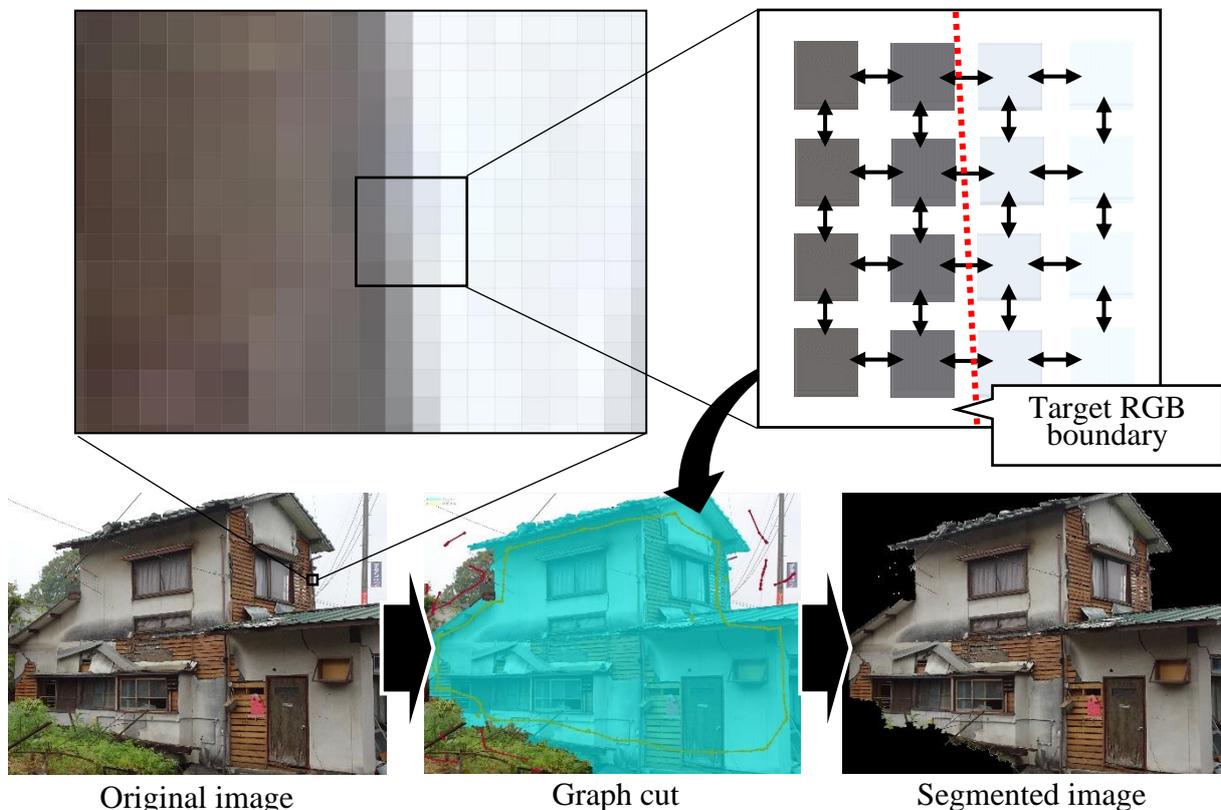
Fig. 3 –Example of graph cut processing

During the pre-image processing, graph cut technique [2] was applied to damage extraction results which were extracted by semantic segmentation. Fig. 3 shows the example process of graph cut processing. The graph cut can segment area such as building and background. In this pre-image processing, the noises in the background were eliminated. However, some noises in the foreground on the building remained, and post-image processing was applied to the results. During the post-image processing, area limitation and Hough transformation [3] denoised the foreground noises. Fig. 4 shows the example of pre- and post-image processing.

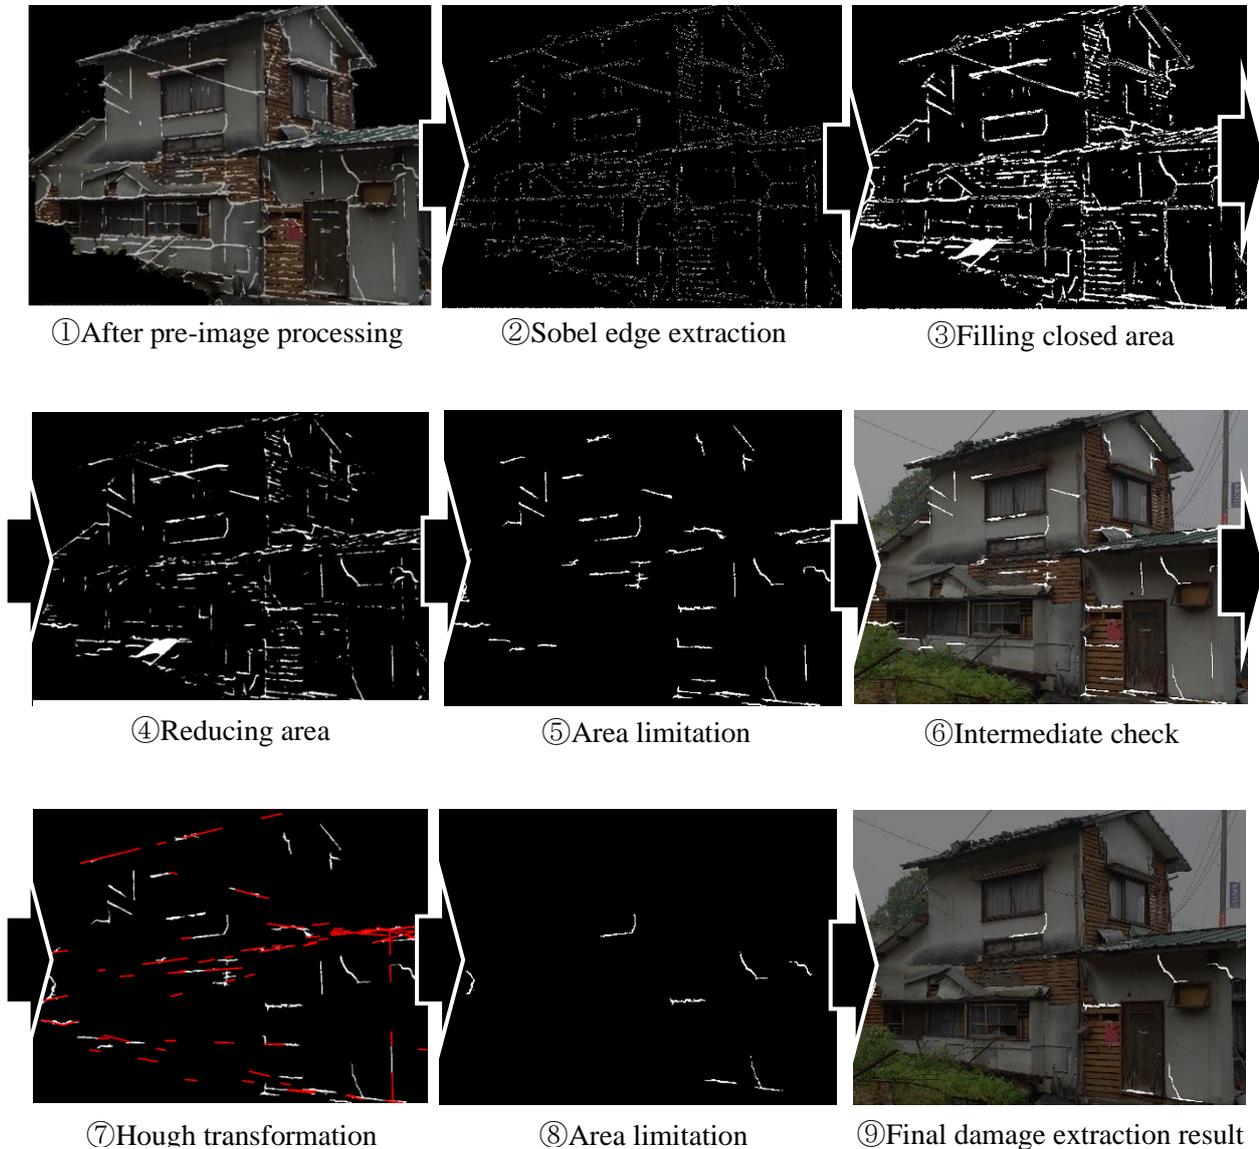
Fig. 4 –Example of pre- and post-image processing

In the post-image processing algorithm, the edge of damage extraction area which was extracted by semantic segmentation and pre-image processing was firstly extracted by Sobel edge extraction method [4]. Then, the closed area was filled and grouped, and deleting 1 pixel of edge from each filled area groups. This is because, Sobel edge extraction usually made area thicker than original area. After that, some noises remain. Thus, noises were eliminated by considering the area ratio which divide the extracted area into crack area and noise area. At the intermediate check, there were still some noises such as wires, eaves and window frames which were straight line. Then, the linear noises were denoised by Hough transformation. And finally, the remained noises were eliminated by area limitation again.

Using only semantic segmentation, the correct damage area was not extracted but a lot of noises were extracted with damage area. After the pre- and post-image processing were applied to the noisy images, its applicability was confirmed.

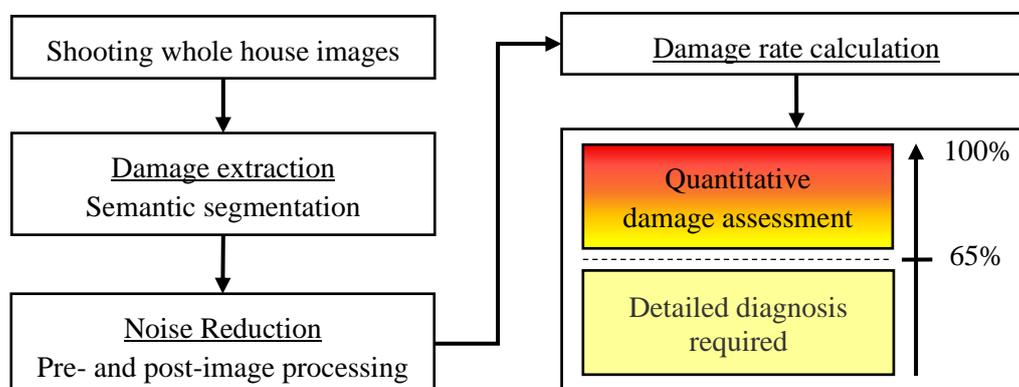
Fig. 5 –System of damage rate calculation based on image diagnosis

From the above results, the image diagnosis system can be proposed as shown in Fig. 5. In this paper, after damage extraction and denoising, damage rate could be correctly and quantitatively calculated in the range over 65%.

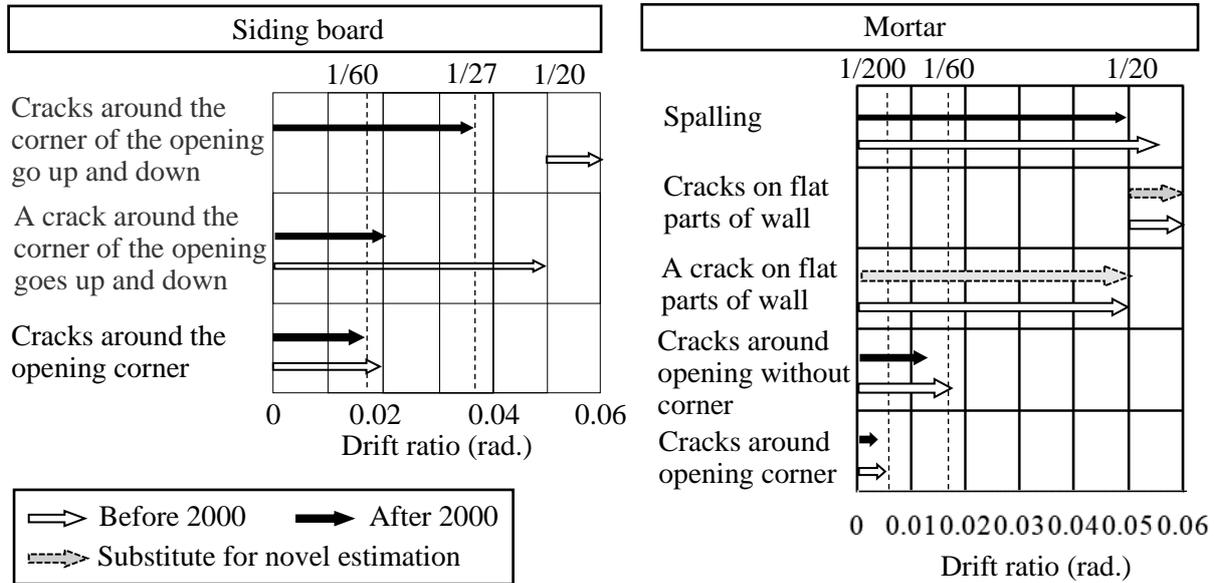
Fig. 6 –Drift ratio estimation classified by construction year

Fig. 5 shows the upgraded estimation method. The estimation of drift ratio of timber houses based on the current seismic standard houses was smaller than that of timber houses based on the old standard. This was because, the value of stiffness and maximum strength of timber houses based on the current standard became higher than that of old standard. Therefore, it was suggested that when the estimation method based on the old standard was applied to the timber houses based on the current standard, the estimation results could be higher than actual drift ratio.
