## EXPERIMENTAL BEHAVIOR OF TWO REHABILITATED BEAM-COLUMN CONNECTIONS UNDER CYCLIC LOADING

### **Abstract**

After the 2017 Mexico earthquakes, significant efforts have been devoted to improve the seismic performance of damaged structures. In that context, two beam-column connections have been tested at full scale under cyclic loading. During the experiments, a displacement-controlled protocol was applied at the tip of the beam by means of a hydraulic actuator. Cross-sectional areas were 600x600 mm for the columns and 450x810 mm for the beams. The specimens were tested up to severe damage (with concrete spalling and crushing and evidence of elongation of longitudinal reinforcement, but not buckling nor fracture). Rehabilitation was carried out using two different techniques. Externally bonded carbon fiber reinforced polymer was used for one specimen and jacketing with high-strength steel-fiber reinforced mortar was used for the other. Re-testing of the specimens was conducted in order to assess the adequacy of the rehabilitation procedures. The results showed that both specimens were able to recover their load-carrying and deformation capacities. As a consequence, comparisons betw

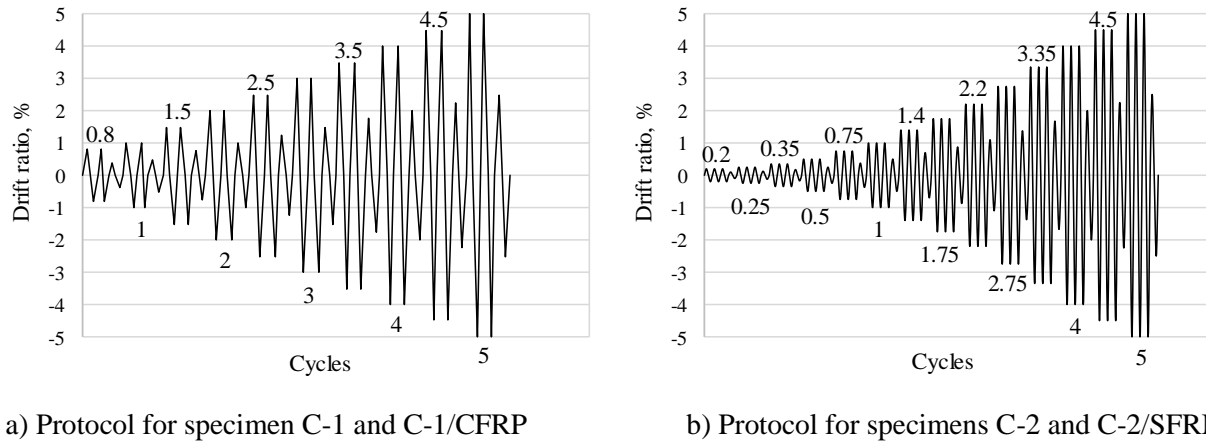
Two different loading protocols were used for the tests in order to evaluate the response of the beam-column connections to various load cycles. These protocols, shown in Fig. 4, follow recommendations given by ACI 374.2R-13 [12]. The displacement history shown in Fig. 4a was applied to specimens C-1 and C-1/CFRP and consisted of two cycles for each displacement target, followed by a smaller cycle at 50% the displacement reached in the previous cycle. Specimens C-2 and C-2/SFRM were tested with the loading protocol shown in Fig. 4b. In this case three cycles were applied for each displacement target, followed by a smaller cycle as with specimen C-1. Additionally, more displacement targets were incorporated.

Fig. 4 – Loading protocols of specimens

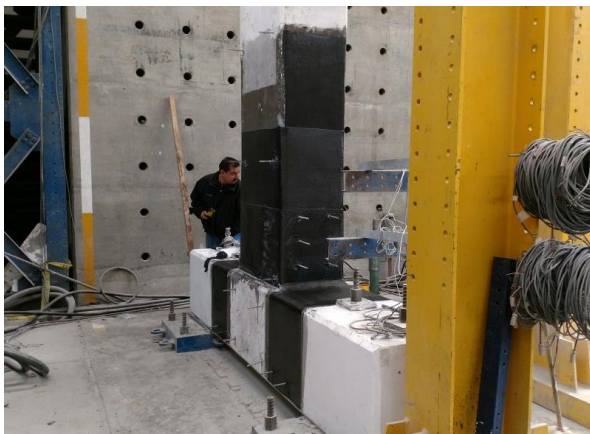
The rehabilitation process of specimen C-1 began with cleaning of the concrete surface, followed by the injection of epoxy in cracks less than 2-mm wide. Voids and cavities were filled with a high-strength mortar with a compressive strength of 70 MPa. Finally, the CFRP sheets were placed after applying a coat of resin. The criteria used for the wrapping of the beam was to confine the plastic hinge region of the beam. Confinement was provided with one layer in the longitudinal direction and one in the transverse direction with lengths of 1.6 and 1.1 m, respectively. Two more sheets were added to the column in order to secure the longitudinal sheets of the beam. Fig. 5a shows the final state of specimen C-1/CFRP.

a) C-1/CFRP

Fig. 5 – Repaired specimens

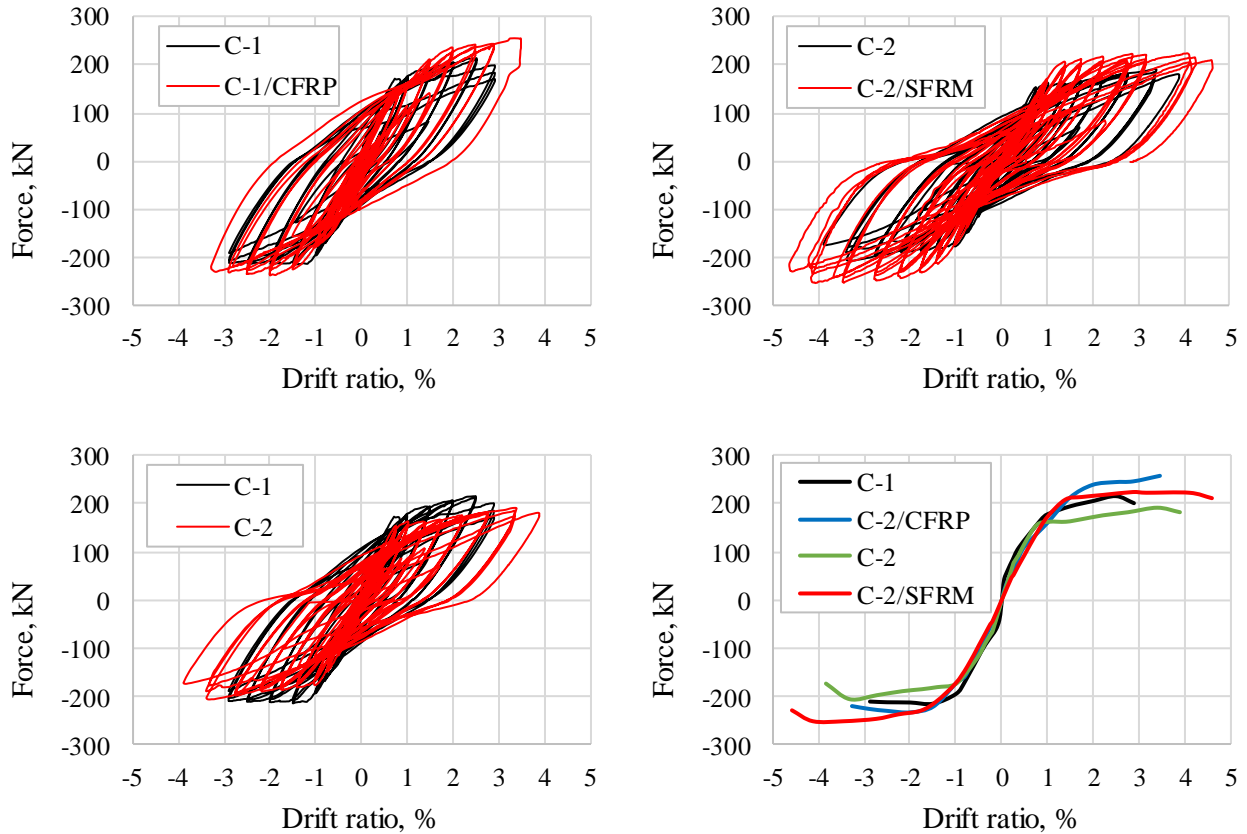
The load-drift ratio curves of all specimens are compared in Fig. 11. A comparison of the envelopes is also presented. As can be seen, specimens C-1 and C-2 were able to recover and, even, exceed their original load-carrying and deformation capacities after rehabilitation. Additionally, the effects of using different loading protocols can be observed. For example, specimen C-2, compared to specimen C-1, presented slightly smaller strength and stiffness. It was, however, able to be taken to drift ratios approximately 25% higher.

Fig. 11 – Comparisons of load-drift ratio curves
