SHAKE TABLE TESTS ON A DAMAGED REINFORCED CONCRETE FRAME STRUCTURE STRENGTHENED WITH COMPOSITE FABRIC

O.A. Petcu⁽¹⁾, I.O. Toma⁽²⁾, P. Mihai⁽³⁾, I.S. Ențuc⁽⁴⁾, G. Opreșan⁽⁵⁾, V.M. Venghiac⁽⁶⁾, G. Țăranu⁽⁷⁾

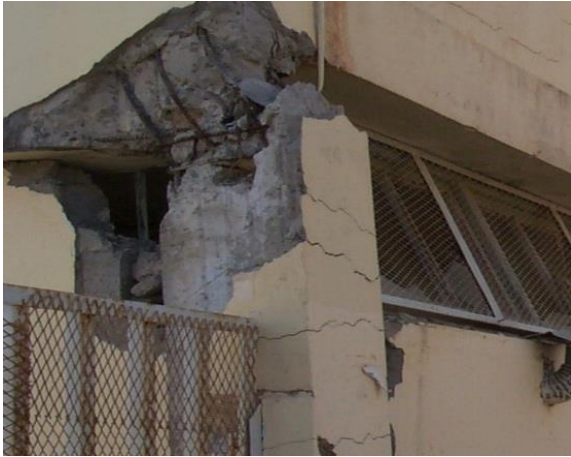
Fig. 1 – Collapsed short-column during the 2003 earthquake in Algeria [19]

Experimental studies also showed a reduction in the ductility of the infilled RC frame with respect to the bare frame. Moreover, partial infill walls may inadvertently lead to the occurrence of short columns thus creating a new set of problems that requires the attention of the civil engineer, Fig. 1, [19]. Such elements are incorporated into structures either as part of the original design or as a result of the changes that took place during the life time of a building. Members that were originally conceived as short columns may not pose significant problems when subjected to seismic loads since every precaution has been taken during the design stage. However, there are cases when, due to later changes in the layout of the structure, the original slender columns become short. This may be the case of non-structural enclosure walls, partial infill walls that shorten the effective length of the column leading to important changes in its behavior during a seismic event.

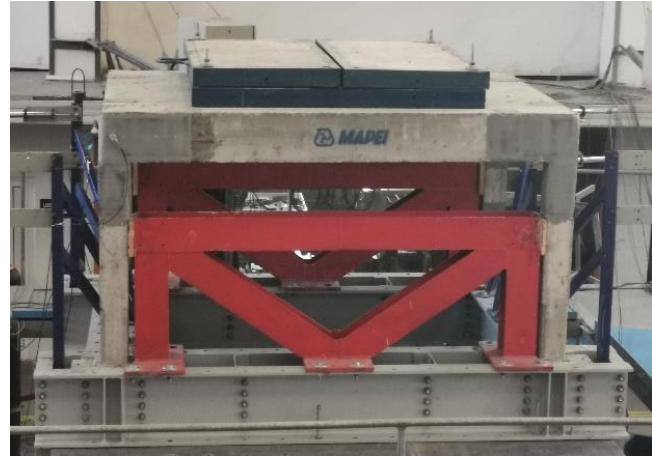
Fig. 2 – Designed experimental model to simulate short-column behavior

The paper presents the results obtained from shake table tests on a damaged RC frame structure that was strengthened with composite fabric. The 1/3-scale symmetric structure was designed according to the specifications of European norms and following the guidelines in the national annex for Romania. The “short column scenario”, as seen in Fig. 2, was considered to account for RC frame structures that have partial infill walls.

The RC frame had an estimated mass of 1.6 tones. The columns were restrained in the direction of the seismic motion so that to obtain a short column with a height of 300 mm. A prefabricated steel frame, as shown in Fig. 3, was fitted between the columns to simulate an infill wall. Soaked wooden planks were placed at the contact points between the concrete and steel frame to fill the gap so as to avoid local crushing from pounding. Gravity load was provided via 4 concrete slabs, Fig. 2, fixed at the top of the slab, transferring a total of 2.8 tones (self mass and additional load).

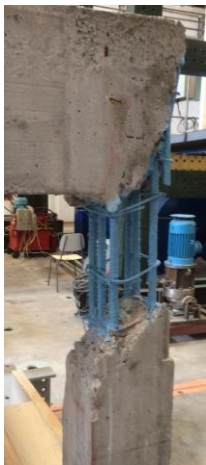
a. Reinforcement

Fig. 4 – Repairing and strengthening of the model

The cracked concrete was removed from the short columns, exposing the longitudinal reinforcement. The reinforcement was inspected for bents or unusual deformations and the recorded values of strains were checked in order to make sure the reinforcement did not reach its yielding plateau. The reinforcement was

then painted with passivating agent to prevent it from possible rusting before the high-flow fiber reinforced mortar would be cast or by coming in contact with the mortar itself, Fig. 4a.

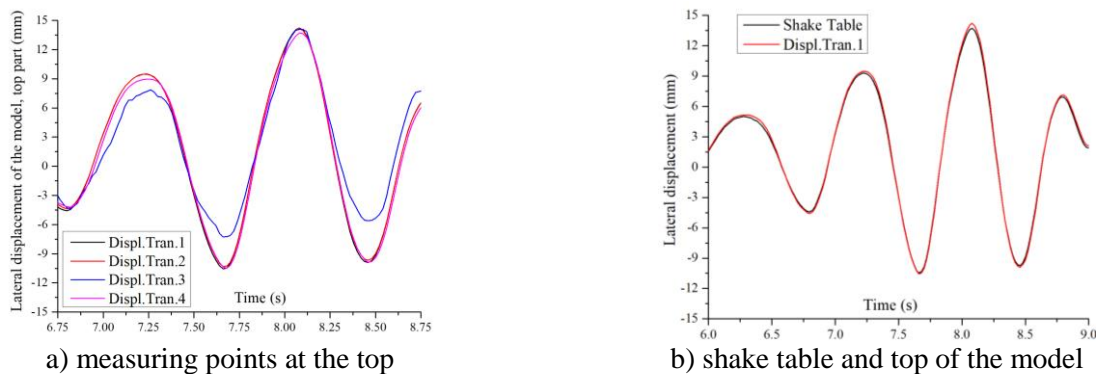
Fig. 8 – Comparison of the lateral displacements for the top of the structure and the shake table

scenarios, reveals the fact that all four displacement transducers recording the displacements at the top of the model, Fig.5, showed similar values for all measuring locations, Fig. 8a. This means that even though the model was subjected to a large number of shake table tests it still follows the uniaxial motion of the seismic input. A comparison of the recorded values for the lateral displacements for the top of the structure and the shake table, Fig. 8b, shows a very small difference between the values which suggests that the structure remains very stiff even at the end of the experimental program.

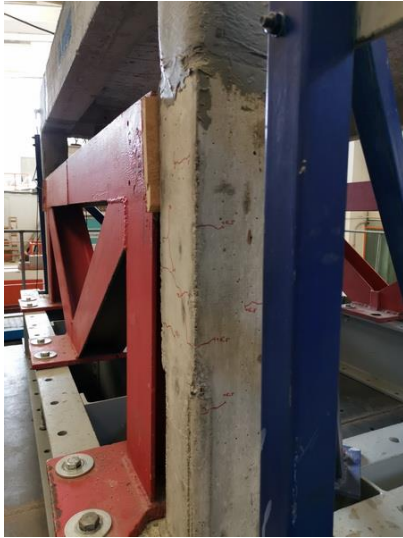
Fig. 11 – Damage in the columns

Upon visual inspection, hairline cracks were identified in all four columns, below the confined area, and at the midspan of all beams, either longitudinal or transversal ones, Fig. 12. This was a visual confirmation of the damage accumulation in the model that confirmed the recorded values for the fundamental frequency of vibration and the calculated values for the damping ratio.

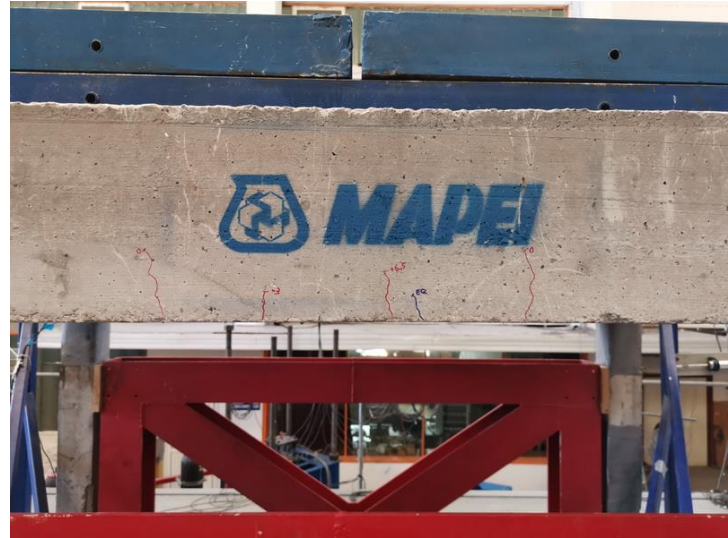
Fig. 12 – Cracking pattern in the longitudinal beam
