BEST RETROFIT BASED ON ENERGY DISSIPATION FOR A BUILDING SUBJECTED TO VARIOUS STRONG EARTHQUAKES

Abstract

Keywords: structural retrofit; energy dissipation; strong earthquake

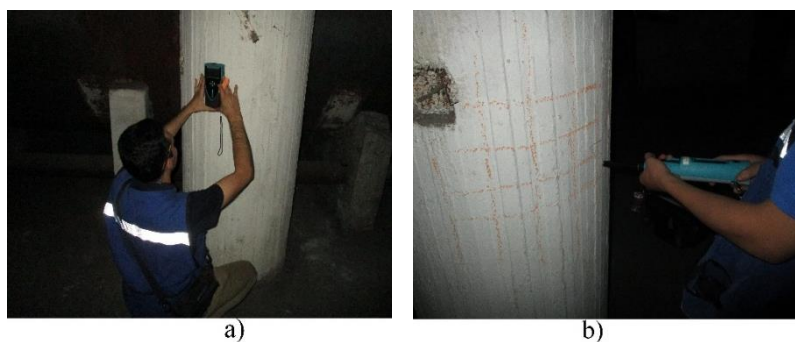
Using the rebar detector (Fig. 2a) it was found that concrete frames have #8 rebar, concrete slabs are 15 cm thick in all floors, and concrete walls are 20 cm thick. Both concrete columns and beams have poor confinement, so they do not fulfill the requirements for ductile members. With the help of the rebound hammer (Fig. 2b), it was possible to know that the concrete compressive strength is 400 kgf/cm². Table 1 shows the different section dimensions found in the field investigation.

Fig. 2 – a) Rebar detection and b) Rebound hammer test on a concrete column

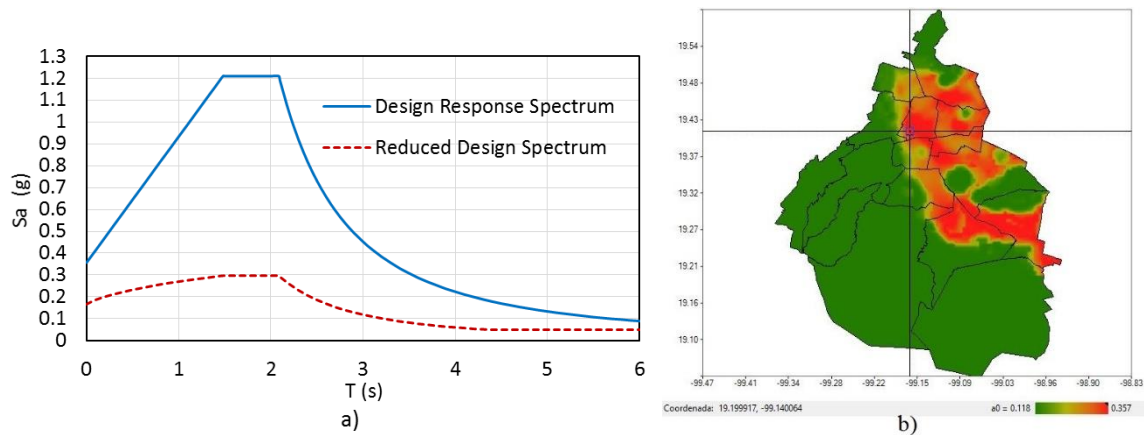
A renovated norm for Mexico City was published after the 2017 earthquake. The considered seismic demand for the a new possible earthquake is based on the new code [1]. This standard uses SASID software [9], which has a seismic regionalization specific for Mexico City. Entering the coordinates of the building, importance factor B, irregularity factor 0.8, Seismic behavior factor 2, and hyperstaticity factor 1.25; the program gives back the design response spectrum. The specific design response spectrum and soil acceleration variation in Mexico City is shown in Fig. 9. For the building retrofit performance, a time-history analysis is performed. The 2017 earthquake record is calibrated to match the reduced design response spectrum that is consistent to the new standard. The accelerograms are shown in Fig. 10.

Fig. 9 – a) Design Response Spectrum and b) seismic regionalization [9]

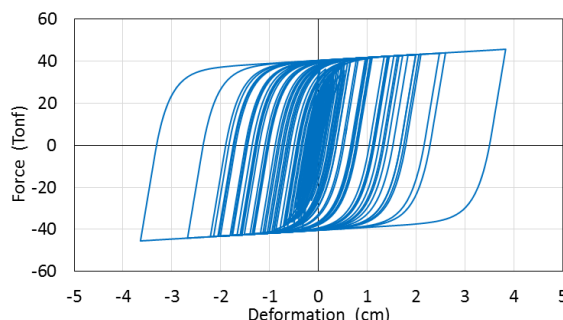
Fig. 18 – TADAS hysteretic loop

Finally, about the energy dissipation devices, a total of 24 FVD and 14 TADAS were used for each retrofit respectively. The greater amount of FVD is due to that they were placed in double diagonal. FVD had a maximum of 175 tonf axial force, 3.8 cm deformation and 110 cm/s velocity. both plots are shown in Fig. 17. While TADAS had a maximum force of 46 tonf and also 3.8 cm of deformation, hysteretic loop of TADAS are shown at Fig. 18. Fig. 19 shows a detail of how to perform the retrofit for the building, due to the poor confinement found in the structure reinforcement, the use of carbon fiber is proposed [15].
