1. Introduction

2. House Reconstruction in Bijulikot – Preparatory Work

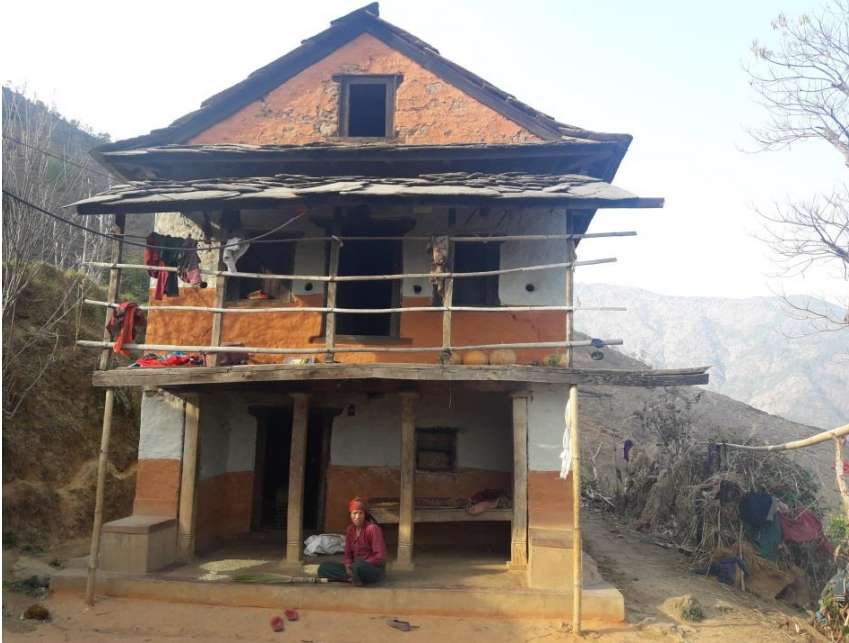
Figure 1. Typical single-family house found in Bijulikot prior to the earthquakes.

Although there are some brick masonry buildings and a few reinforced concrete buildings (confined masonry), the vast majority of buildings in this area are traditional houses 2-story high plus an attic (prior to the earthquake; one-story plus attic after the earthquake) made of stone masonry joined with mud mortar, and with locally sourced timbers for the roof. A typical house can be seen in Figure 1. These houses are built by self-trained masons using locally available materials, often resulting in poor workmanship. The most common problems observed in the buildings were the lack of through stones (wide stones that go through the full width of the wall), lack of bands (sill, lintel and gable) and stitches, improper opening positions and sizes, lack of bonding between masonry units, irregular configuration, and lack of vertical reinforcement at wall junctions. All these structural deficiencies were compounded by other issues such as construction on sloped ground and on unstable slopes, significantly adding to the seismic vulnerability of the structures.

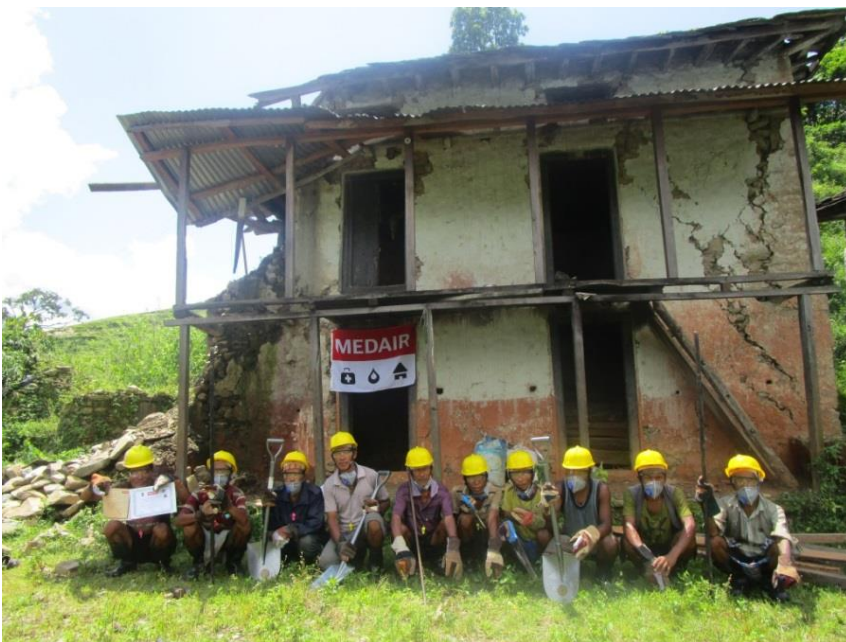
Figure 5. House ready for demolition.

The first step in the reconstruction was to demolish unsafe houses and to classify materials that could be reused such as stone and timbers. Reusing materials played a crucial role in allowing beneficiaries to save money and be able to finish the construction of their houses since the government only provided 3,000 USD per household, which was not sufficient to finish a house. It should be noted, however, that not all beneficiaries chose to demolish their old house as some preferred to keep it for storage and or as cattle shed.

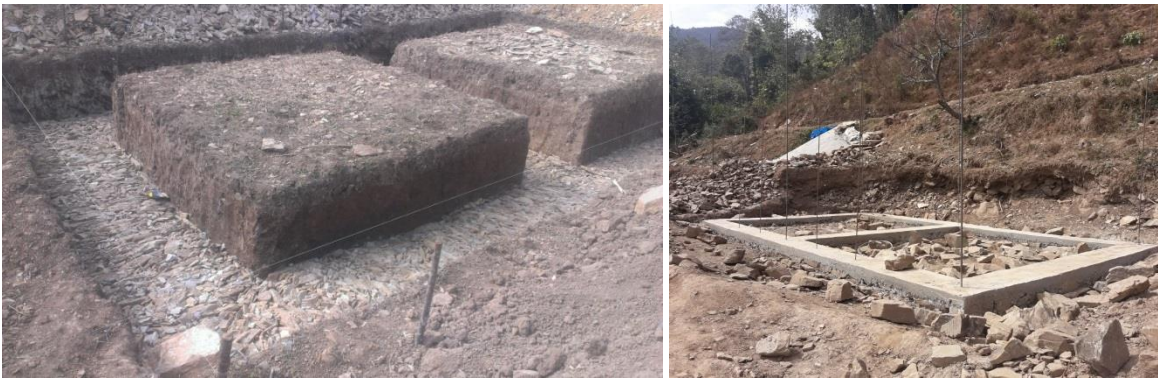
Figure 6. Excavation for foundations, left; construction up to plinth level, right.

Once construction started, Medair engineers supervised the progress on a daily basis, to ensure quality workmanship and compliance with the agreed standard design. Construction started with the layout, excavation, stone compaction, vertical reinforcement erection, stone laying at foundation, and plinth beam construction. Government engineers would perform an inspection once the plinth beams had been poured, and if the required quality was achieved, the house owner would be eligible to receive the second installment. Figure 6 shows the foundation work, with a layer of compacted stone in preparation for the reinforced concrete footing, on the left, and the plinth level finished on the right.

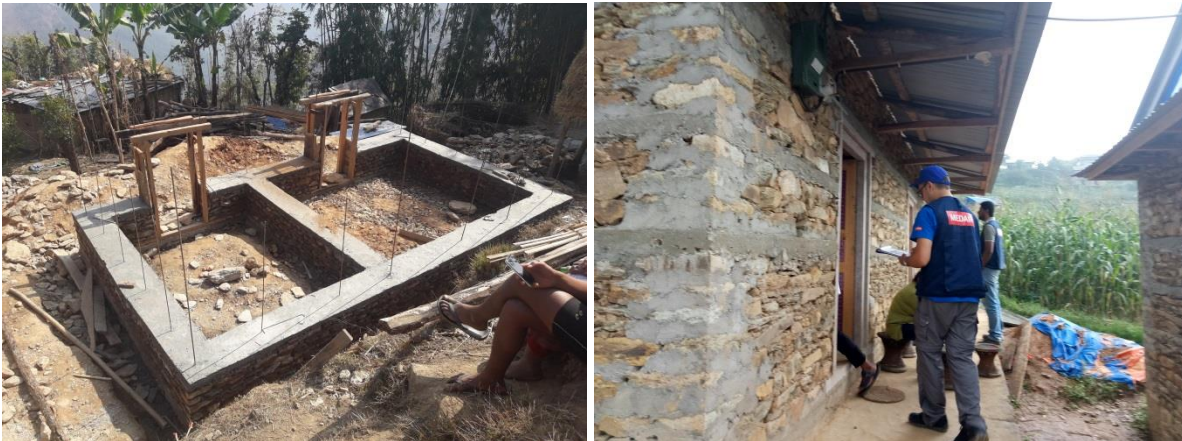
Figure 7. Construction of a house up to sill level, left; inspection of completed walls, right.

After completing the construction of the foundations, the floor was filled with small stones and compacted. Then, wall construction began by laying stones, ensuring that through stones were properly placed, followed by the sill band, intermediate bands and lintel bands, all placed with proper reinforcement details and a 1:2:4 ratio of cement, sand and aggregate. Figure 7 shows the construction of walls up to sill level, on the left, and Medair engineers performing an inspection of the full wall on the right.
