Development of Displacement Sensor for Detecting Seismic Damage of Bearing at Railway Structure

Keywords: Displacement sensor, Bearing, Seismic damage, Damage detection method

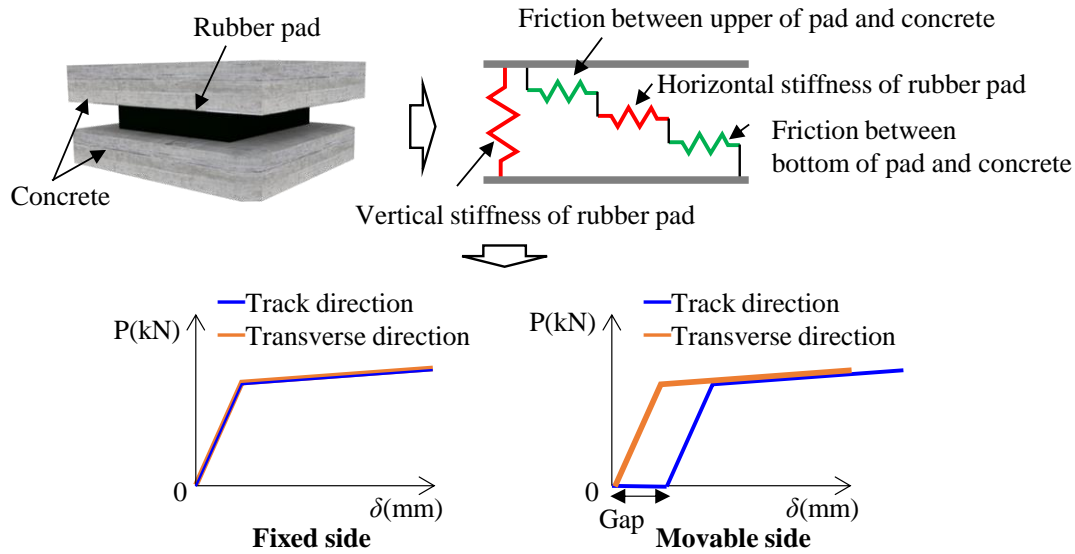
The rubber pad was modeled by vertical and horizontal spring elements, these values of stiffness was calculated by Japanese design standards [4]. In addition, the sliding friction of rubber pad was also considered. The modeling method of bearing is shown in Fig. 5.

Fig. 5 – Bearing model

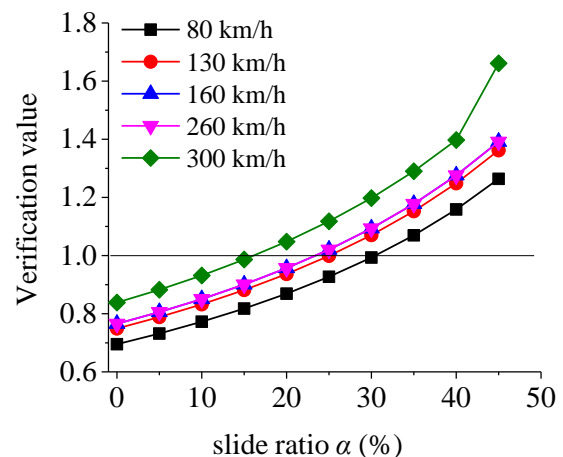
The relationship between the slide ratio α and the verification index with respect to the maximum vertical stress of bearing according to each running speed V is shown in Fig. 6. The maximum vertical stress of bearing was the greatest effect on the running safety. As shown in Fig. 6, in case the slide ratio α is 15% or more, the running safety is not satisfied when the running speed V is 300 km/h. In case the α exceeds 30%, the running safety is not satisfied when the V is 80 km/h or more.

Fig. 6 – Relationship between α and check value of vertical stress of bearing

From the above, it is possible to determine the allowable maximum running speed according to the amount of damage of pad bearing after the earthquake.

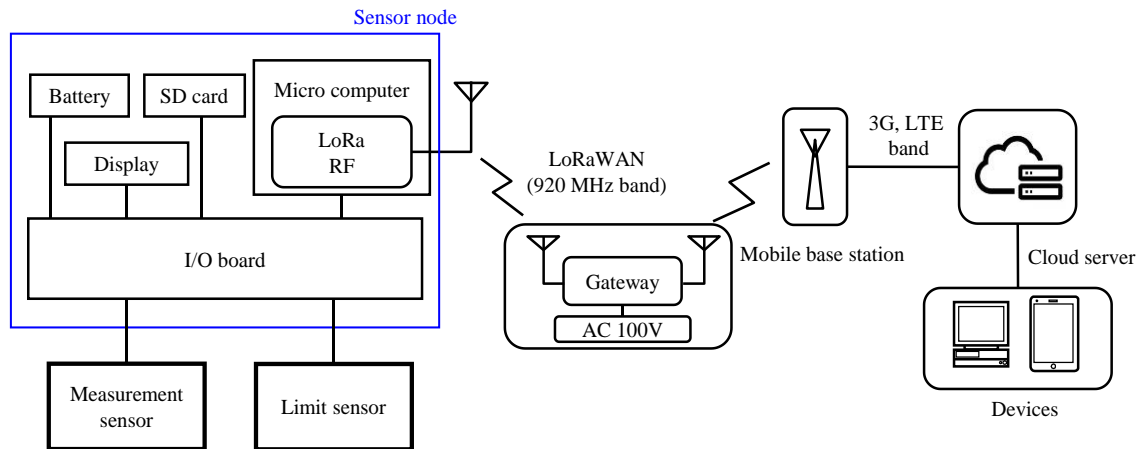
The sensor that satisfies all required performance was developed. The outline of system is shown in Fig. 8. The system of sensor was composed of the following elements:

- A sensor node that measures slide displacement and transmit the data to the gateway
- A gateway that connect the sensor node and the cloud sever
- A cloud sever that store the measured data
- A mobile device such as smart phone or laptop that access to the cloud sever

Fig. 8 – System of the sensor
