ENGINEERING ASPECTS OF THE JANUARY 1ST, 1980 AZORES EARTHQUAKE

E.C. Carvalho^I

SUMMARY

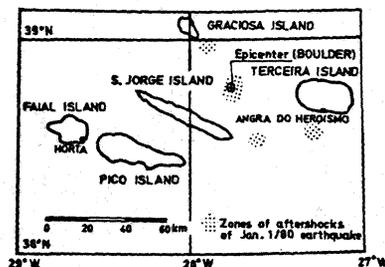
Fig.1 - Jan 1st, 1980 earthquake epicenter

A destructive earthquake of Richter magnitude 7.0 occurred in the northern mid Atlantic ridge at 16: 42: 39 GMT on January 1st, 1980 and affected the Central Group of Azores Islands. According to the determination of the Boulder University in Colorado (USA) the epicenter was located at 38.76° N-27.73° W and the focal depth was 10 km (Fig 1). The earthquake was followed by a large number of aftershocks with epicentral locations in four different areas (Fig 1). The tectonic mechanism of this earthquake is still under study but the available information suggests that it had a strike-slip faulting generation.

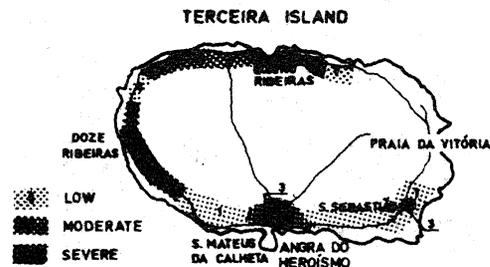
Fig.2 - Damage distribution

The main event caused 60 deaths and severe damage in Terceira and S. Jorge islands and moderate damage in Graciosa. It was clearly felt in Pico and Faial islands where it triggered a strong-motion instrument. Overall damage is estimated at US \$ 100 million. 22 000 out of a 55 000 inhabitants in the 3 islands remained homeless. Even though the final isosseismal map is not yet available, preliminary estimation of intensities anticipates a maximum MMI = VIII occurring in small areas of Terceira and S. Jorge islands. A brief inspection along the peripheral road where the population lives provided a first evaluation of the damage distribution (Fig 2). In the town of Horta, 80 km from the epicenter, the accelerogram recorded (Fig 3) shows a peak horizontal acceleration, a_{max} , of 50 cm/s² and a slightly smaller vertical component. Preliminary response spectra are presented in (Fig 4). Based on that a_{max} and taking into account the different epicentral distances, a value of 100-150 cm/s² seems a credible estimation for the a_{max} in Terceira Island. These values are in agreement with the observed MMI.

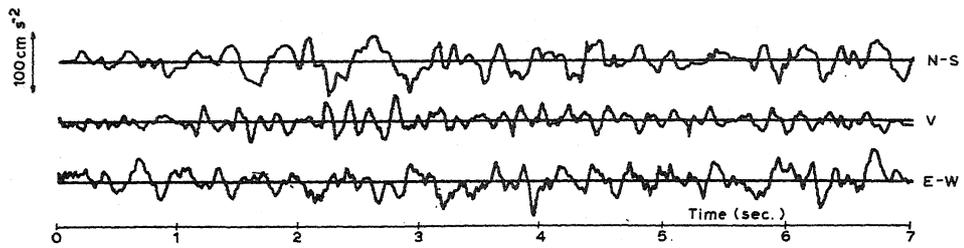
Fig. 3 - Main portion of accelerograms recorded at Horta

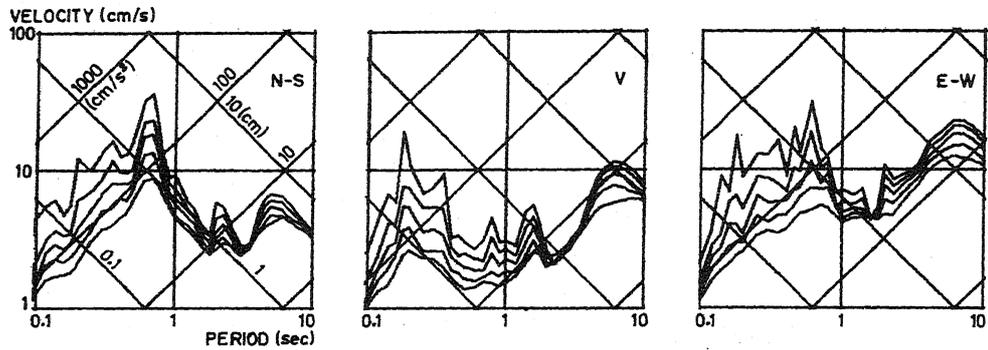
Fig.4 - Computed response spectra for 0,0.02,0.05,0.1,0.2 damping (preliminary)
