Performance and Post Earthquake Assessment of CFA Pile Ground Improvement – 22 February 2011 Christchurch, New Zealand Earthquake

K. M. Murahidy, S. W Sutherland & M. E. Jacka

Tonkin & Taylor Ltd, Christchurch, NewZealand

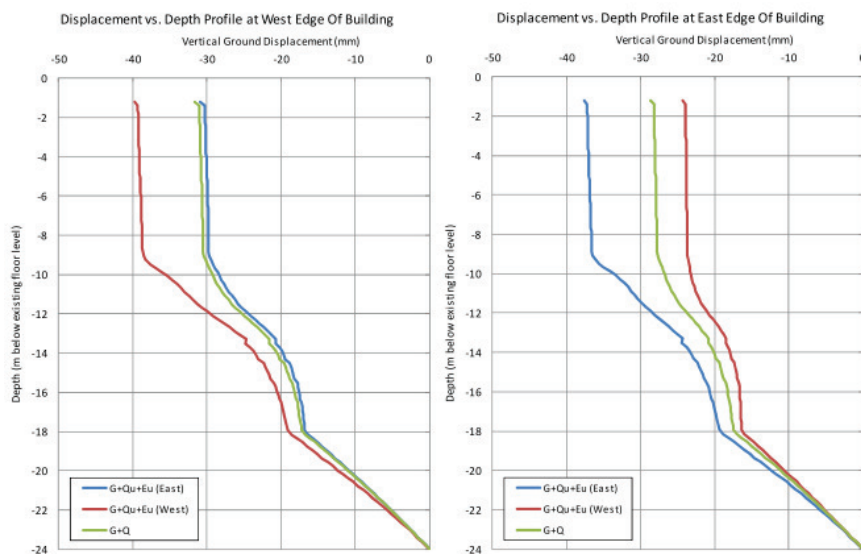
Figure 2.3. Predicted displacement versus depth profiles along selected gridline

Figure 2.3 shows the predicted accumulation of settlement with depth beneath the west and east edges of the building at the selected gridline. These plots show that little settlement accumulates over the upper 9m of the soil profile, as the majority of the vertical loading is carried by the CFA piles. For the various cases analysed, approximately 15-20mm settlement is predicted to occur in the medium-dense to dense sands which extend for approximately 9m beneath the toe of the piles. A further 15-20mm settlement is predicted to occur in the deep silt layer which is present at approximately 18-24m depth. Our model assumes that the gravelly soils inferred to exist below 24m depth are relatively incompressible. As the majority of this settlement occurs at significant depth, the resulting differential settlements at the ground surface are expected to be minor.

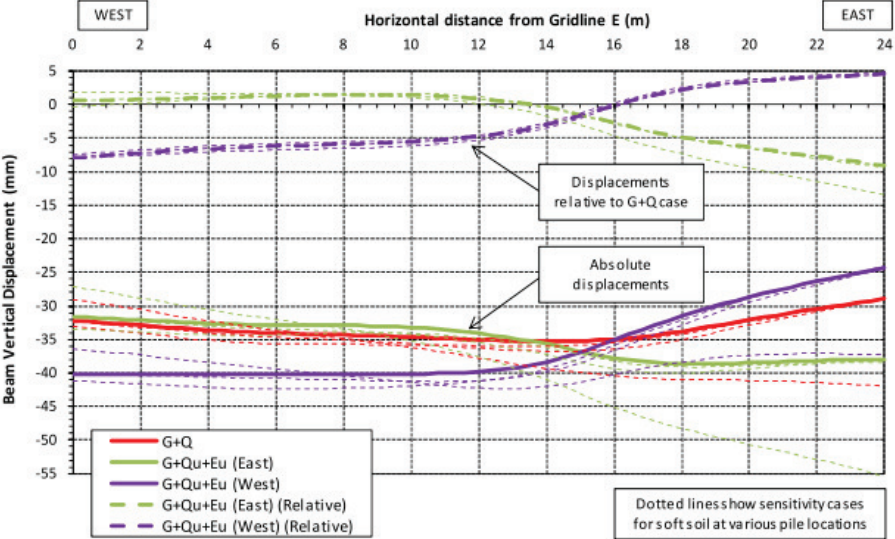
Figure 2.4. Predicted displacement along selected gridline

These analyses show a slight increase in the predicted peak ground beam moments if there is soft ground beneath a heavily loaded column/wall, and a moderate increase in the building-edge settlement if there is soft ground under the side walls. This is shown in Figure 2.4.
