# Seismic strengthening of historical stone masonry structures in Bosnia Herzegovina

**M. Hrasnica & S. Medic**

## SUMMARY:

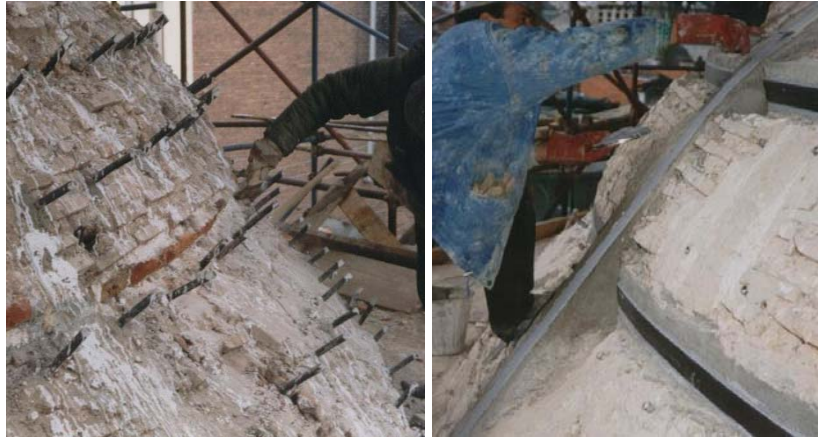
**Figure 3.** Injection of cracks and built in carbon strips.

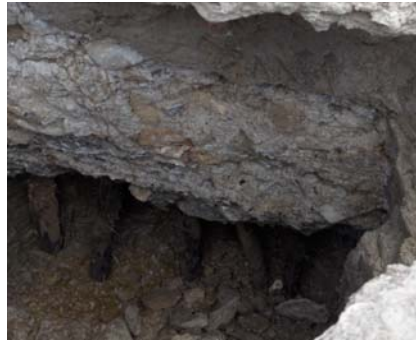
**Figure 5.** Detail of existing foundations with emphasis on oak micro-piles.

The loads are further transmitted to the foundation structure which comprises upper layers of fine stones and detritus beneath, forming foundation strips. The traditional foundation structure is strengthened with oak piles which act as micro-reinforcement (see Fig.5). Finally, the most elegant element of the mosque is slender minaret (tower) which is usually connected with the thick mosque wall at its bottom part. This affects positively the lateral behavior of the high minaret exposed to horizontal forces like wind and earthquake.

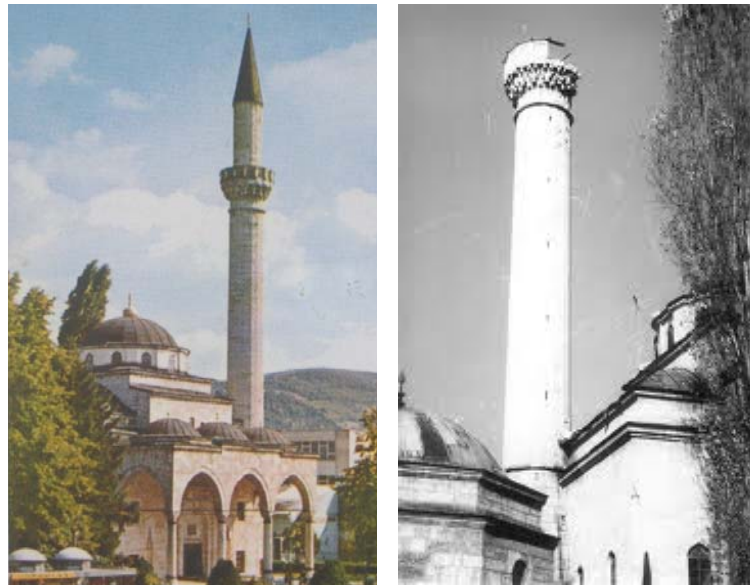
**Figure 7.** 1969 Earthquake damages on Ferhadija's minaret that cracked above balcony.

Three strong earthquakes consecutively hit the city of Banja Luka on 26<sup>th</sup>, 27<sup>th</sup> and 31<sup>st</sup> Oct , 1969, whose intensities were 7.5 MCS, 8.5 MCS and 6.5 MCS respectively. Numerous buildings were destroyed, 15 people lost their lives and 1300 were injured. Two mosques were heavily damaged. Still, from the structural point of view, the damages occurred at the expected places. The minaret of Ferhad-Pasha's mosque cracked above the balcony, where the significant change of stiffness exists (see Fig.7). As usual, the minaret's cross-section is thinner above the balcony and exactly at that level the minaret was cut by the earthquake. The walls of Arnaudija mosque suffered from large inclined cracks over the window (see Fig.8). The windows in the mosque's walls and domes represent the weak places in the rather stiff and brittle structure. It cracks already due to moderate earthquake motions. It is to notice that damages can be accumulated through history as the consequences of different seismic activities.

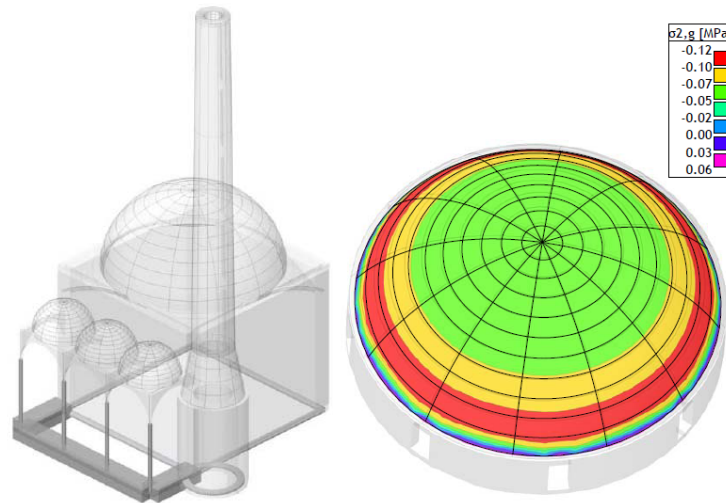
**Figure 10.** Global FE model (left) and detail with equatorial stresses in dome (right).

Simple models of the dome, drum, arches, minaret etc. as well as the global FE models with beam, solid and shell elements (see Fig.10) encompassing also the sub-soil influence were used. Geometry generation was quite demanding because no easy input from the drawing file was possible. The differences in the precision and interpolation type of CAD (splines) and FE (polynomials) program caused major problems especially for intersections of different elements. With the help of program Mathematica, this problem was overcome.
