Seismic Performance of RC frame Retrofitted by Epoxy Injection Technique Tested on Shaking Table

Yuanmiao ZHANG, Jiangtao YU, Zhoudao LU, Lei TAO, Hui SUN

Research Institute of Structural Engineering and Disaster Reduction, Tongji University, Shanghai, China

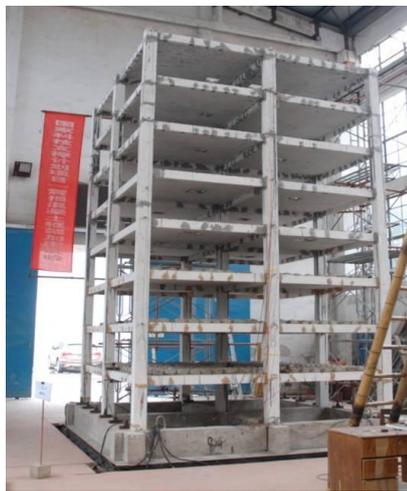
a) The repaired model frame

b) The layout of displacement & acceleration transducers

Figure 2. Facade view of initial model frame and repaired model frame

A 1/4-scale two-bay eight-storey RC frame (shown in Figure 2a) tested on shaking table had a rectangular plan of dimensions 3.4 m×3.4 m, a total structural height of 6 m and its typical storey height is 0.75 m. The cross sections of column and beam were 150 mm×150 mm and 125 mm×50 mm respectively, the thickness of slabs was 30 mm. Model concrete, with a ratio of 0.76:1:4.58:1.69 were made of regenerated aggregate served as coarse aggregate and fresh sand served as light aggregate. The total weight of the model was 23560 kg.

Engineering at Tongji University. 12 displacement transducers, 28 accelerometers and 6 strain gauges were installed on the model to measure the lateral displacement and the angular rotations in the ends of beams and columns, acceleration at each story, and strain on the columns. Figure 2b shows the view of the experimental setup and instrumentations for the shaking table test, where letters A and D refer to accelerometer, displacement transducer respectively.

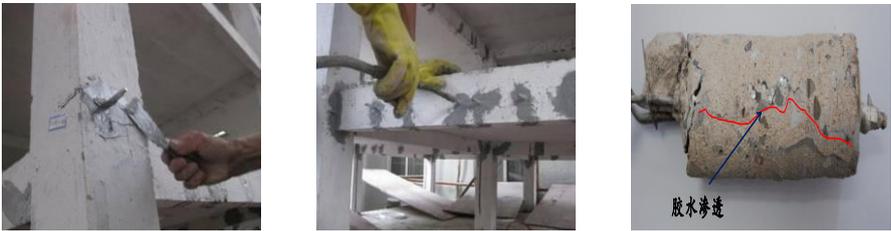
a) crack sealing b) pressure injection c) concrete sample

Figure 3. Process of epoxy-injection technique and concrete samples

presented as follows (in Figure 3): a) drilling small holes in the beams and columns along the cracks; b) cleaning dusts and particles in the hole with blower; c) putting needles in the holes; d) sealing the cracks by XH111 Normal A/B; e) injection under pressure which can be varied according to the location and width of the crack. During the injection, appropriate pressure should be taken to avoid the rupture of the concrete. And cyclical injection was recommended to make sure that the crack was filled with epoxy. After repairing of the beams, columns and joints, the crack in the slabs was rehabilitated by epoxy grouting. Epoxy XH160 A/B was painted along the cracks.

When the retest finished, rock driller was used to take samples (diameter=60 mm) of model for examination of the effectiveness of epoxy-injection, as is shown in Figure 3c. It can be found that the epoxy whose location shown by the red line in the picture can permeate the concrete along the crack which demonstrate the favorable effect of such injection technique.
