Some Recent Developments of Post-Earthquake Restoration and Pre-Earthquake Preparation

R.C. Lo

Klohn Crippen Berger Ltd.

ABSTRACT:

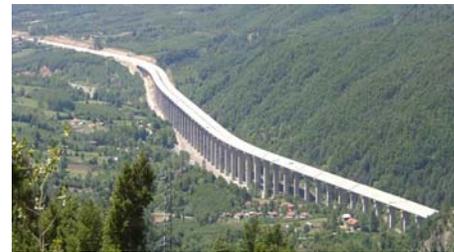
Figure 4. General View of West Bolu Viaducts (Ghasemi 2004)

The 2.3 km long, dual-structure West Bolu Viaduct (see Fig. 4) was near completion when the Düzce earthquake occurred. The viaduct has 59 spans, and its 40 m long spans consist of 7 lines of simply-supported, pre-stressed concrete V-shaped box girders seated on pot bearings with stainless steel passive energy dissipation units. The top portion of the device is a crescent-moon-shaped yielding element to provide two-dimensional energy dissipation over a 32-cm range of horizontal motion. The unit is connected to the base by a pair of piston dampers (see Fig. 5). The deck slab is continuous over 10 spans. A piston and a sliding unit were incorporated in the energy dissipation unit at the expansion joints and at the centre pier of each 10-span deck segment. The piers are single, octagonal hollow-core reinforced concrete columns, which are 8 by 4.5 m in section and varying in height from 10 to 49 m. The piers are founded on reinforced concrete footings, which are supported in turn by twelve 1.8-m

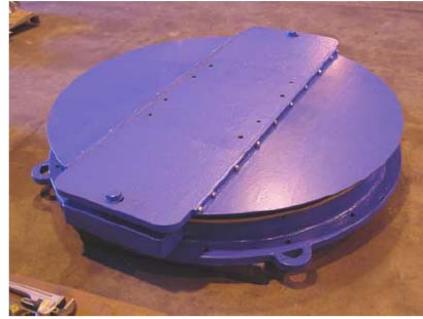
Figure 6. Retrofit Scheme at Typical Interior Pier Using Friction Pendulum Isolation Bearing (Ghasemi 2004)

- replacing the initial damping device shown on Fig. 5 by the friction pendulum device shown on Fig. 6, which was judged to be able to accommodate a large permanent fault rupture offset without damaging the isolation unit and the viaduct as well as capable of dissipating large amounts of energy;
- repositioning the deck slab for an entire 10-span segment at a time; and
- including additional piles and extending existing footings to repair damaged footings near the fault rupture.

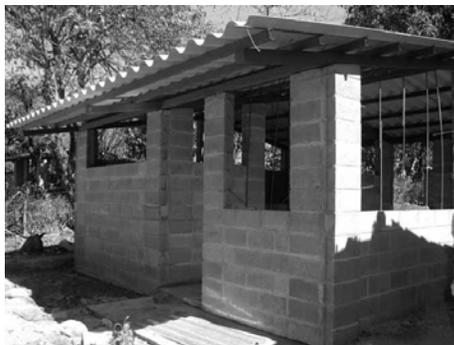
Figure 7. Reinforced Masonry Building to Improve Seismic Resistance (Calvo et al. 2010)

To cope with the seismic threat to population, traditional adobe and bahareque (supported by mud-filled wooden lattice or timber skeleton) houses are discouraged, improved adobe construction method (Blondet et al. 2003) and reinforced masonry house (Calvo et al. 2010, see Fig. 7) are adopted. In addition, grass-root community efforts have been mobilized to improve the public awareness of natural hazards as well as the self-help means to protect themselves. Figure 8 shows that gabion structures have been used effectively to protect the geothermal wells against rock fall, mud-flow and landslides.

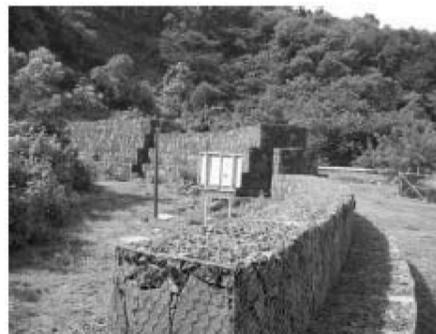
Figure 8. Gabion Walls Constructed to Protect Geothermal Wells (Barrios et al. 2011)

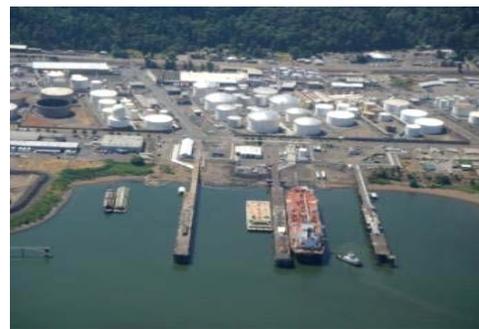
Figure 15. Marine oil terminals in Portland, Oregon, USA.

Figure 15 shows three oil terminal piers, with a ship and a barge berthed at either side of the middle pier. Figure 16a shows one of the piers at the water's edge with a timber "wall" that would likely concentrate seismic stresses and lead to failure of the pier. Figure 16b shows a poorly maintained post with inadequate element connection. All three piers would likely experience extended damage due to a combination of lateral spreading and major structural deficiencies.

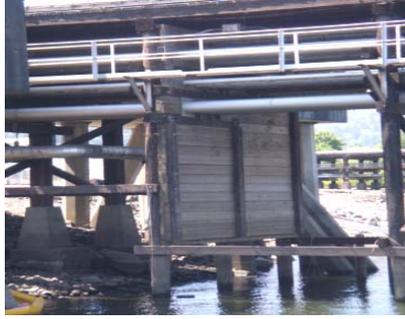
Figure 16. (a) Side view of pier and its foundation (b) Close-up of a wooden post on spalled concrete post.

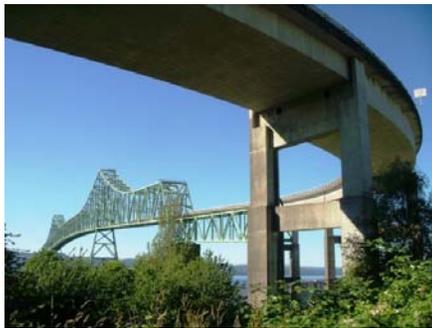
Figure 17. The 1966 Astoria Megler Bridge that spans the Columbia River. The approach segment in the foreground has major structural deficiencies

The structures that may collapse or fail and block the waterway include the 1966 Astoria-Megler bridge (Fig. 17), 1930 Lewis and Clark bridge in Longview, Washington, 1931 St Johns bridge, 1908 BNSF rail bridge, multiple high-voltage electrical transmission-line crossings (Fig. 18), and several 1960s-vintage buried natural gas and liquid-fuel pipelines. The closed channel has to be cleared and restored by the U.S. Coast Guard before resumption of navigation.

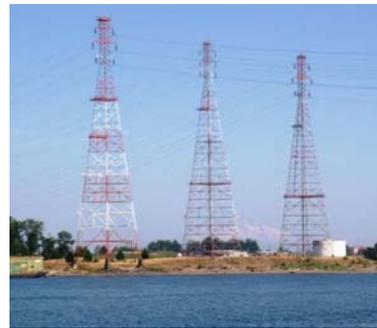
Figure 18. The high-voltage electrical transmission-Line crossings founded on subsoil susceptible to liquefaction and lateral spreading

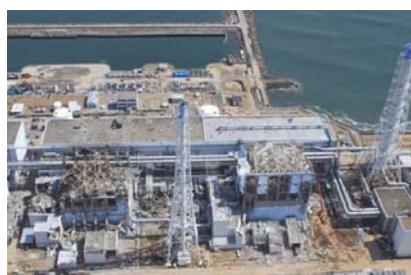
Figure 20. Blast-Damaged Fukushima Dai-Ichi Nuclear Power Plant Unit 3 (left) and Unit 4 (right). (Image: ©Fabio Iuliano, <http://pinktentacle.com/>)
