# SEISMIC RETROFIT OF URM WALLS WITH FIBER COMPOSITES

### Juan I V DIMAS<sup>1</sup>, Mohammad R EHSANI<sup>2</sup> And Hamid SAADATMANESH<sup>3</sup>

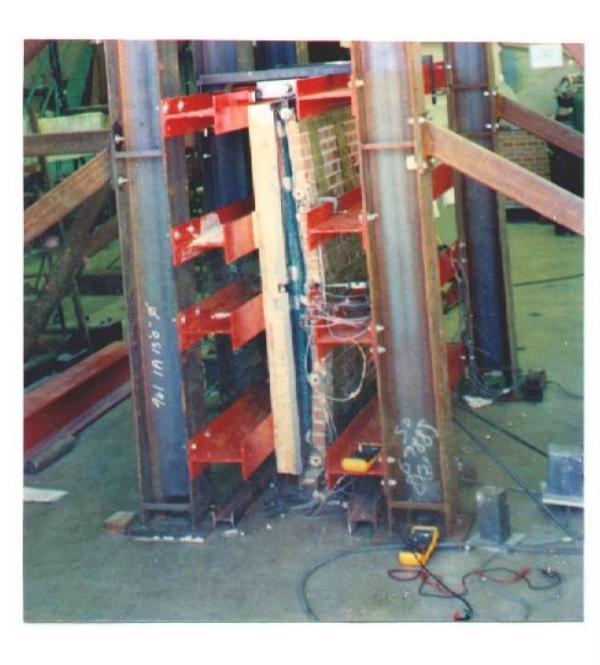
# Fig. 1. Test setup

The walls were tested in a steel reaction frame. The specimens were simple supported along the top and the bottom edges; the two vertical sides were free. With these boundary conditions, it was intended to reproduce a portion of the wall free of corner and joint interference. A roller condition was provided at the top, i.e. vertical displacements and rotations were allowed. The specimens were subjected to cyclic out-of-plane loading. The lateral pressure was applied through an airbag system which was moved from one face of the wall to the other; more details about the test set-up is presented elsewhere (Velazquez-Dimas, 1998). The load was applied to the walls in two stages: a load-controlled stage, which consisted of two pairs of cycles to observe the uncracked behavior, and a displacement-controlled stage, where the maximum displacement in each pair of cycles remained constant. The stiffness degradation was monitored using two loading cycles for the same displacement level. This procedure was continued until the failure of the wall was reached. In order to exclude the beneficial effect of overburden pressure, no axial load was applied to the specimens. An overall view of the testing frame is given in Fig. 1. The maximum deflection at mid-height of the west edge and the applied pressures were monitored in real time by two voltmeters and the corresponding load vs. deflection curves were plotted on the monitor of the data acquisition system. A number of clinometers and LVDTs and strain gages were also used to monitor the response of the specimens.

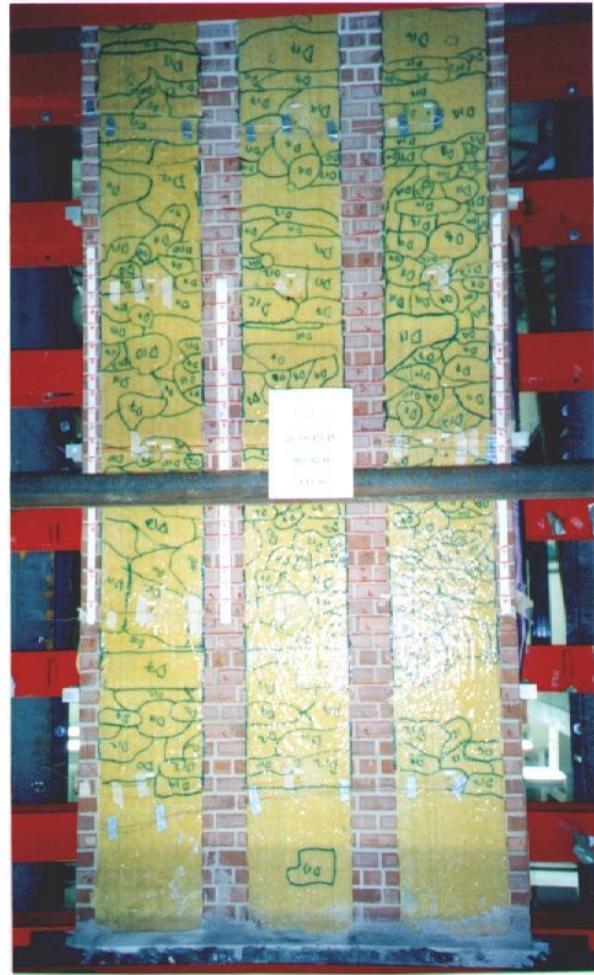
Fig. 2. Delamination pattern for Specimen D100

In addition to the bed joint cracks, the initiation of debonding of the composite materials from the brick surface was the next significant stage in the behavior of the specimens. This debonding was usually accompanied by a sound in the composite. This stage contributed greatly to the loss of stiffness for the wall. The gradual development of new delaminations were mapped on the composite strips as shown in Fig. 2. It is noted that in spite of the formation of these delaminations, the walls did carry a large number of load cycles before final failure of the wall was reached.

The failure of the walls could be characterised by a number of modes as outlined in Table 1. The most common mode of failure was complete delamination of one or more of the composite strips, although in no case did this delamination occur in a symmetrical manner at both ends of a strip. Examples of specimens failed by this mode are S75/25, S20/40, and D100 that is shown in Fig. 2. Another mode of failure was the rupture of the composite strips in tension. While in coupon tests, the composite strips carried strains upto 0.02, tension failure in walls occurred when the strips had reached strain levels of only 0.01-0.013. This is attributed to the cyclic tension-compression nature of loading that the strips experienced. Consequently, it is recommended not to rely on the full strain capacity of the composites under these conditions.

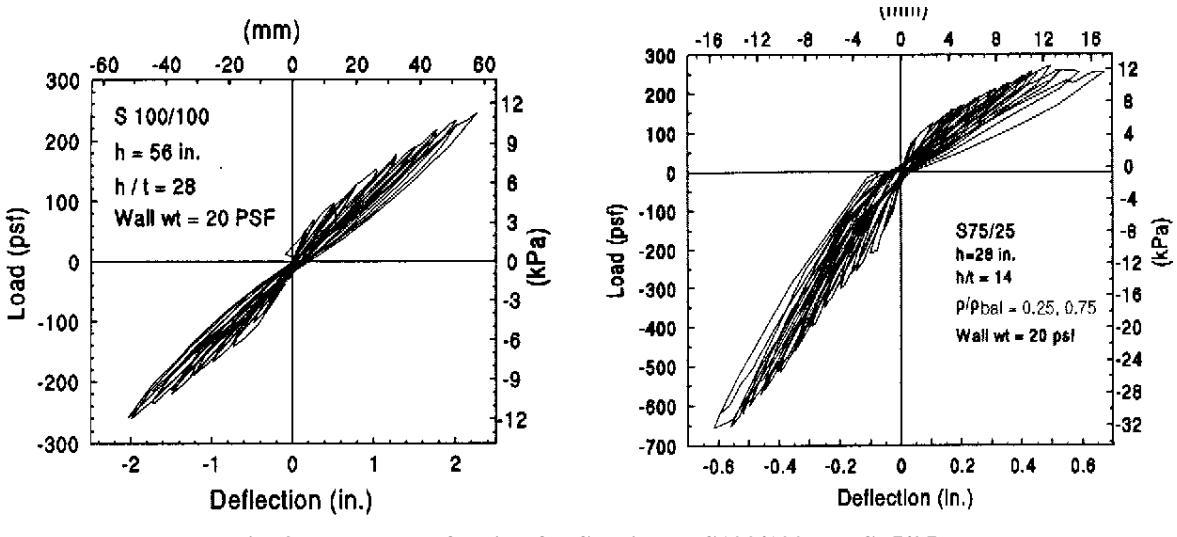
Fig. 3. Load vs. deflection for Specimens S100/100 and S75/25

The load-displacement hysteretic response for a symmetrically-strengthened wall (S100/100) is sown in Fig. 3. This wall was reinforced with three vertical composite strips, resulting in a balanced reinforcement ratio. The behavior of the wall was characterised by excessive cracking along the mortar joints all over the north and the south wall surfaces. The crack patterns on both faces seemed more or less uniformly distributed. Extensive delamination also took place on the composite strips on both faces. By the conclusion of the test, delaminated areas covered approximately 75% of the entire area of the strips. But, delaminated patterns were non-symmetrical for the two faces. On the north face where tensile failure occurred, the east strip delaminated fairly symmetrically above and below the middle brick course. However, the central and west strips delaminated from bottom, midway to the top support. The wall was subjected to 23 cycles of loading, supported a maximum lateral pressure of 11.7 kPa (249 psf) and deflected 58 mm (2.3 in.). The failure load was equivalent to nearly 13 times the weight of the wall and the maximum deflection was almost 4% of the span.

Noting the symmetrical behavior of the previous specimen, several walls were retrofitted with different amounts of reinforcement on the south and north faces. This would increase the amount of information obtained from each test. One such specimen is S75/25 whose load-displacement response is shown in Fig. 3. In order to determine the load carrying-capacity of plane brickwork, this wall was first tested as a Control Specimen (without any composite strips). Under these conditions, the wall failed at an applied pressure of 4.13 kPa (0.6 psi) by splitting in two pieces. The wall was later retrofitted and tested again as specimen S75/25. The south face was subjected to 21 cycles of loading while the north face supported 23 cycles. The behavior on both faces was characterised by a progressive bed joint cracking and gradual delamination of the composite strips as the applied pressure increased. Wider cracks were observed on the south face of the wall, where a 2-mm crack width was measured. Cracks spread for almost 75 % of the wall area on both faces. Essentially, linear elastic behavior was observed before a major crack development on both faces. Additional information about this specimen is given elsewhere (Ehsani, et al. 1999).

Tensile failure occurred on all three north composite strips. Prior to the fracture of the north strips, cracking sounds indicated the imminent failure. While the central and the west strips failed above the middle brick course, the east strip broke at mid-height. Although the balanced reinforcement ratio suggests simultaneous tension and compression failure of the wall, no compression failure of the brick was observed. The composite strips broke

along a jagged line rather than a straight line across the width of the strip. This may be attributed to the uneven wall surface that would create local stress concentration points at the edges of each brick. Due to the failure on the north face, the composite strips of the south face did not fail. A vertical crack passing through the brick was detected underneath the central strip at failure. This indicated that the flexural capacity of the brickwork parallel to the bed joint was reached. Therefore, a minimum amount of horizontal reinforcement needs to be provided to avoid such failure.

Different mode failure occurred on the two faces. Twenty-one cycles were applied to the south face. Due to the severe damage caused by delamination on the three strips, the test was terminated. The top half of the west-strip was almost completely delaminated. The same situation was observed for the bottom half area of the central strip. The east strip was almost fully delaminated from the top to the bottom support. Delamination started at mid-height then spread above and below the middle brick course. No tensile failure on the composite strips was reached due to the fact that the load was stopped at pressure of 12.4 kPa (1.8 psi) at a maximum deflection of 16 mm (0.63 in.). This was done in order to continue the test for the north face.

Very stiff behavior was observed for the north face. The failure occurred by a sudden peeling of the three strips at the top support. On this face, delaminated areas were located mostly above the middle brick course. This failure took place at a maximum pressure of 31.03 kPa (4.5 psi) and for an ultimate deflection of 15.5 mm (0.61 in.). Peeling controlled the mode of failure for both faces, although a tensile failure of the fabric was expected due to the relatively low reinforcement ratios used. However, these peeling failures did not occur until the specimen had resisted significant load and displacement. In addition, the ratio of maximum supported lateral pressure for the north and the south face (PmaxN/PmaxS=2.5) was in agreement with that given by the corresponding reinforcement ratios, i.e. close enough to 3. However, the same pressure ratio was not observed for the first major crack and the first delaminated area on both faces of the specimen.

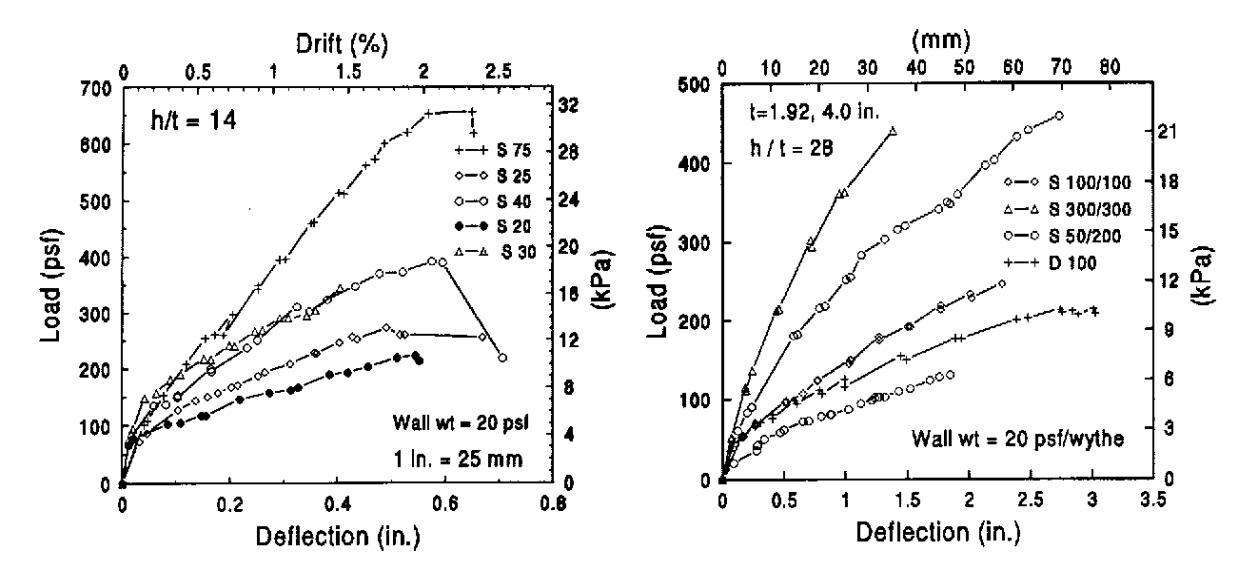
Fig. 4. Load vs. deflection envelopes for the specimens

The envelopes for the peak load at each cycle for all specimens are shown in Fig. 4. The ultimate deflection for the short walls was about 15 mm and that for the slender walls was 80 mm; this demonstrates that the ultimate displacement capacity of the wall is proportional to the square of the height and not the amount of reinforcement.

As can be seen from the data in Fig. 4, the presence of composite strips increased the failure load of the walls significantly. The specimens resisted loads, which ranged from 5 to 30 times the weight of the wall. As can be seen, for specimens with h/t = 14, the diplacements have been also reported in terms of the percentage of drift. However, in calculating the drift ratio for the slender specimens (h/t = 28), one must recognize that the height of the double-wythe wall (D100) was twice that of the remaining specimens. These large failure loads are considerably larger than the walls that a typical URM wall may experience during an earthquake. The figure also indicates that the ultimate load is proportional to the amount of reinforcement. The composite overlays transformed the brittle walls into very strong and ductile URM elements. Based on the analysis of the strain gage data and an examination of the behavior of the test specimens, it is recommended that the service loads be limited to that resulting in a longitudinal tensile strain of 0.004 in the composite strips.

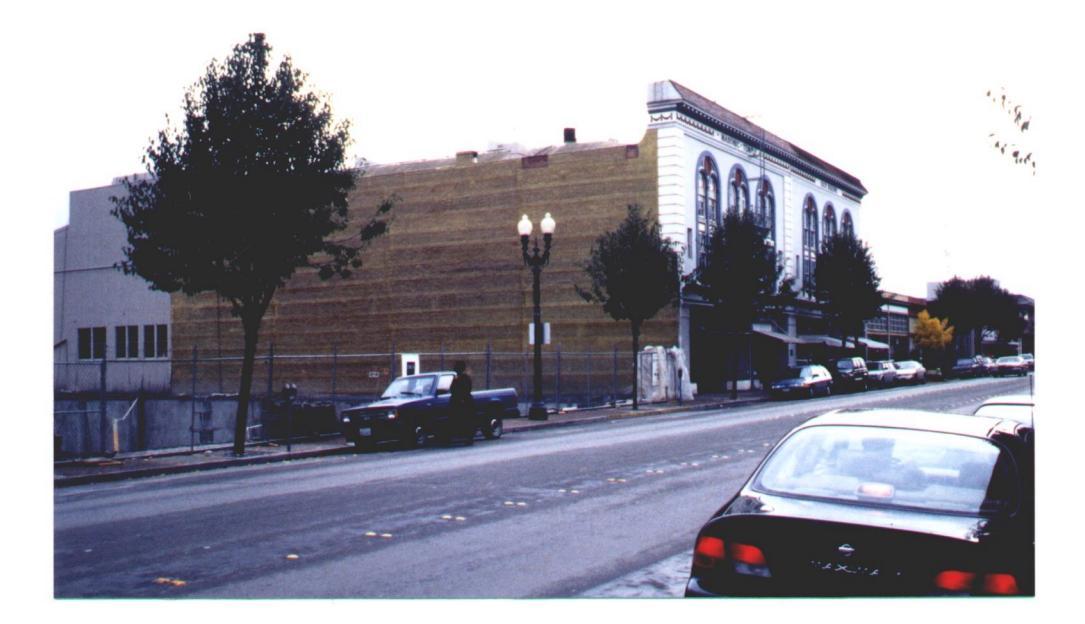
# Fig. 5. Retrofit of a URM building with glass fiber composites in northern California (Courtesy of External Reinforcement, Inc., Tucson, AZ)

A recent application in northern California is shown in Fig. 5. In this case, the property adjacent to the URM wall was being excavated, causing a concern regarding the stability of the wall. The composite system was used to strengthen the 18.3 m (60 ft.) long by 10 m (30 ft) high wall. The total thickness of the composite was about 3 mm and the project was completed in less than a week.
