INVESTIGATION AND SHAKING TABLE TESTS OF SUBWAY STRUCTURES OF THE HYOGOKEN-NANBU EARTHQUAKE

SUMMARY

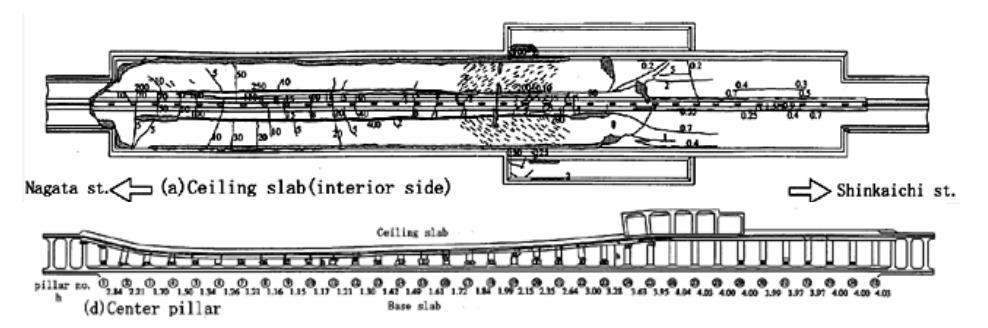
Figure 1-a Schematic figure indicating damage of the ceiling slab and the center column

The most serious damage brought to underground structures in Kobe was the damage to those of subway structures, most part of which was constructed by means of cut-and-cover techniques. Six underground stations out of the total 21 subway stations in the Kobe area were severely damaged by the earthquake: the Daikai and Kosoku-Nagata Stations of the Kobe Rapid Transit Line, the Sannomiya, Kamisawa and Shin-Nagata Stations of the Kobe Municipal Subway, and the Nishidai Station of the Sanyo Electric Railway. Also, some sections of running tunnels connecting with the damaged stations and the tunnel section of the Hanshin Railway sustained damages. The Daiichi Station was the most seriously damaged. Figure 1-a shows schematic diagrams of the damages in the longitudinal direction and Figure 1-b shows schematic figure of the damage pattern in the transverse direction. In the station, more than half of the center columns completely collapsed, and the ceiling slab supported by them bent and fell down. Typical damages to the center columns are shown in Photo 1. This

resulted in subsidence at the surface street with a maximum depth of 2.5 m. At the other stations, as well as the running tunnel, a large number of central reinforced concrete columns cracked. Major factors to have led the cut-and-cover box structures to failure are inferred to be large shear distortion of the box structures induced by shear strains in the surrounding ground during the earthquake, and lack of shear-ductility of the center columns.

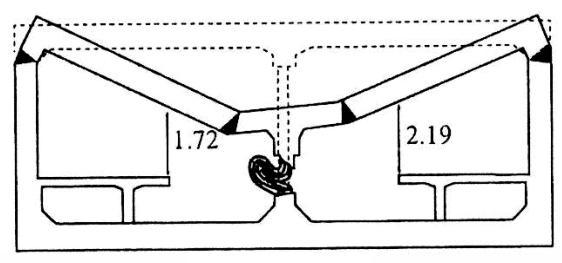
Figure 1-b Schematic figure showing the damage patterns in the transverse direction

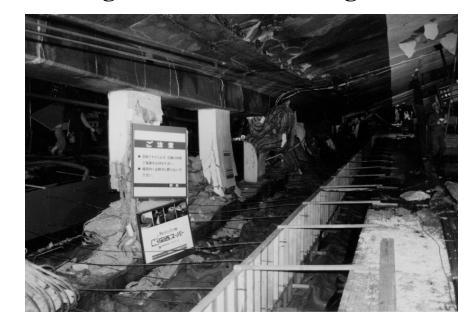
Photo 1 Collapse of center column of the Daikai station

3. The center column collapsed due to lack of the load carrying capacity against shear resulting to failure of the ceiling slab.

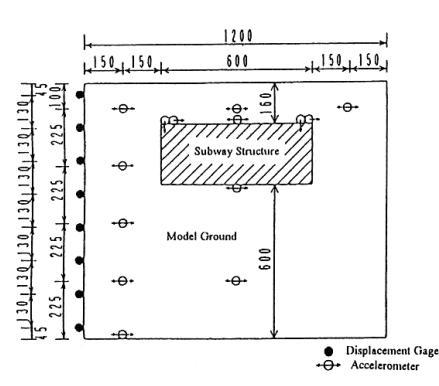
Photo 2 Soil container of shaking table tests

A new type of soil container has been developed to reproduce the ideal horizontal shear motion in the model ground as shown in Photo 2. The model ground made of fine dry sand (Gifu-Sand) of 1.0m in depth consists of two layers, namely the subsurface layer with 0.4m in depth, and the bearing stratum. 1/30 scaled subway structure model of Daikai Station is set on the bearing stratum. The subway structure model has a box type frame structure with center columns made of polyvinyl chloride resin, with dimensions of 60 cm in length, 60 cm in width, and 24 cm in height. The thickness of the overburden soil is 16 cm, and the joints between the center column and the ceiling and base plates were modeled two types (Type-1 and Type2). Type-1 is a fix-type: , the center column fix on ceiling and base slabs and Type-2 is a hinge-type: the center column hinges on ceiling and base slabs.

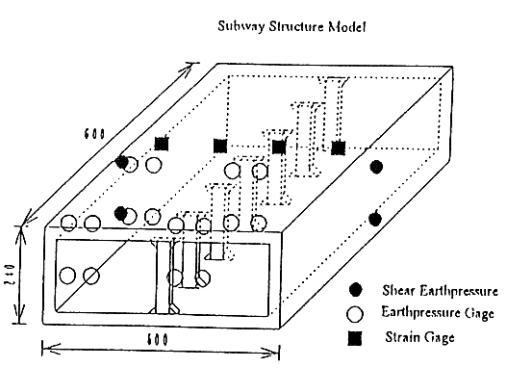
(b)Subway structure model

Figure 2 Measuring points of the shaking table tests

The measuring points of the shaking table tests are shown in Figure 2. In these tests, the acceleration responses of the structure and the surrounding ground, shear earth pressure acting on the ceiling walls, horizontal earth pressure acting on the side-walls, and the dynamic strains of the center columns and side-walls were measured.

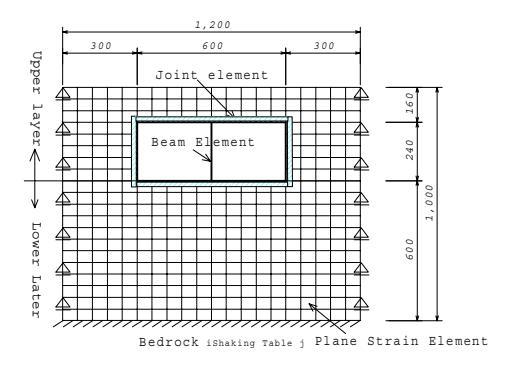
Figure 3 2-dimensional FEM model

In this analysis, the ground is modeled into two-dimensional finite element (Figure 3) and the soil properties of the ground were the converged values obtained from the first step simulation, and the structure is modeled into an elastic beam. The acceleration response of the structure and the dynamic forces (shear earthpressure and lateral earthpressure) acting on the structure and the strain induced in the structure were evaluated.

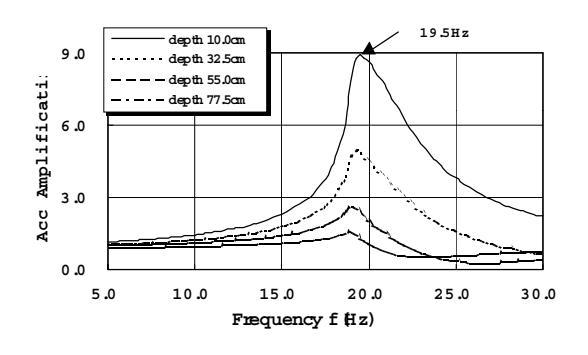
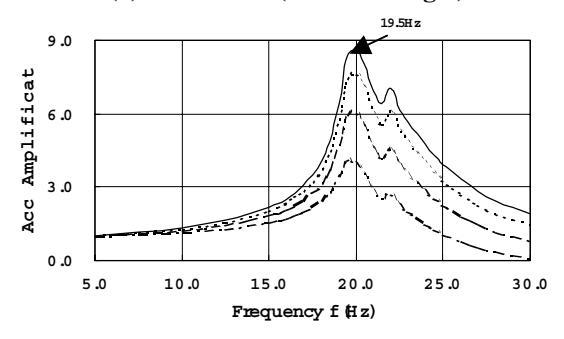
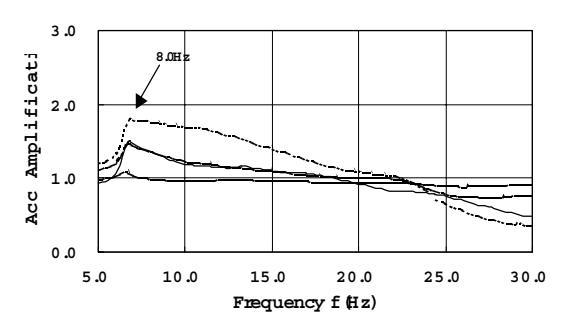
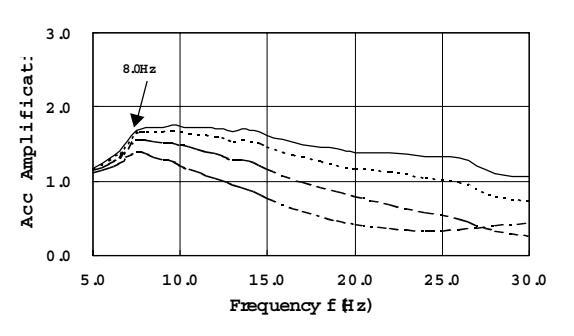
(a) Test results(Base Acc 20gal)

(c) Calculated results (Base Acc 20gal)

(b) Test results (Base Acc 400gal)

(d) Calculated results (Base Acc 400gal)

Figure 5 The resonance curves of model ground (Sine sweep tests)

- (1) The shear wave velocity (Vs) of the model ground determined by seismic exploration was 90m/sec 100m/sec.
- (2) The strain-dependency of soil properties of Gifu-sand was estimated from the tests. The obtained shear modulus (G) vs. shear strain (γ) curve, and damping (h) vs. (γ) curve for strain ranged more than 10^{-6} that agreed well with theoretical ones proposed by Kokusho-Iwatate (1979) are shown in Figure 4.
- (3) The resonant curves of model ground with base accelerations of 20 gal and 400 gal, are shown in Figures 5a, and 5-b, are experimental results, and Figures 5-c and 5-d are calculated ones, respectively.

The decrease in amplification and the resonant frequency of the ground with increase of base acceleration are shown in these figures. The model ground exhibits strong nonlinear properties from low strain level.

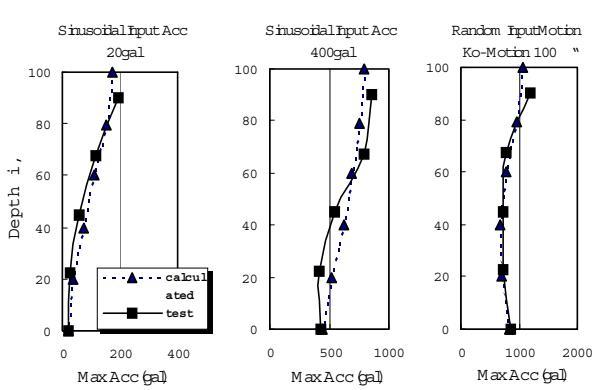
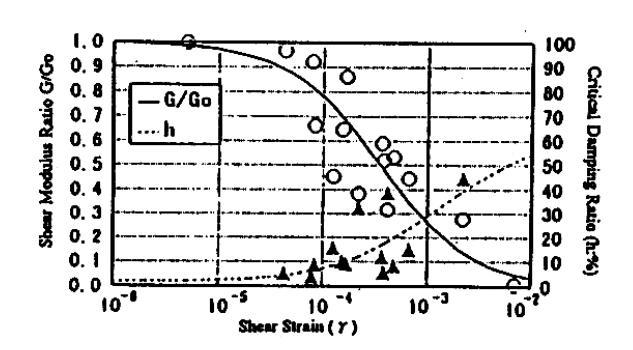
Figure 4 The strain-dependency of soil properties Gihu-sand

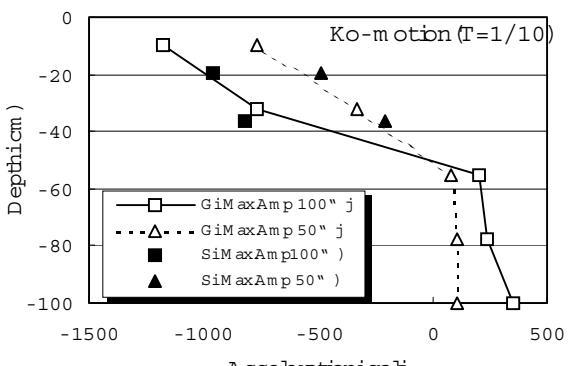
Accelerationigalj Figure 7 Maximum acceleration responses of model ground and the structure subjected to Ko-motion with maximum input acceleration 100% and 50% and shorting process

- (1) Figure 7 shows the acceleration responses of the structure and the surrounding ground subjected to Komotion with 1/10 time shorting processes and the maximum amplitude 50% (Case-A) and 100% (Case-B). Comparing the dynamic motions of the structure and the ground, in Case-A, the difference in acceleration amplitude and phase lag between the structure and the ground were observed slightly and the amplitude and vibration mode coincide well with each other. The structure moves in shearing mode predominantly. On the other hand, in Case-B, the difference in amplitude and phase lag between the two was observed more remarkably. The structure model moves predominantly not only in shearing mode but also in rocking mode.

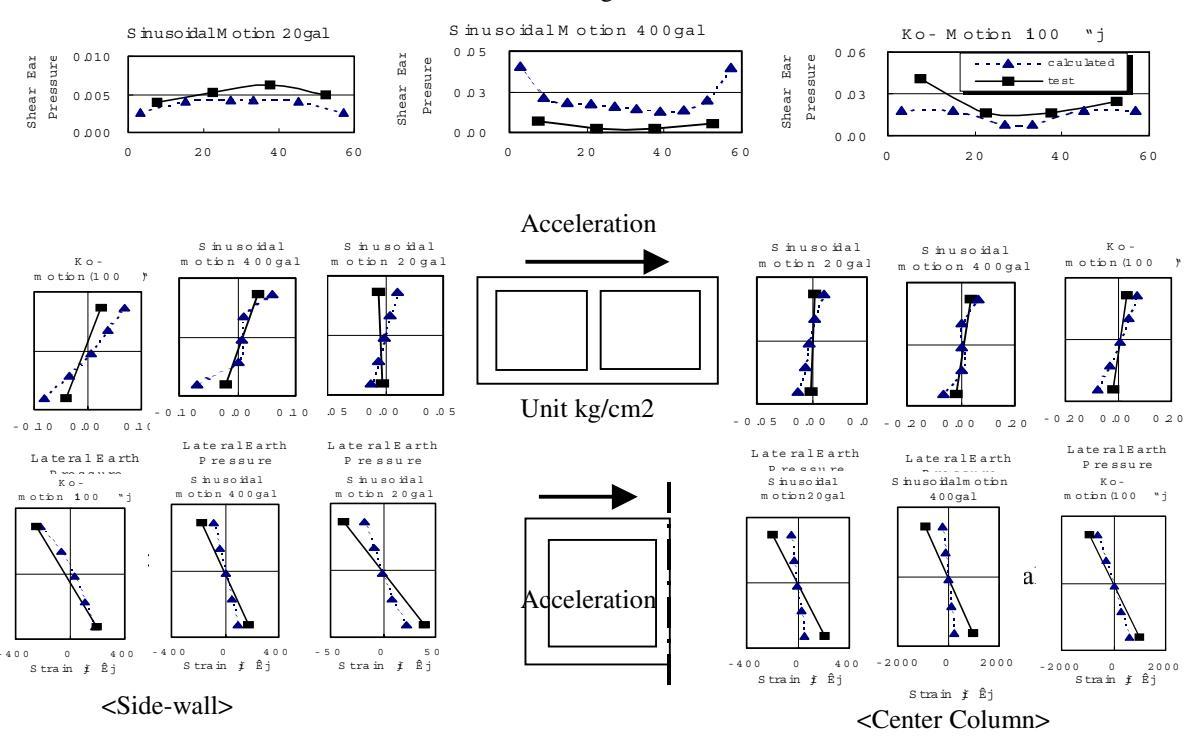
Figure 8 The dynamic lateral and shear earth pressure acted on the structure and bending strains of induced in the structure subjected to sinusoidal motion and Ko-motion

- (2) Figure 8 shows the maximum dynamic lateral earth pressure, dynamic shear earth pressure, and bending strain distributions of the subway structure at the resonant frequency subjected to the sinusoidal motions with base accelerations 20 gal and 400 gal, and Ko-motion (100%), respectively. In this figure the solid lines are test results and the dotted lines are the calculated ones. Both results agree well with each other.

- (3) The distribution of the lateral earthpressure acting on the side-walls have different effects on the shear deformation of the structure. In the case of weak motion (20 gal), the lateral earth pressure acted to resist the shear deformation of the structure, but in the case of strong motion (400 gal, Ko-100%), it did not resist the shear deformation of the structure.

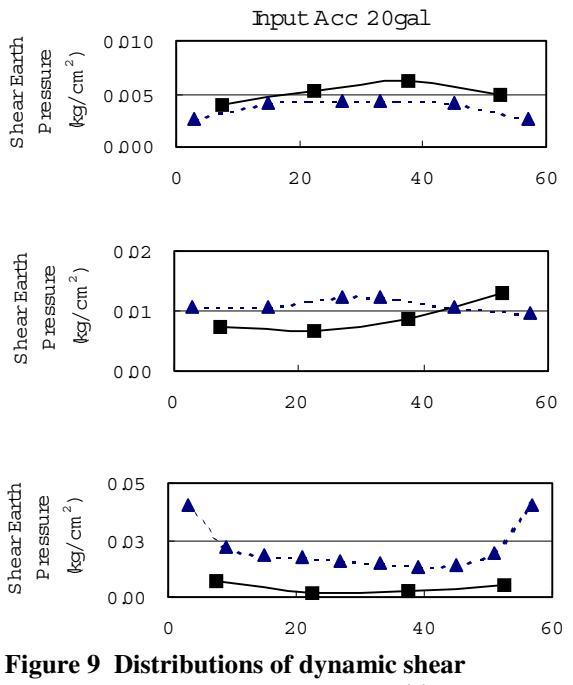
earth pressure acted on the ceiling slab subjected to sinusoidal motion

- (4) Figure 9 shows the distributions of maximum dynamic shear earth- pressures acted on the ceiling slab at the

resonant frequency subjected to the sinusoidal motions with base accelerations 20 gal, 100 gal and 400gal. In this figure the solid lines are test results and the dotted lines are the calculated ones. Both results agree well with each other. The distribution of the shear earthpressure varies with the intensity of input motion. In the case of low-level input motions (20 gal to 100gal), the distribution shape is almost uniform, but in the case of strong input motion (400 gal), the distribution shape is a concavity, the center is smaller than the both edges. From these results, a slide and an exfoliation phenomenon occurs in the case of 400 gal.

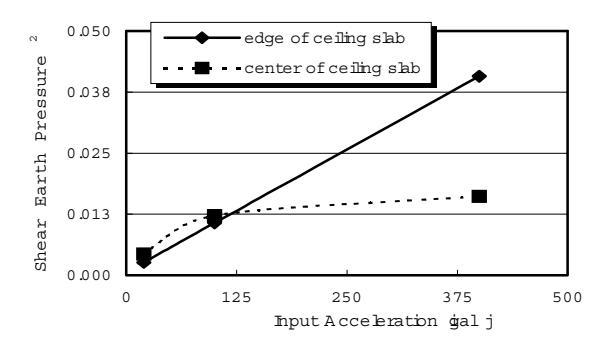
Figure 10 Relation between shear earthpres- sure acted on the ceiling slab and input acceleration

- (5) Figure 10 shows the relation between input acceleration and the shear earthpressure acting on the ceiling slab evaluated by the simulation analyses. In this figure, the solid line is the shear pressure acting on the center of the slab and the dotted line is that acting on the edge of the slab. From this figure, a slide phenomenon occurs at the center of the slab over 100 gal.

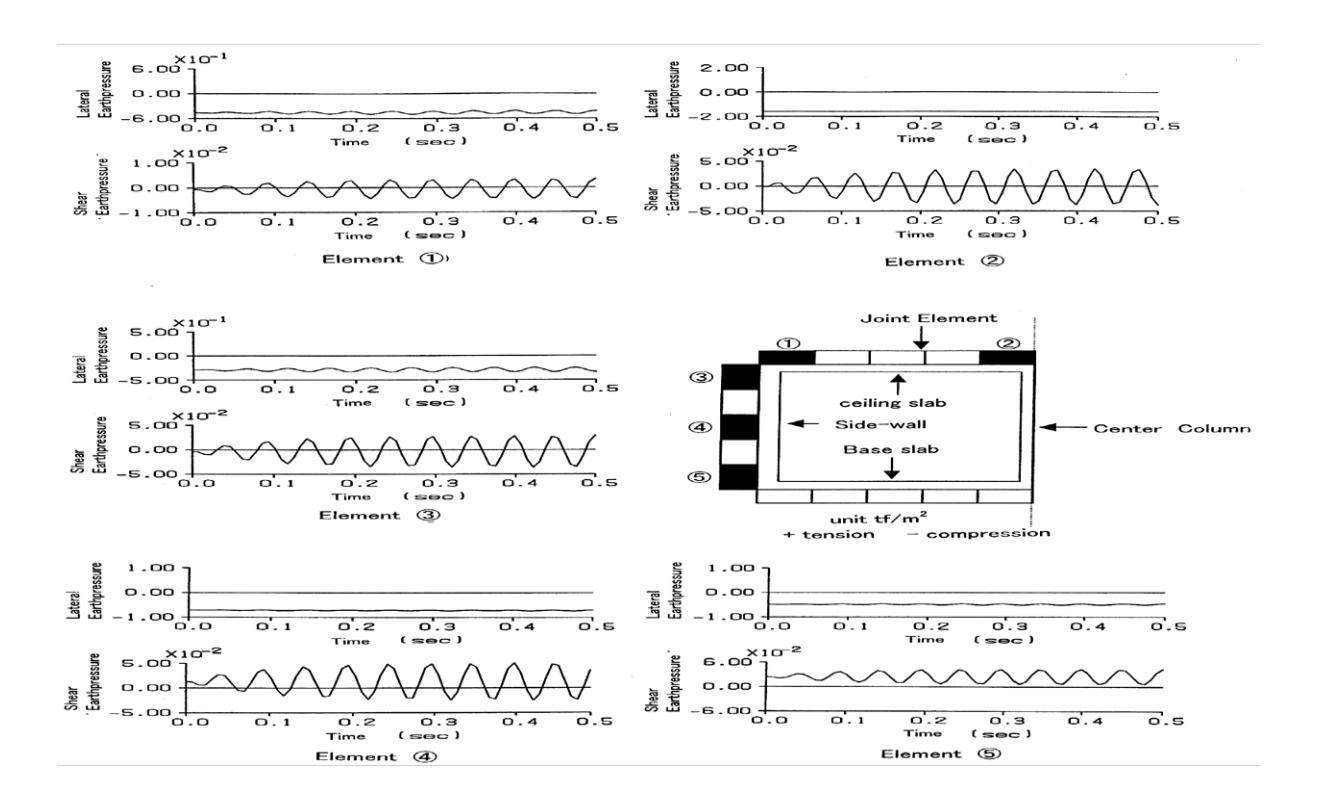
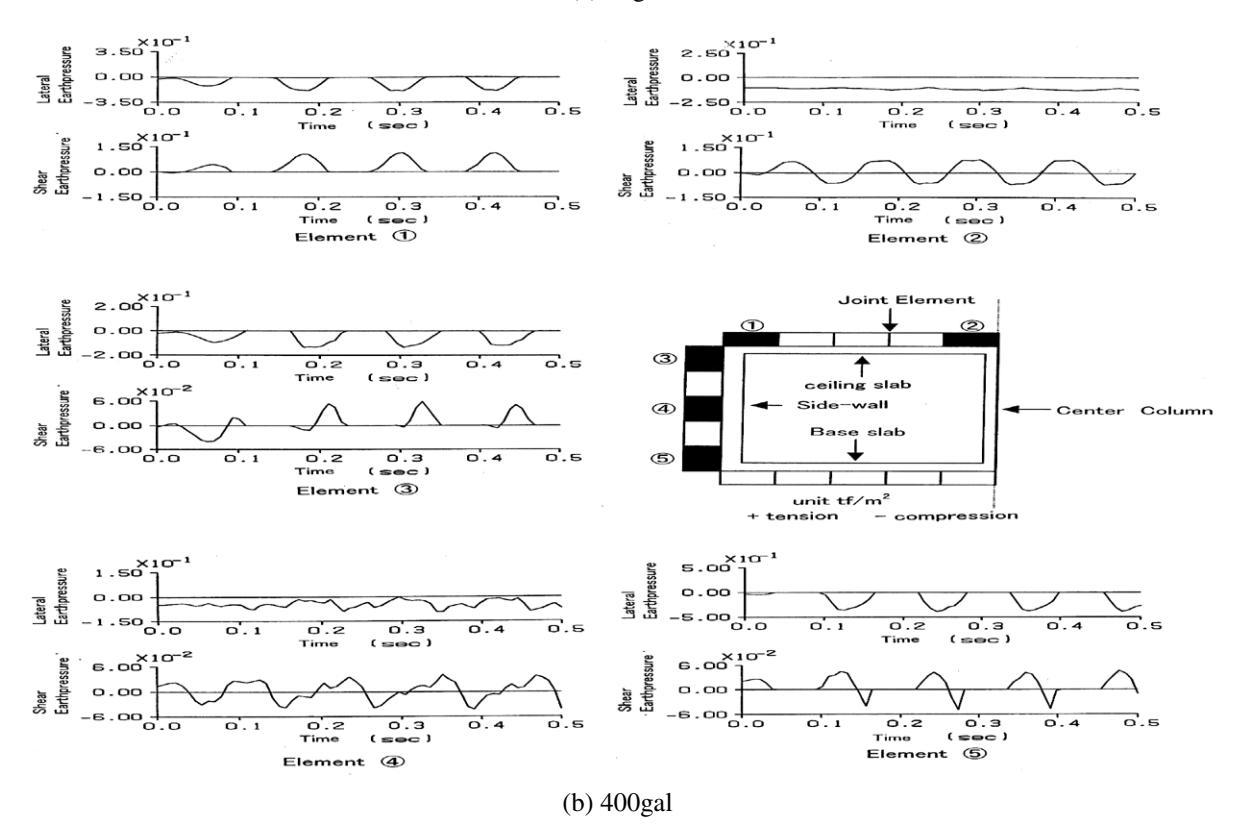
(a) 20gal

Figure 11 Calculated time histories of the dynamic earthpressure acted on the joint element of the ceiling slab and side-wall subjected to sinusoidal input motion

- (7) Figure 11(a) and 11(b) show the calculated time histories of the dynamic earthpressures (lateral earthpressure and shear earthpressure) acting on the joint element of the ceiling slab and the side-wall subjected to sinusoidal input motion of 20 gal and 400 gal respectively. From these figures, a slide and an exfoliation phenomenon occurs at 400 gal.
