NON-DUCTILE SLAB-COLUMN CONNECTIONS SUBJECTED TO CYCLIC LATERAL LOADING

Ian N ROBERTSON¹ and Gaur P JOHNSON²

SUMMARY

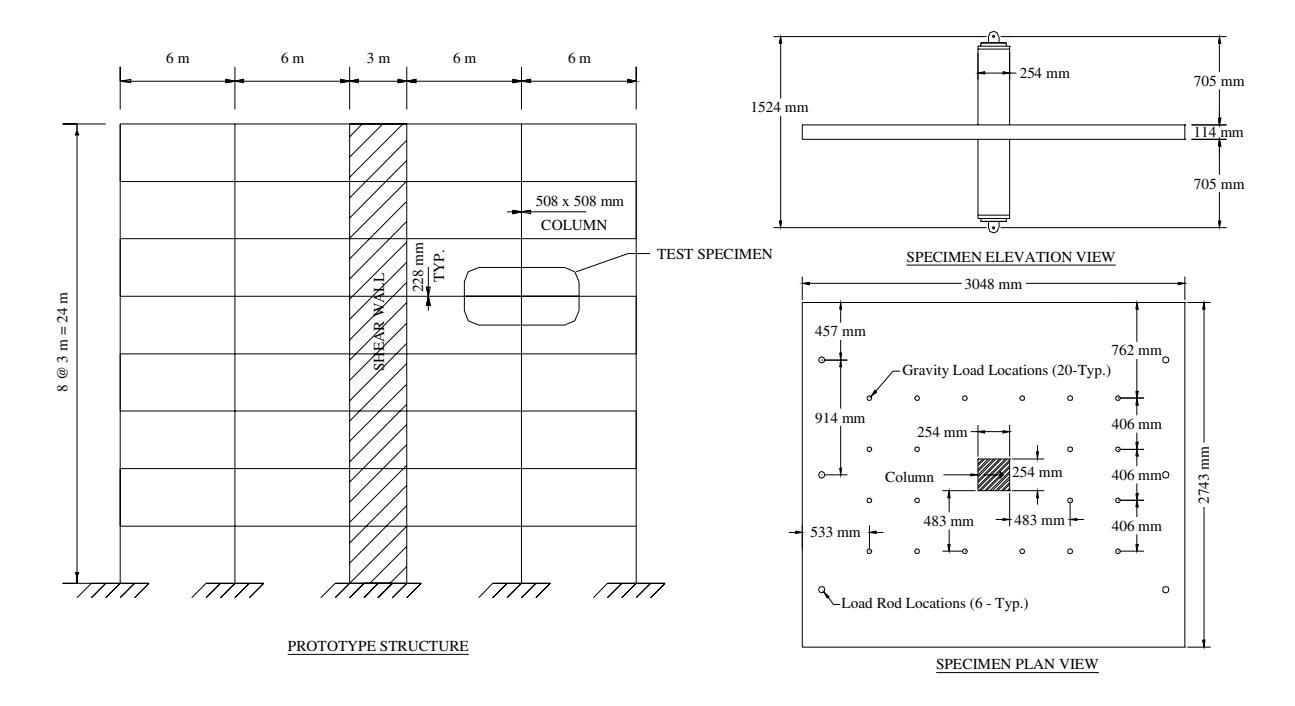
Figure 1-Prototype Building and Test Specimen.

Each test specimen represents a half-scale model of an interior flat-plate slab-column connection (Figure 1). The specimens were designed to evaluate the influence of gravity load, slab reinforcement ratio, and bent-up bars in the connection region, on the seismic performance of interior slab-column connections.

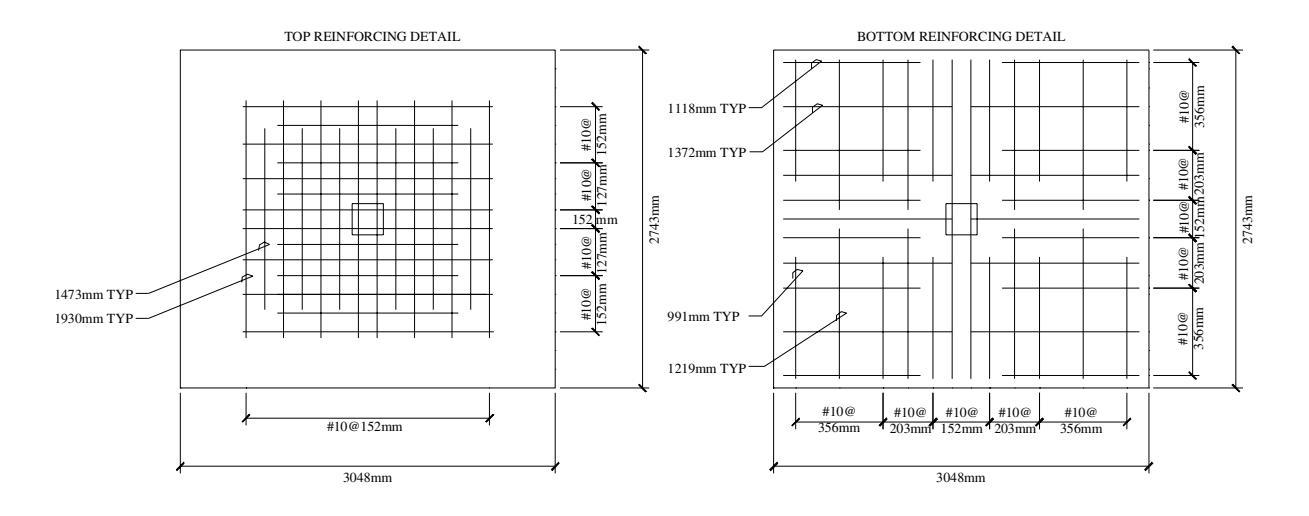
Figure 2-Slab Reinforcement for ND1C, ND4LL, and ND5XL.

The slab reinforcement layout for specimens ND4LL and ND5XL was identical to that of the control specimen, ND1C as shown in Figure 2. Specimen ND6HR had heavier slab reinforcement than the control specimen as shown in Figure 3. Because of the increase in slab top reinforcement, it was anticipated that this specimen would resist a greater lateral load than the control specimen. As a consequence, if all of the top reinforcement were curtailed at one third span as for the control specimen, it is likely that the negative moment induced at this section would exceed the cracking moment of the unreinforced slab, resulting in a premature flexural failure. In order to fully test the slab-column connection region, half of the top reinforcement was continued through midspan as shown in Figure 3. It should be noted that older flat slab buildings with heavy top reinforcement curtailment. Any retrofit scheme for such a structure should provide reinforcement to prevent this premature flexural failure.

Figure 15 shows the comparison between backbone curves for three specimens with significantly different slab flexural reinforcement ratios. Specimen ND6HR has more slab reinforcing than the control specimen, ND1C, while specimen ND7LR has less (See reinforcement lavouts in Figures 2, 3 and 4). As expected, the peak lateral load capacity varies with the reinforcement ratio. The increased unbalanced moment in the stronger and stiffer ND6HR specimen results in punching shear failure during the first cycle to 5%lateral drift.

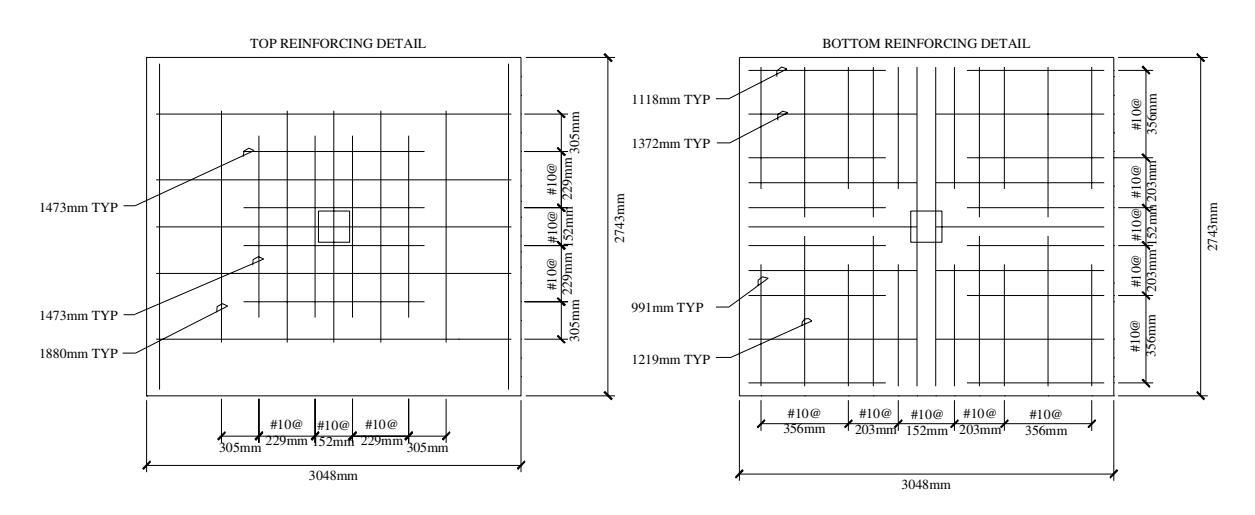
Figure 4-Slab Reinforcement for ND7LR.

Specimen ND7LR had lighter slab reinforcement than the control specimen as shown in Figure 4, while specimen ND8BU had a similar reinforcement layout except with additional bent-up bars added (Figure 5). These bent-up bars increased the top reinforcement ratio at the face of the column and the bottom reinforcement ratio at midspan. Again, half of the top reinforcement was continued to midspan to ensure that flexural cracking of the slab at the curtailment of top reinforcement would not cause premature flexural failure.

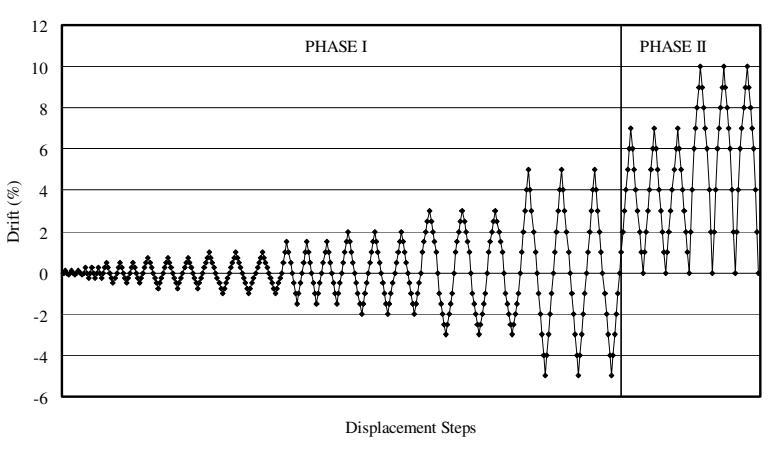
Figure 6-Lateral Displacement Routine.

performed in two phases: Phase I consisted of both positive and negative cycling to 5 percent drift level (maximum capacity of the actuator); Phase II consisted of cycling up to 10 percent drift, but only in the positive drift direction (Figure 6). This protocol gradually increases the drift level from $\pm -0.1\%$ to $\pm -5\%$ in Phase I and from +7% to +10% in Phase II. To evaluate the loss of strength and stiffness after repeated loading of the structure, and to induce the type of damage expected in a seismic event, each drift level was repeated three times.

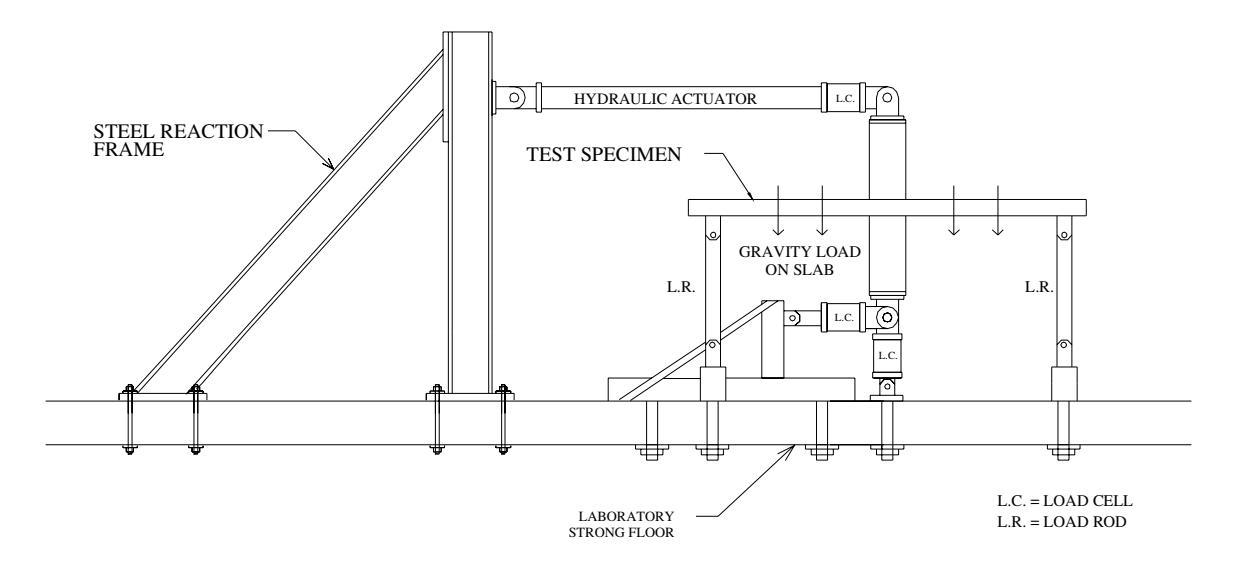
Figure 7-Test Frame Configuration.

The specimens were tested as shown in Figure 7. A pin support, with two load cells to monitor column axial load and shear, was located at mid-height of the column below the slab. Three pin ended vertical load rods at each edge of the slab prevented vertical displacement of the slab, but allowed free lateral movement and rotation, thus simulating mid-span conditions in the direction of loading. The cyclic lateral displacement routine (Figure 6) was applied to a pin connection at the mid-height of the column above the slab via an actuator with an internal linear variable displacement transducer (LVDT) and an inline load cell.

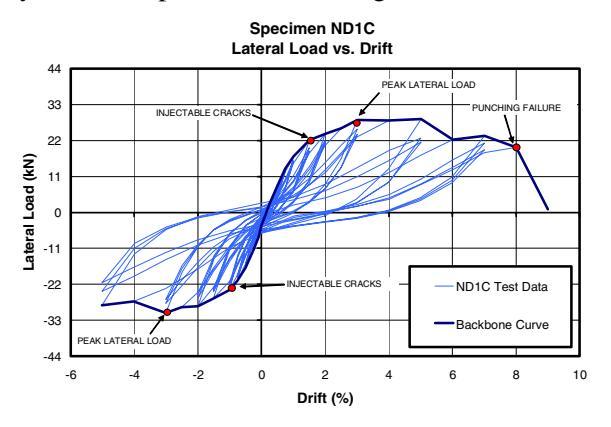
Figure 8-Behavior Specimen ND1C

The load-drift relationships for each specimen are shown in Figures 8 through 13. These figures show the hysteretic response, the resulting backbone curve, and critical points identified on these curves.

The backbone curves shown in Figures 8 through 13 represent the envelope of peak lateral loads supported by the specimen at each drift level. Figures 14 to 16 show comparisons of various backbone curves.

Specimen ND1C was observed to fail first in flexure at 6% drift followed by punching failure at 9% drift. The average moment ratio of 1.73 and an average shear ratio of 0.87 are consistent with the observed behavior. The extensive crack formation during flexural concrete deterioration lead to the shear failure at an induced shear stress less than that predicted by Eqn 1. The average moment ratio of 1.86 and average shear ratio of 0.92 for specimen ND4LL would also indicate this type of behavior. The peak lateral load occurred at a drift of 3% followed by a reduced lateral load at a drift of 4% just prior to punching. For specimen ND5XL, the average shear ratio of 0.96 indicates that punching shear failure was imminent. Indeed, punching shear failure occurred prior to reaching the flexural capacity of this connection.

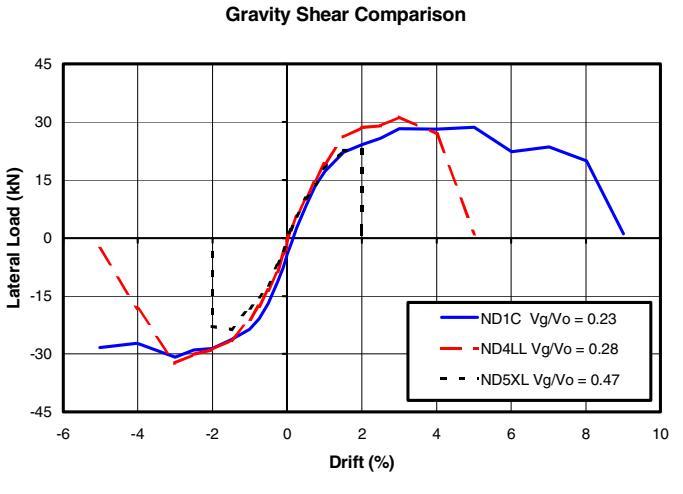
Figure 14: Effect of Gravity Shear Ratio.

Figure 14 shows the comparison of the control specimen, ND1C, with the two nominally identical specimens subjected to increased gravity load, ND4LL and ND5XL. The initial response of all three specimens is similar, however, the maximum drift level decreases as the gravity shear ratio (Vg/Vo) increases. Specimen ND4LL achieves the same peak lateral load at a similar drift as the control specimen, but fails due to punching shear soon thereafter. Specimen ND5XL with the heaviest slab gravity load suffers punching shear failure before reaching the flexural capacity of the slab reinforcement.

Because of the lack of continuous bottom reinforcement passing through the column, both punching shear failures would have lead to complete collapse of the slab and potential progressive collapse of floors below this level.

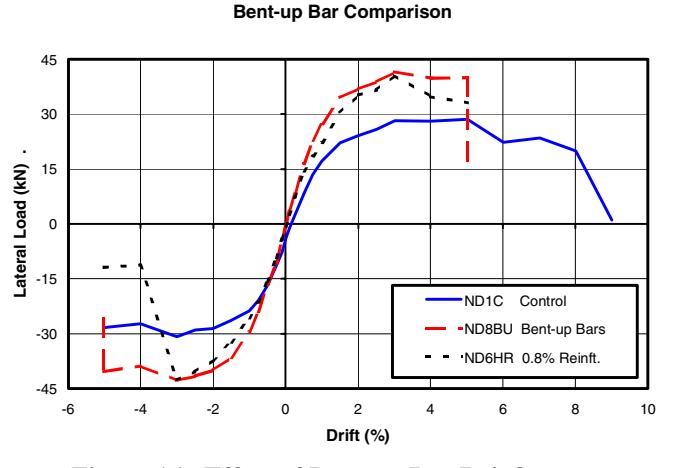
Figure 16: Effect of Bent-up Bar Reinforcement.

Figure 16 shows the comparison between backbone curves for the control specimen, ND1C, the specimen with increased slab flexural reinforcement, ND6HR, and the specimen with bent-up bars, ND8BU. Because of their similar reinforcement ratios, specimens ND6HR and ND8BU resisted the same peak lateral loads at the same lateral drift level. Both specimens experienced punching shear failure during excursions to 5% lateral drift. The bent-up bars were effective at preventing progressive collapse of the slab since they are anchored into the bottom of the slab adjacent to the connection region.
