# SIMULATION OF DAMAGE PROGRESSION IN LOWER STORIES OF 11-STORY BUILDING

## SUMMARY

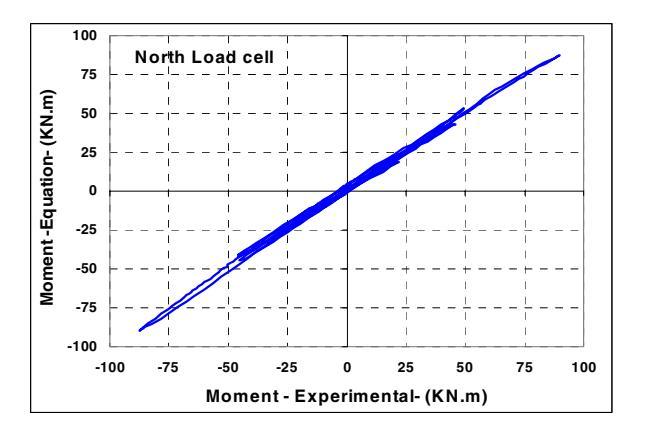
Figure 1: Moment calibration result

To evaluate the axial load, shear load and the bending moment at the first story column bases, four identical load cells were designed and calibrated before the test. A regression analysis was carried out to evaluate the coefficient for each set of load cells. Good agreement was found between the test results and the analytical results for the axial, shear and bending moment. An example for the prediction of bending moment is shown in Figure 1, where a  $45^{\circ}$  straight line can be seen.

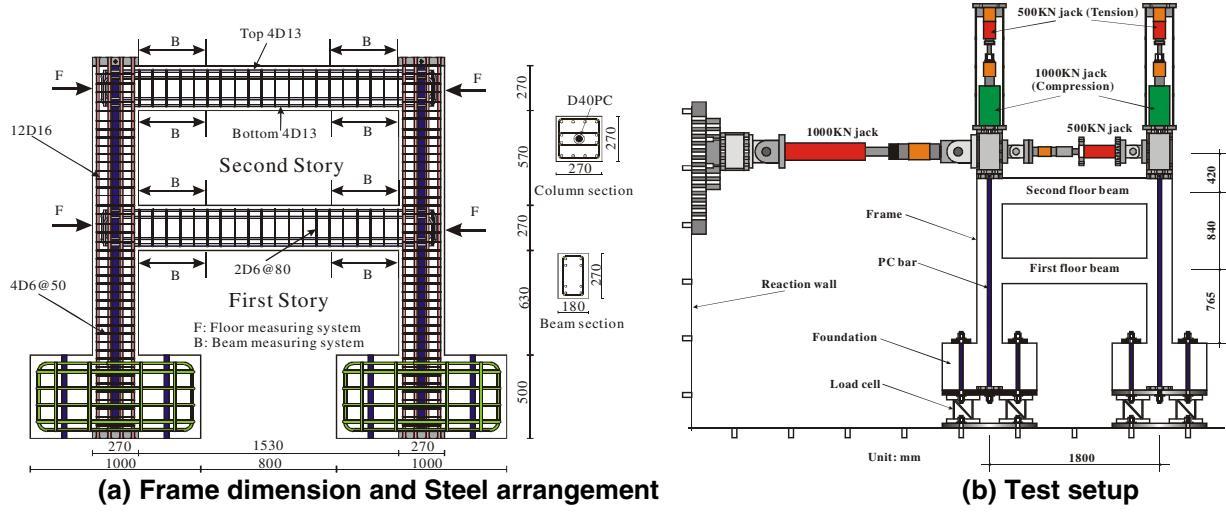
Figure 2: Frame geometry and test setup

The cross section was 270x270 mm for columns and 180x270 mm for beams. The heights of the first and second floor were 765 and 840 mm respectively. The span length was 1800 mm as shown in Figure 2 (a). Load cells were inserted under each foundation as shown in Figure 2 (b). The horizontal load was applied through a 1000 kN jack at mid height of the third floor. A 40 mm diameter high strength bar passing

through the column center was used to simulate the axial load variation of the third floor column based on the elastic frame analysis. The bar was used to apply either compression or tension to the columns by two jacks. The axial load, N, varied linearly with respect to the applied horizontal load, H, as follows:  $N = 239 + \Psi H (kN)$ , where  $\Psi = 2.30$  for SN30 frame and  $\Psi = 4.59$  for SN50 frame. The concrete and steel mechanical characteristics as well as the test variables are shown in Table 1.

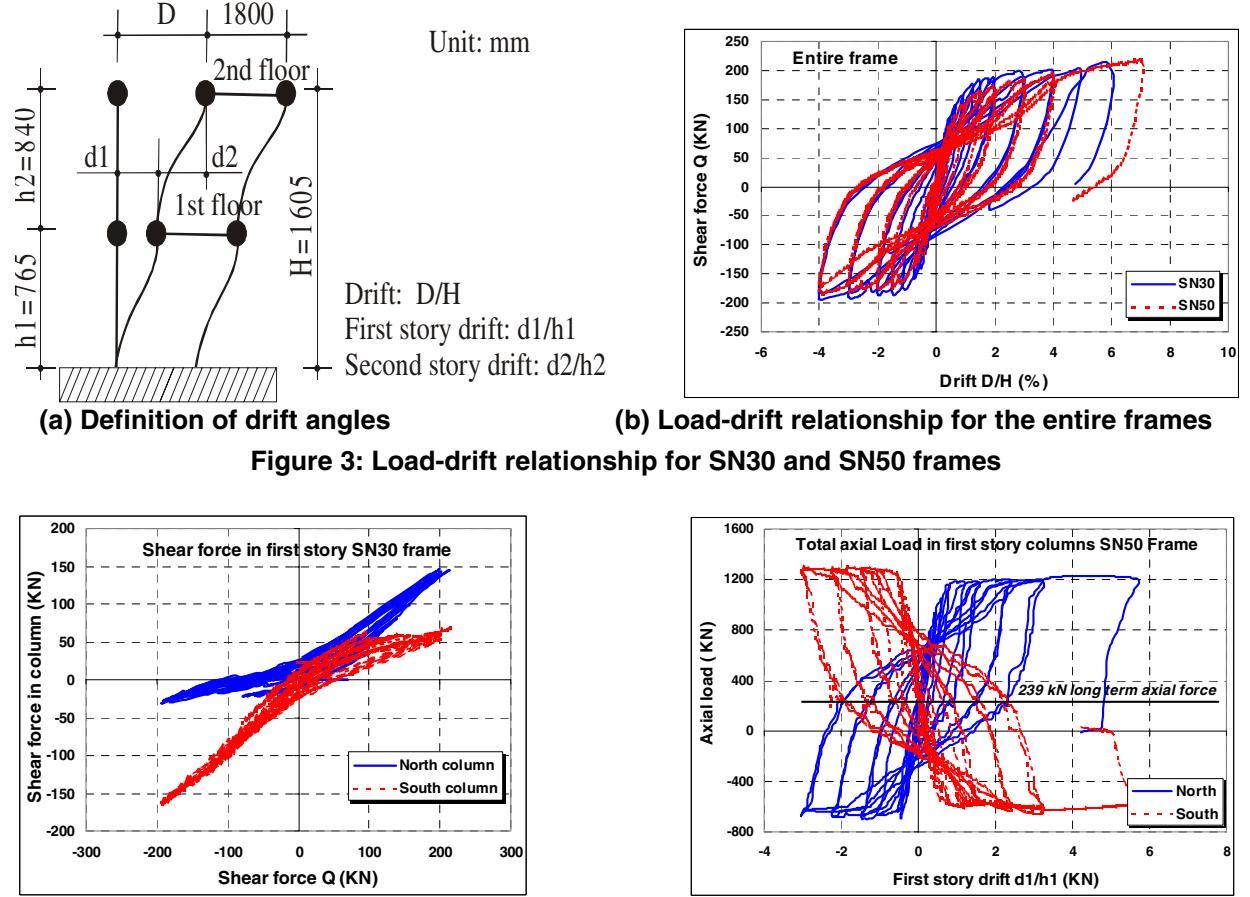
(a) Shear force variation SN30 (b) Axial load variation SN50 Figure 4: Shear and axial load variation at first story column for SN30 and SN50

Shear force, axial load and bending moment at the column base were determined from load cells. It was observed that the total shear force was not distributed evenly to the column bases. The shear force was rather distributed as a function of the applied axial load intensity. As an example, Figure 4 shows the shear force variation at first story column of SN30 and the axial load variation in the north and south first story column of SN50.

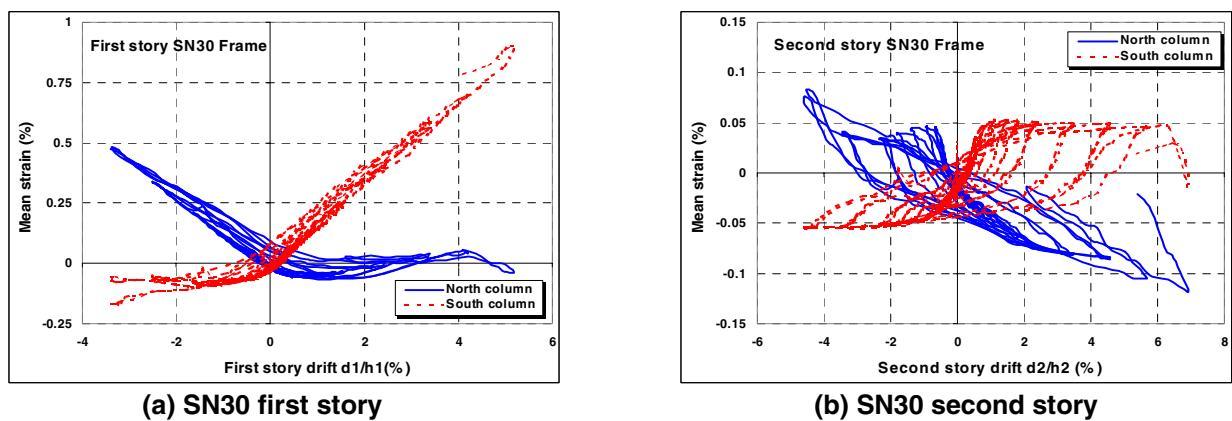
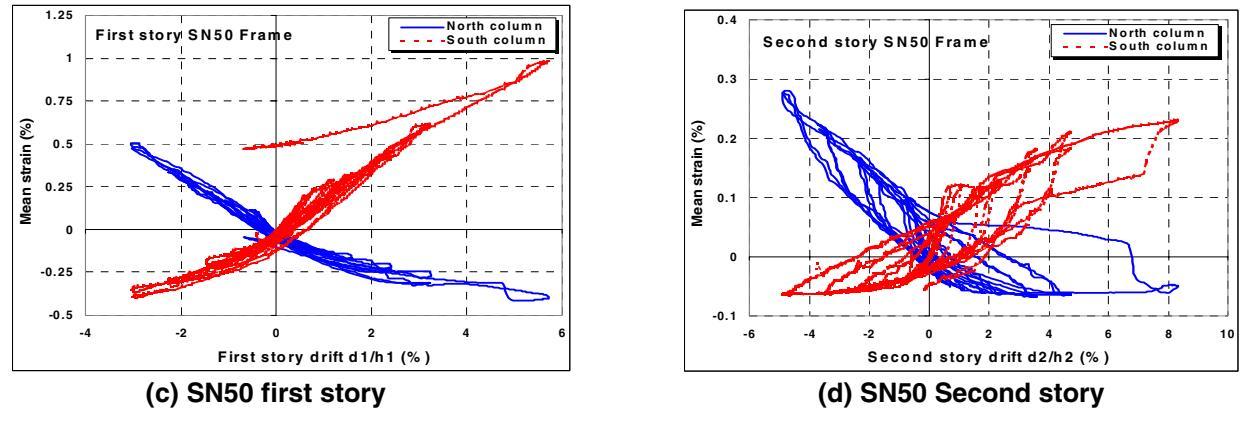
Figure 5: Columns shortening -elongation positive-

At the same drift angle and for a given story, column under tension showed more elongation than the one under compression as illustrated in Figure 5. However, the second-story columns for SN30 showed nearly the same amount of shortening and elongation as shown in Figure 5 (b). Mean strain was defined as the average of the measured elongation or shortening divided by the clear column height.

In both frames and under tensile axial loading, the first story column elongation followed almost identical linear line regardless the amount of applied axial load as illustrated in Figure 5 (a) and (c). Column axial stain under tension was compared to the measured strain of the longitudinal bar located at 35 mm from the column center. The strain gauge was set on this bar at 25 mm from the column base. Figure 6 shows a good matching between the column mean strain and the longitudinal center bar strain. Until this time, no reasonable explanation was found showing the reason of the good matching.

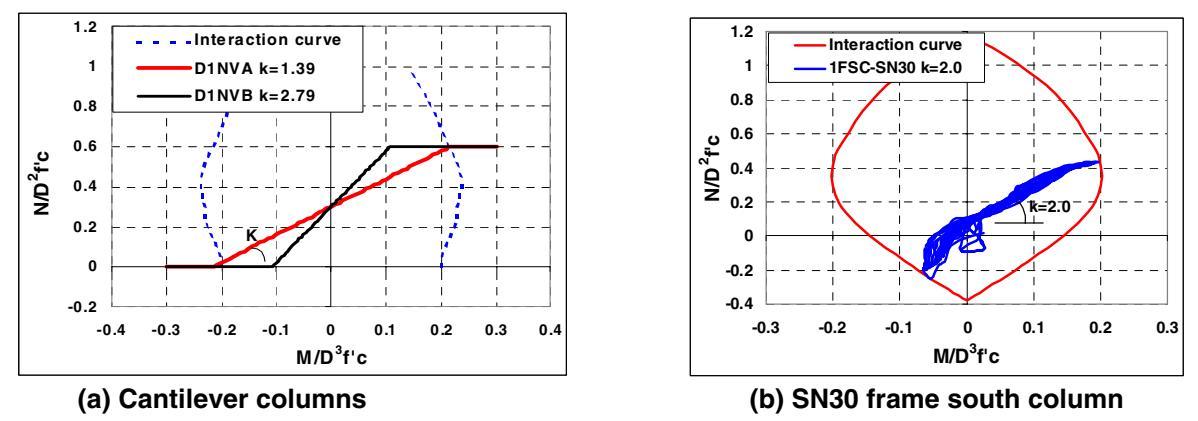
Figure 7: Axial load variation on the MN interaction curves

First floor column's mean strains were compared to two isolated cantilever columns tested earlier in Kyoto University. The two cantilever columns had a square section with 242 mm depth. The horizontal load was applied at 625 mm from the column base. Material and test variables are given in Table 2. Axial load varied from zero to  $0.6A_g f'_c$  for both columns but with different slope on the normalized M-N interaction curve as shown in Figure 7 (a).

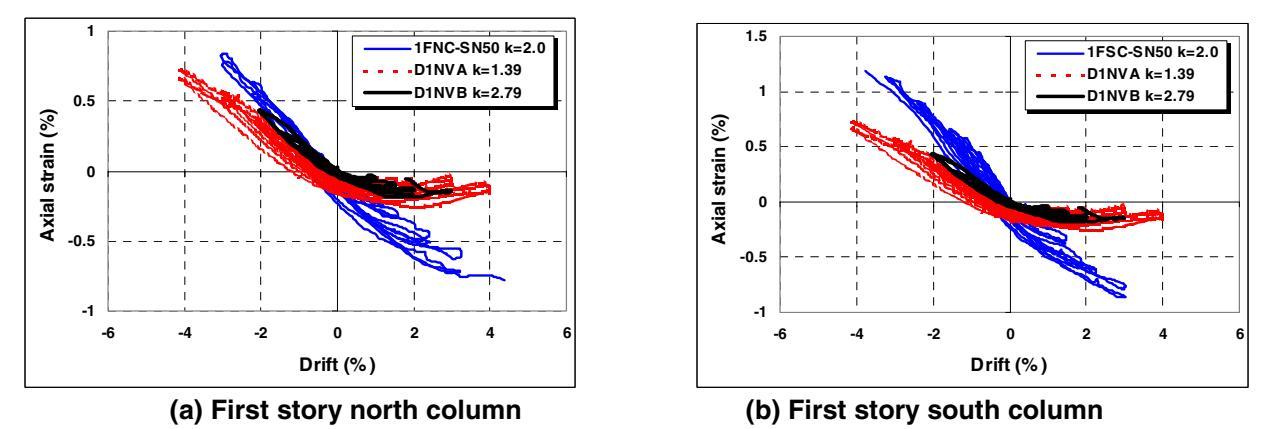
Figure 8: Comparison of axial strain of cantilever and first story SN50 columns

First story column mean strains were much higher than those for cantilever columns, especially for columns under high axial load of SN50 frame as illustrated in Figure 8. Even though the normalized compressive axial load,  $N/A_g f'_c$ , was 0.5 for specimen SN50's columns and 0.6 for the cantilever

columns, the axial strain of 1FNC-SN50 under compression at 3% drift was more than three times larger than those of D1NVA and D1NVB. Normalized moment-drift relationships for the first story south column (1FSC) of specimen SN30 and the cantilever column D1NVA are shown in Figure 9. D1NVA showed a drop after reaching the peak around 1% drift, however the south column did not show any strength degradation. As mentioned previously in section "experimental results", the shear force at the column base was not evenly distributed to columns and so is the bending moment. This can be seen clearly when comparing D1NVA and 1FSC in the negative cycles in Figure 9, where a big gap can be observed between the two curves. This behavior cannot be detected while testing a single isolated column hence, the importance of such frame testing.

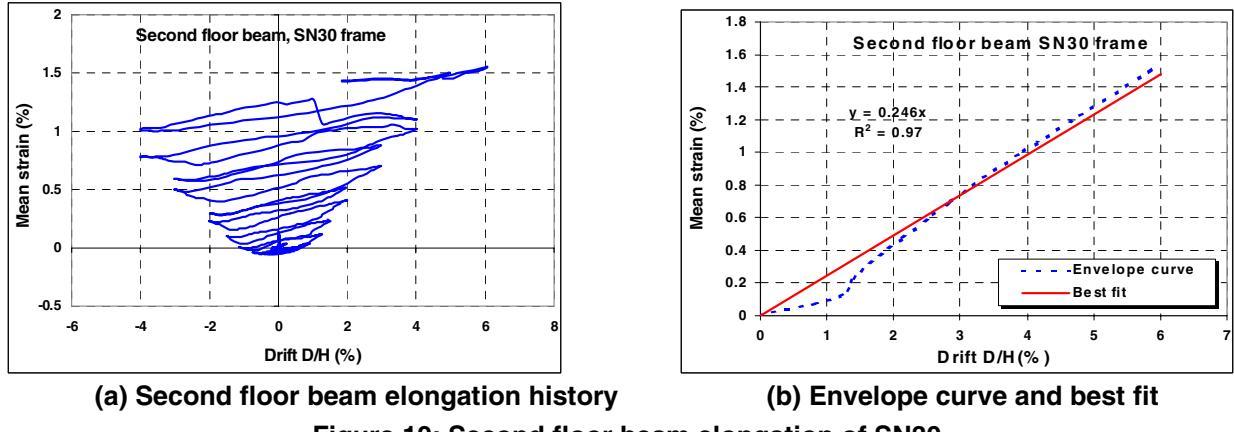
Figure 10: Second floor beam elongation of SN30

First and second floor beams were severely damaged especially near the beam -column joint. Using the displacement gauges attached directly to the beams, beam's length changes were evaluated. Best fit for the envelope curves of each beam was computed and compared to Reference [8]. In this reference and based on the mathematical expression proposed by Fenwick and Magget [9] and Restrepo [10], the beam elongation was reported to be 2 to 5% of the beam depth per plastic hinge. Using the clear beam length, and taking into account two plastic hinges per beam, the mean strain in this test frame was found to be

between 0.71 to 1.76%. The best fit for the second floor beam of frame SN50, shown in Figure 10, gave the maximum mean strain of 1.59% at 6% drift, which is within the range given by Reference [8].

All the best fits, mean strain-drift relationships, had a linear equation passing through the origin with a form of y = ax. The "*a*" coefficients for frame SN30 were 0.130 and 0.246 for the first and second floor beam respectively. These values were 0.129 and 0.225 for frame SN50 that are nearly the same as those for SN30. Taking an average of the above coefficients, Eq. 1 and Eq. 2 can be used to evaluate the beam mean strain,  $\mathcal{E}$ , at the first and second floor respectively:

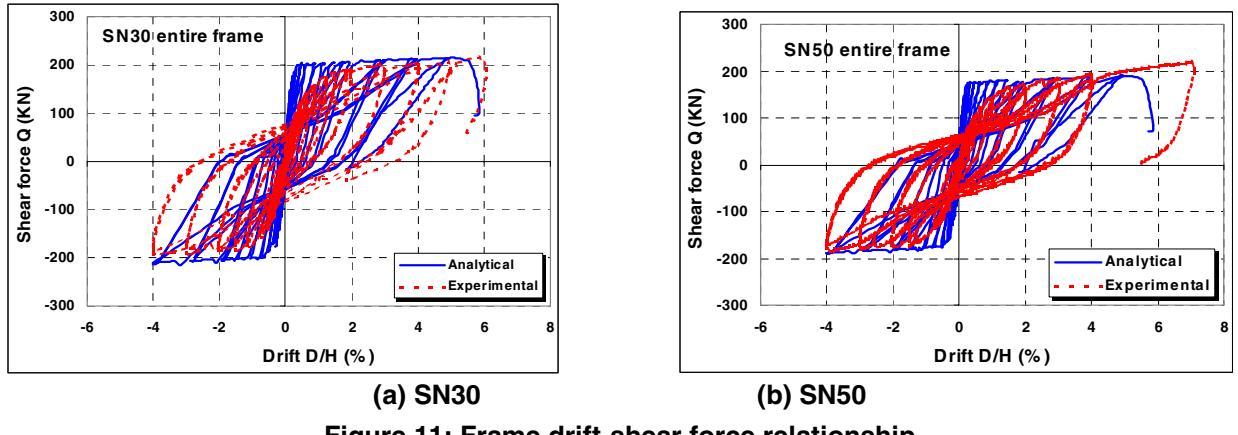
Figure 11: Frame drift-shear force relationship

Analysis was carried out using the nonlinear IDARC [11] program. Both frames were modeled as a lumped mass. In IDARC program the moment-curvature analysis is carried out on the cross-section using a fiber model. The incremental curvature that is applied to the section is continued until the specified ultimate compressive strain in the concrete or the specified ultimate strength of one of the rebar is reached. Figure 11 shows a sample of the results consisting of the shear force-drift of the entire SN30 and SN50 frames respectively. The analytical load-story drift results, showed a higher stiffness than the experimental one at low cyclic loading. However, maximum peak and no drop of horizontal load capacity were predicted with a good accuracy.

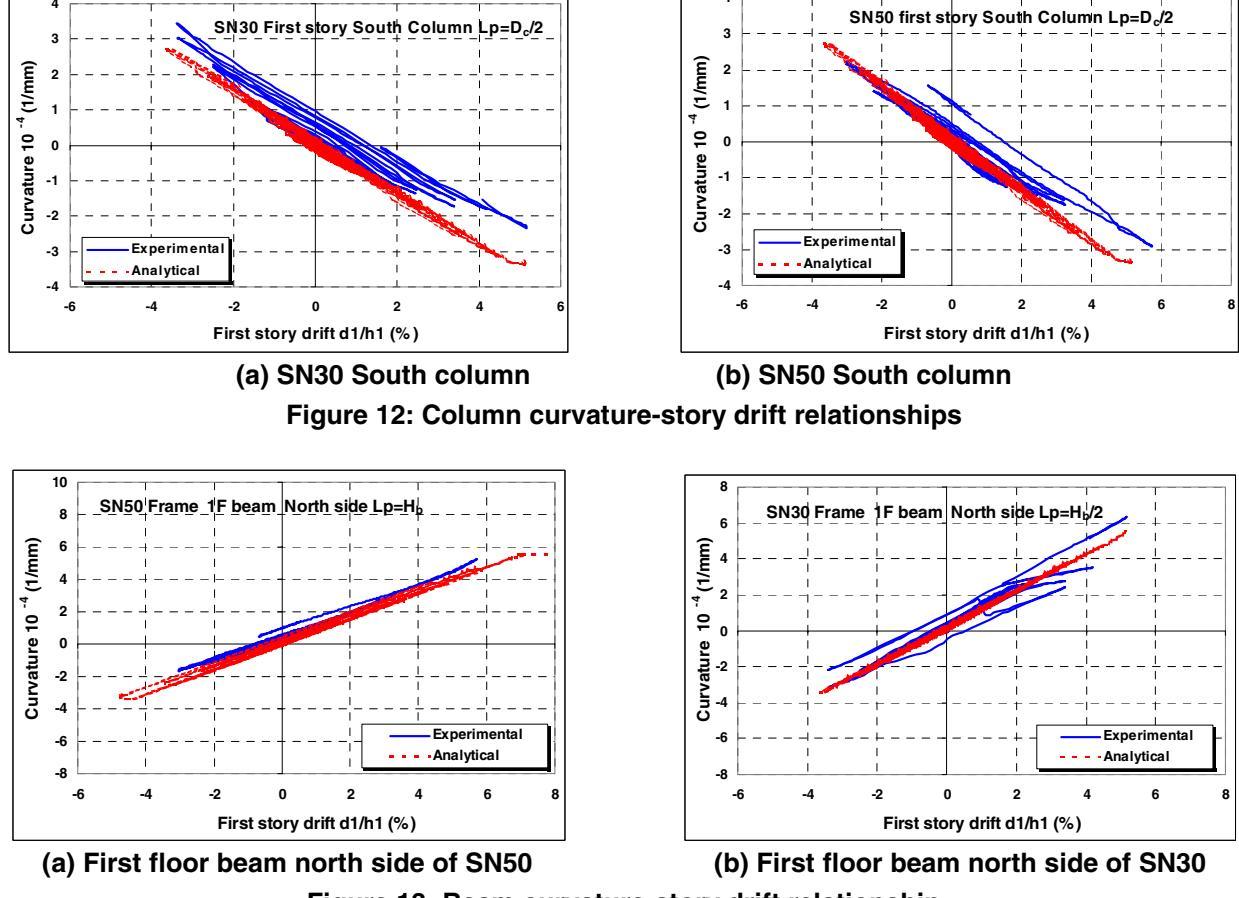
Figure 13: Beam curvature-story drift relationship

Good agreement between the experiment and the predicted curvature-story drift relationship was also found for frame SN30 beams using a plastic hinge length equal half of the beam height. For the first floor beam of specimen SN50, and as shown in Figure 15 (b) for the crack spreading in that beam, the experimental curvature was computed using the strain gauges reading placed at  $H_b$  where  $H_b$  is the beam height. For the second floor beam this value was set to  $0.5H_b$ . Figure 13 shows a comparison between the analytical and the experimental results of the first floor beams for both frames.

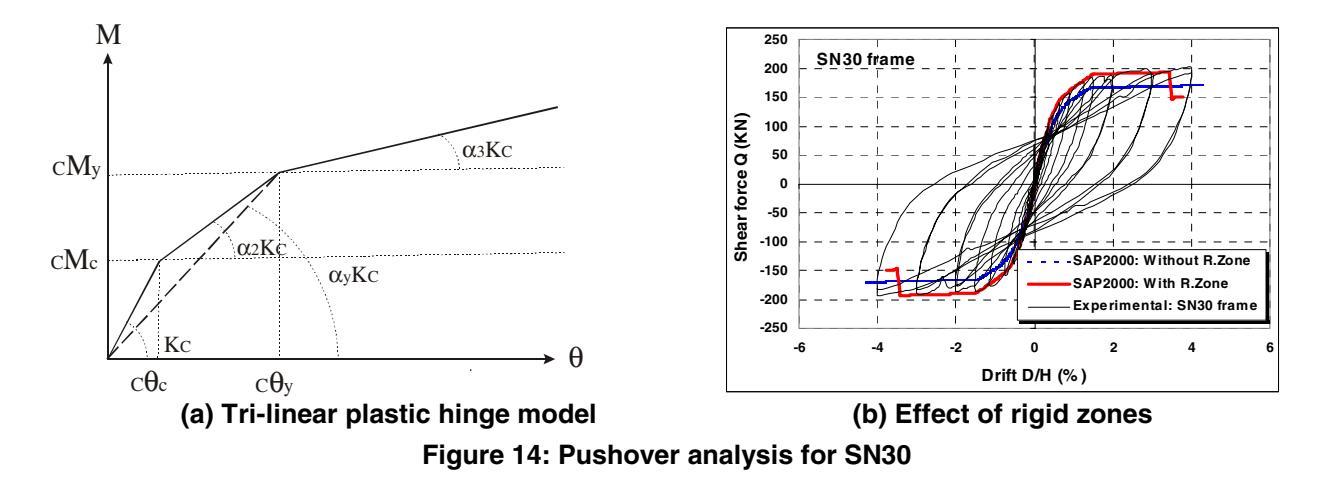
To predict the envelope curve of the shear force-drift relationship pushover analysis was carried out using SAP2000 program [12]. This software possesses a pre-processor and post-processor that makes it very easy to deal with. Columns and beams were modeled with a beam element that exists in the library of the program. Plastic hinges where introduced at each element ends having the characteristics recommended by the Japanese design guidelines [7] that are not given here due to space and size limitation. Figure 14 (a) shows the shape and the different parameters of the tri-linear model. As an example, Figure 14 (b) shows a comparison between the experimental and the analytical SAP2000 results for SN30 frame. The analytical results agreed with the experimental results quite well. Inserting rigid zones at the edge of the columns and beams improved considerably the prediction. In Table 3 a comparison, in term of horizontal peak load Q, between the SAP2000 predictions with and without the rigid zones and the experimental results are compared.

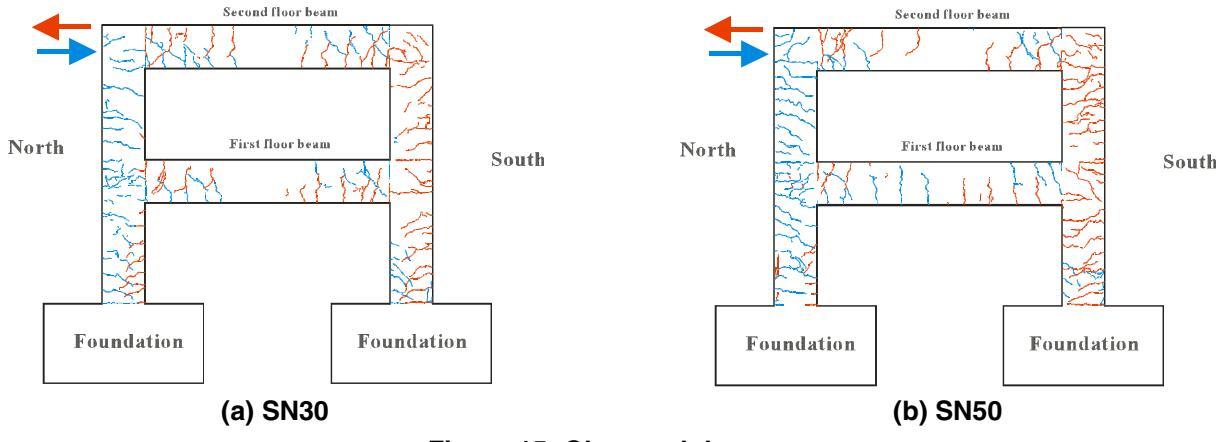
Figure 15 shows the crack pattern at 2% drift angle for both frames. More crack can be seen on the SN50 columns than those of frame SN30. No buckling or severe concrete crushing was found for any column. At the end of the test, the outside concrete cover located at the base of the first floor column either in the north or south side of the frame was found to be 26 cm for SN50 and 15 cm for SN30 as shown in Figure 16. Even though the spacing of the shear rebar was as much as 80 mm, six times the longitudinal bar diameter, buckling of the longitudinal reinforcement of the second floor beam ends were observed for both frames. Concrete of the lower part of the south side of the second floor beam crushed due to high compression, and its length was found to be 10 cm for frame SN30 and 20 cm for frame SN50. The same crushing was found at the upper part of the north side of the second floor beam with 10 cm length for both frames due also to high compression force. Damage was also predicted analytically using Park et al.'s cumulative damage index [13]. The damage model consists of a simple linear combination of normalized deformation and energy absorption. Figure 17 shows the damage progress at beams and columns of frame SN50. According to Park et al's damage classification, first floor beams sustained a minor damage. Whereas, the second floor beams suffered a severe damage. The first story columns suffered no damage while; the second story columns suffered a minor damage. These classifications were consistent with the observed damage.
