SOME ASPECTS OF ANTISEISMIC STRENGTHENING IMPLEMENTATION FOR HISTORICAL BUILDINGS IN TASHKENT

In the paper are presented results obtained during implementation of rehabilitation and strengthening of some old buildings of Tashkent city (50-70 years old): Hotel "Tashkent',

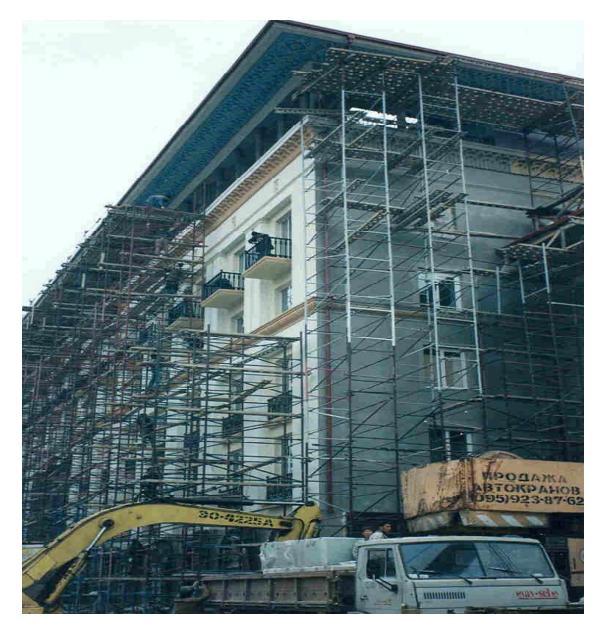
Fig. 1 General view of hotel Tashkent building under reinforcement.

As a construction the building of hotel 'Tashkent' consists of 5 objects, separated by deformation junctions. Main part of building has 6 storey, including technical floor and roof used as restaurant. Other parts are 4 storey. Buildings were designed as combined construction. External walls are masonry with vertical RC inclusions with step 4m. Internal bearing elements are columns with cross-bars in longitudinal direction. Ceilings are ribbed reinforced concrete plates with bottom flange, supported at longitudinal walls and cross-bars by beam scheme. Part of ceilings are assembled, other part are monolith. In fig. 1 is presented general view of hotel "Tashkent". In some cross-sections of building in transversal direction of axes there are RC shear walls with wire mesh reinforcement. Shear walls by the height discontinuous for example at level of first floor. The walls of first floor are sparse with purpose to provide freedom for planning. Partition walls with thickness 20 cm from slag blocks are bearing; they have horizontal reinforcing fabric and vertical RC inclusions, connected with ceilings and vertical bearing elements. Foundation under columns is monolith RC and under external walls - strip RC or rubble concrete. The height of underground floor is 2.6m, first floor – 4.6m, typical floors -3.3m, technical floor -2 m. step of columns -4m. Technical inspection showed the state of building: compression strength of columns concrete is varied between 100-200kg/cm²; normal cohesion of brick with mortar -0.6 - 0.9 kg/cm² that is less than minimal requested by building codes (1.2 kg/cm^2) . In some cross sections the vertical inclusion are absent. According to acting building codes in earthquake prone areas permitted to construct buildings with discontinuous frame such as hotel "Tashkent" only in regions with expected intensity 7 with height not higher than 3 floors. By conditions of customer request we are not permitted to provide reinforcement from external side.

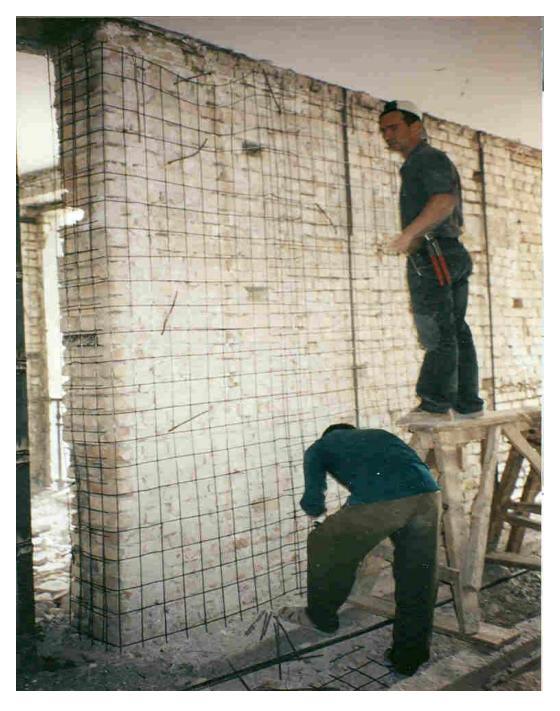
Fig.2 Reinforcement of wall by reinforcing fabric.

The walls were reinforced by plastering by cement mortar grade M100 by reinforcing fabric from internal side; to provide better cohesion of mortar layer used reinforced connectors in the walls; reinforcing fabrics anchored in walls by inclined on angle 30-45 ° steel bars with diameter 8mm driven into holes with diameter 7mm (fig.2).

Window and door openings were framed by reinforcing bars with anchoring in the walls. Reinforcing by the building height is continuous – parts of wall within ceiling were framed by short steel bars. Reinforcing fabric in underground part anchored into foundation and in upper floor to the ceiling.

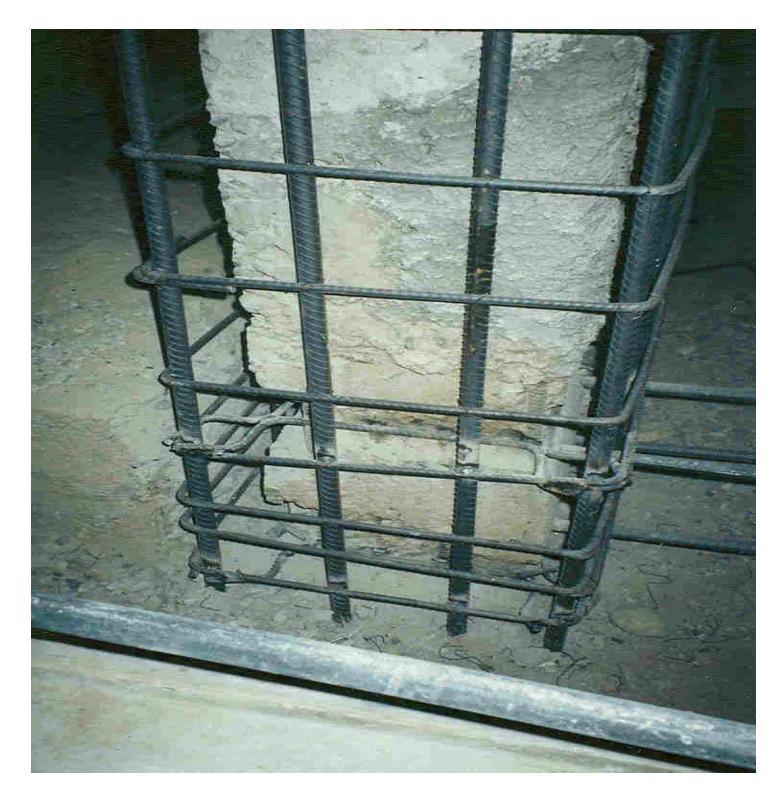
Fig.3 Columns covered by concrete jacket

Columns in underground and first flexible floor covered by concrete jacket which anchored in underground floor to monolith foundation, at first floor to newly implemented monolith RC spanner (fig.3). Columns of other floor reinforced by angle bars with following plastering by reinforcing fabric.

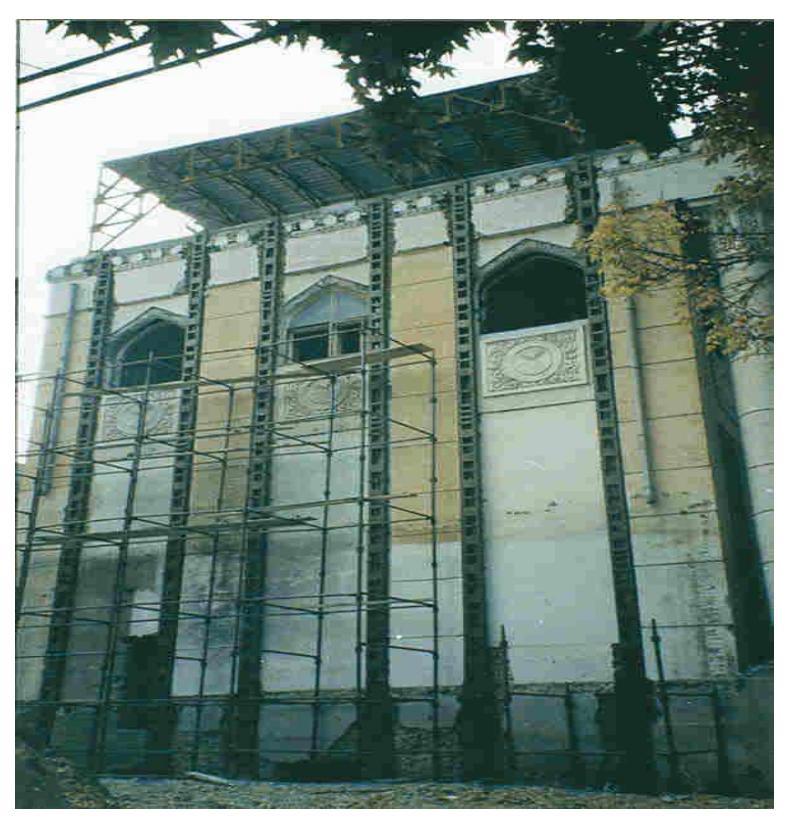
Fig.4 Building of concert hall "Bahor" under reinforcement.

By perimeter of external walls were used metal or RC applications, presenting horizontal and vertical bars with discrete reinforced connectors with bearing walls. For provision of ties with existing walls the elements of joints have free ends in internal walls. Vertical cross - bars were anchored in foundation, and by perimeter of building were connected by metal insertion pieces (fig.4).
