# CORRELATION OF FRAGILITY CURVES FOR VERNACULAR BUILDING TYPES: HOUSES IN LALITPUR, NEPAL AND IN ISTANBUL, TURKEY

Dr. Dina D'Ayala<sup>1</sup>

# SUMMARY

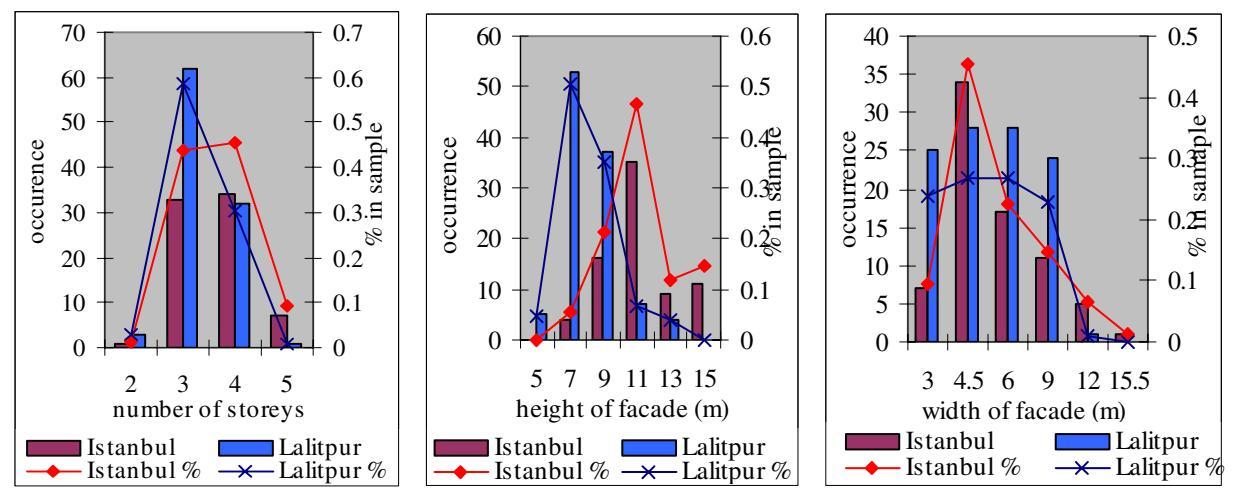
Figure 1: a) number of storey, b) height of facades, and c) width of facades.

The Fener-Balat sample has an almost equal proportion of 3 and 4 storey buildings (39% and 41%, respectively) while the Lalitpur sample presents a majority of three storey buildings (65%) with a minority of 4 storeys (32%) while both 2 and 5 storeys are very rare (Figure 1a). Late vertical additions are not included in this count. The Lalitpur sample is correspondently shorter, with the majority of facades having a height up to 7m (60%), while in the Istanbul sample 46% of buildings have height between 9 and 11 metres (Figure 1b). The average storey height of Lalitpur is 2.15m, against 2.90m for Istanbul. Moreover Istanbul buildings, with a majority of 4.5m wide facades, are on average narrower than the Lalitpur sample, with an even spread over a range from 3 to 9 m width (Figure 1c).

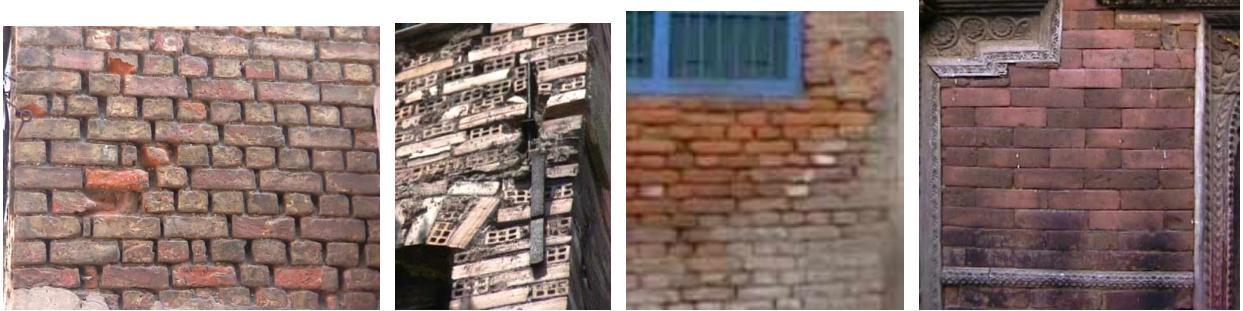
Figure 2 a) solid brick masonry, with large numbers of through thickness units and loss of mortar, Fener Balat; b) extruded hollow bricks used in jetties and chumbas, Fener- Balat; c) example of ordinary unfired brickwork, Lalitpur; d) original dachi aapa glazed brickwork with pathology. Note the very thin external mortar join.t.

In the Lalitpur sample the most common masonry fabric is made of unfired clay brick bonded with mud mortar. There are two types of bricks: ordinary sun dried bricks of dimensions 220\*105\*40 mm, set in mud mortar, and vitrified fired bricks, called *dachi aapa*, with dimensions 220\*150\*60 with a trapezoidal cross section, so that the mud bed-joint is partially covered externally by the brick, (see Figure 2d) This type of brick is usually used in better quality construction for the facing of external walls, as the vitrified surface and the overlapping over the joints, renders this wall fabric substantially impermeable to rain water. The wall construction historically is of three solid brick leaves with courses of runners alternated to courses of stretchers, bonding the leaves together. Commonly the thickness of the walls at ground floor is about 450 mm reducing to 300 mm at the third floor. Typical pathologies observed are: rising damp, efflorescence, loss of surface material, loss of mortar. The houses traditionally do not have dump courses, and very often recent repointing and replastering with cementitious material are responsible for the occurrence of efflorescence and loss of material (Figures 2a and 2c). The geometry of the unit and the type of mortar define in the FaMIVE procedure the mechanical model of the masonry, via the overlapping length of unit the number of courses for a given height of wall and the friction coefficient. For Lalitpur fabrics this last parameter was set to 0.3 for ordinary brickwork and 0.35 for the dachi aapa, while in Istanbul a value of 0.40 was used through out. These values correspond to typical Mohr coulomb curves for respectively mud and lime mortars.

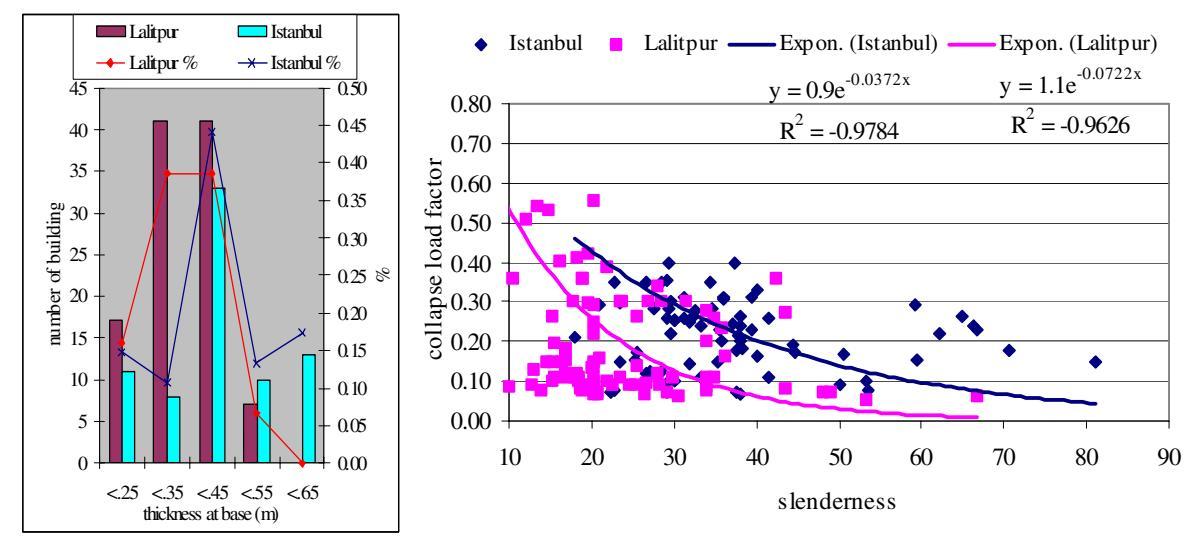
Figure 3 a) Distribution of thickness; b) Correlation between collapse load factor and slenderness of the façade

The distribution of thickness at the basis of the walls shows, for Lalitpur's sample, two clear sets corresponding to 2-leaf brickwork and 3-leaf brickwork, while the Istanbul sample is more homogeneous with 450mm the most common thickness class, Figure 3a. Both samples show no reduction of thickness along the height for the 3 storeys buildings. For the purpose of the seismic capacity assessment, the thickness considered is the effective thickness, obtained by applying to the geometric thickness surveyed, a reduction factor, (of range between 0.05 and 0.15), which accounts for the loss of material, either of mortar or brick, due to decay of the external surfaces and loss of bonding. The ratio of height to effective

thickness, defined as slenderness of the façade, is hence calculated to provide a first estimate of the out of plane capacity of each façade. However the actual collapse load factor of the façade will depend not only on this geometric criterion, but also on the structural constraints that the other elements of the buildings impose to the façade. The collapse load factor is calculated by applying concepts of limit state analysis and modified plasticity theory, and identifying for each façade a number of feasible mechanisms. In Figure 3b the correlation of collapse load factor to slenderness is shown for the two samples, together with regression curves. It can be noted that the collapse load factor is not inversely proportional to the slenderness for all facades. This is due mainly to the change in structural provision and construction details as the height, and hence the slenderness increases; for instance in building with 4 and 5 storeys there is a larger proportion of ties than in shorter buildings. Comparison between the two samples shows that the Lalitpur regression curve is lower than the Istanbul one, suggesting a more vulnerable stock.

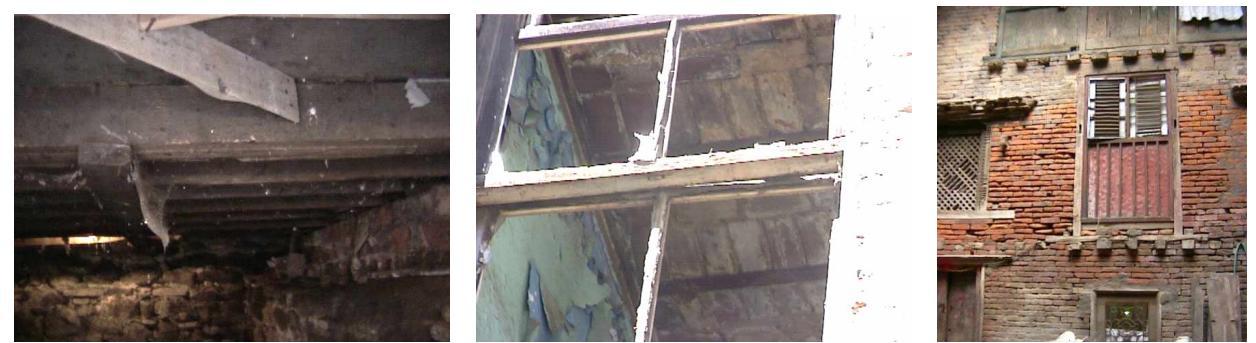
Figure 4: a) traditional floor structure with joist on the external leaf of the wall; b) iron beams and jack arches in a forth floor ceiling; c) traditional floor structure with joist on the external leaf of the wall

The traditional floor structure typologies surveyed are timber joists running from party wall to party wall with variable dimensions, but usually 100\*70 mm or 120\*50 mm, spaced at intervals of 300 to 450 mm in Istanbul (Figure 4a); and timber joists spanning from facade to back wall of dimension 50\*100 mm and closely spaced at 200 to 300 mm in Lalitpur (Figure 4c). The joists are usually bearing on an internal timber wall plate which runs just above the windows. Spandrels above windows are hence usually very narrow, the height of 3 to 4 courses of bricks, especially in more recent houses with storey high windows. Above the joists, the most common solution in both cases entails planks covered by linoleum sheets or thin layer of compressed mud (type a1 in Figure 5). An equally common solution in Lalitpur, but more rare in Istanbul is a finishing with screed and tiles above (type a2). The most substantial difference in the two samples consists in the layout of the joists, spanning between party walls in Istanbul, while in Lalitpur are laid normal to the facade and, in many cases, the joists come through to the external surface of the wall. A third typology, only present in Istanbul, is made of iron beams, of depth of 100mm, spanning parallel to the facade and spaced 750 mm apart supporting shallow arches formed by brick tiles 300\*150\*60 mm. (type b) (figure 4b). This system is used in the chumbas or jetties, although it rarely forms the only type of floor in a building. Concrete flat slabs, not thicker than 120 mm, in most cases laid directly on the masonry walls, are becoming increasingly common in both samples (type d). The traditional roof structures in the two samples are timber rafters differing only for the shape of the local tile and for a rather thick mud insulating layer present in the Nepalese sample (a1). A slightly lighter alternative is represented in Istanbul by Marseillese tiles and in Lalitpur by jhingati (a2). (Figure 5b). The rate of replacement of traditional roof structures is however very high, the most common alternative being represented by timber joist with corrugated metal sheet (a3) in Lalitpur (35% of the sample), and by flat concrete slabs (d) in Istanbul (10% of the sample). Concrete ring beams, although included in NBC 203 (1995), have not been seen on site, not even in newly extended or strengthened buildings. Very common is the use of timber floors at the lower storeys and concrete slabs at the upper, corresponding to a later conversion with possibly the addition of one floor and a flat concrete roof.

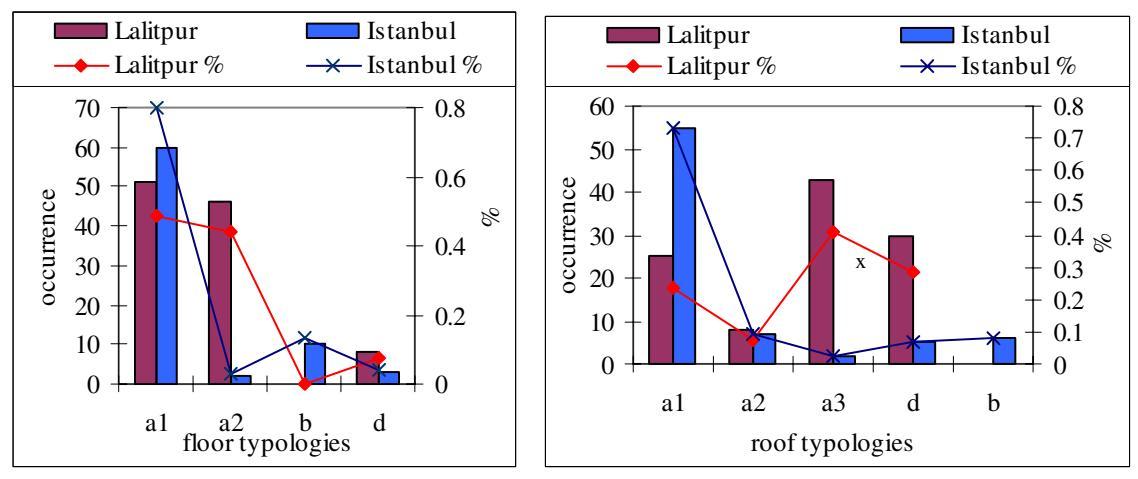
Figure 5 Histograms of typologies of a) floor structure, b) roof structure

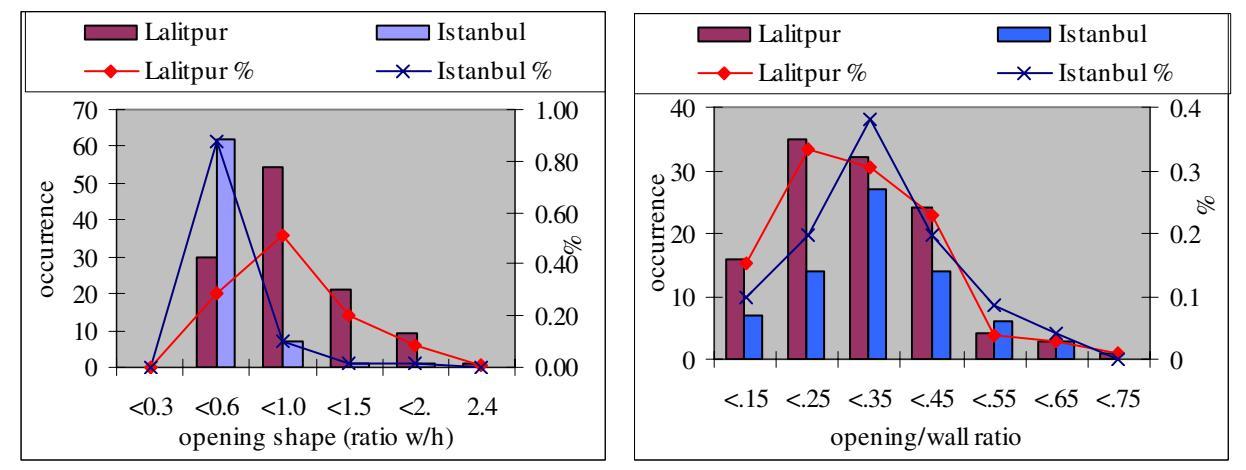
Figure 6 Histograms of a) shape ratio of openings, b) opening to wall ratio.

substantial difference of the opening to wall ratio values. Although the Lalitpur sample presents a slightly higher standard deviation and wider range, the two average values are very close, at 0.28 for Lalitpur and 0.33 for Fener-Balat. Maximum values of the opening to wall ratio in the two samples are 0.74 and 0.65 respectively. Façades tend to be rather narrow and tall in Fener-Balat, with an average width to height ratio of 0.55, resulting in piers between opening and lateral piers being very narrow, just one or two bricks wide. Conversely the spandrels are comparatively high with an average height of 0.6 m. The Lalitpur sample instead has an average façade shape ratio of 0.875, resulting in relatively regular piers, but very shallow spandrels of just two or three courses above the windows. Histograms for the window shape ratio and for the ratio of voids to wall are shown in Figure 6a and b.

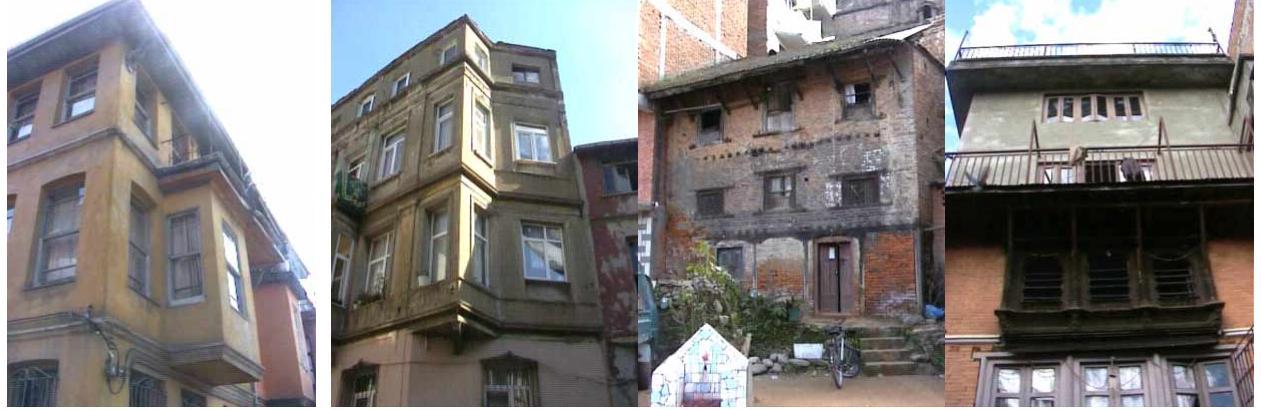
Figure 7.)Typical window size and layout in Fener and Balat, a) oriel window, b) corner jetty. c) Lalitpur Malla period windows, with variable size at same floor. Note the concrete frame in the background; d)Lalitpur, San jhya window, with addition of two upper storeys.

The shape and layout of openings defines the actual dimension of structural piers and spandrels. In Istanbul, there is relatively little variation within the sample, with an average shape ratio of 1:2 and most common width of 0.8 m and height of 1.6 m. The opening layout is usually regular, aligned in vertical columns and with same height at each floor. In the Lalitpur case, opening shape ratio and layout depends on period of construction and level of alteration. The older buildings have generally smaller squared windows with lintels extending well into the surrounding masonry and built with a double frame (Figure 7b). A feature of the older buildings is the San Jhya window, a richly decorated window that takes most of the façade at the third story level, with seating framed within it. Latter buildings have more homogeneous openings, usually taller and narrower, about 800 mm wide and up to storey height. In this typology spandrel above windows are very narrow. In more recent construction or alteration the concept of the San Jhya has been extended to each floor so that there is very little masonry left on the front façade of the house. This difference in shape and lay out within the two sample does not however results in a

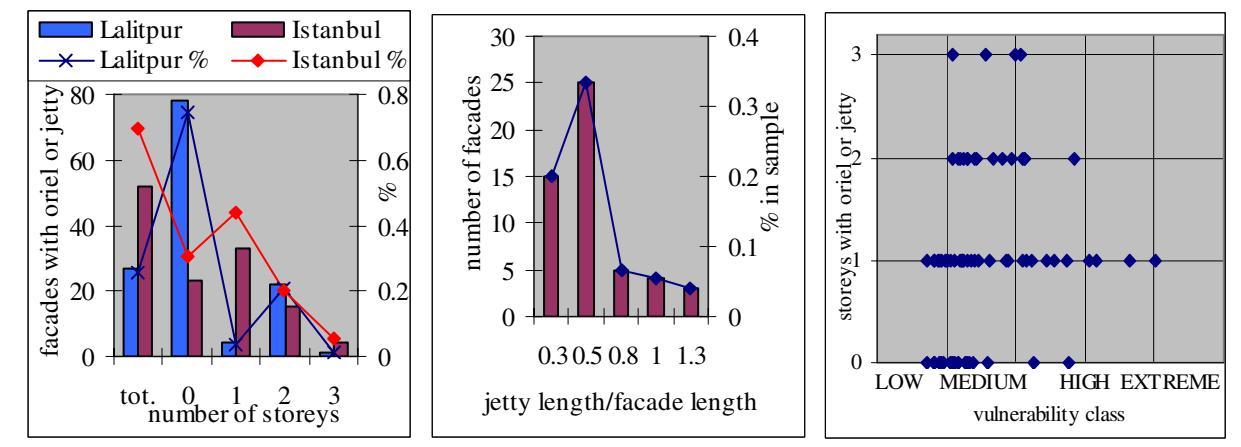
Figure 8: Statistical distribution of a) number of storeys and b) length of chumba and jetty; c) corresponding vulnerability classes

The oriel is the central window of the façade at first floor. Figure 8a shows that 70% of facades in the sample have oriels or jetty, 45% only at one storey. In order to quantify the portion of sample with jetties or oriels, the length of the jetting portion is taken as ratio of the façade length in Figure 8b. As it can be seen more than half of the total sample have a ratio = 0.5, clearly oriels, while about 10% have jetties, and a small number of buildings on corner present jetties on both sides of the corner resulting in ratios greater than 1 (4%). Although the oriel and jetty are clearly perceived as a feature increasing the vulnerability of the façade, due to their eccentricity with respect to the main wall, in reality their associated overturning moment is relatively small, compared with other restoring actions, due to the large opening ratios. It is not immediate to quantify any increment in seismic vulnerability directly related to the presence of the chumba, especially because a number of structural details are present to limit their adverse effect, such as orientation of horizontal structure, presence of ties, presence of brackets to support it, and use of lightweight brickwork. However it can be noted in Figure 8c that the buildings with just one storey oriel tend to have higher vulnerability than others. This might be explained by the observation that in this category of buildings, anchors are less common than in buildings with oriel or jetty over more storeys or buildings without it.

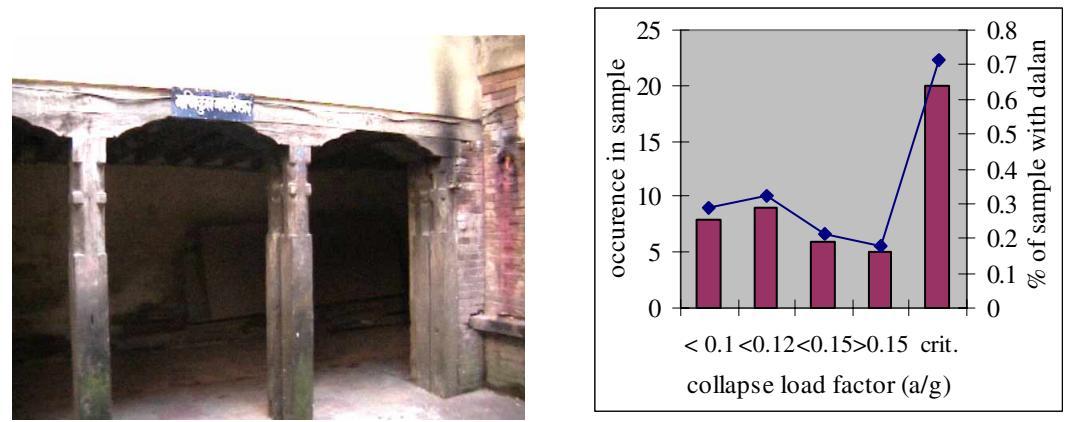
Figure 9 a) dalan structure at ground floor of a courtyard, b) collapse load factor distribution

its associated failure mechanism, as all connections are simply pinned; the only lateral restraint, when present, is represented by the shear strength of the masonry piers at the edge of the façade. Figure 9a shows a well-preserved example of *dalan* in the internal courtyard of a *math* house. The presence of the *dalan* can trigger three different types of mechanism: a) lateral in plane failure, due to overturning of the *dalan* columns in the plane of the façade; b) out of plane overturning of the façade above the *dalan* beam; c) a specific type of arch effect when the top of the façade is retrained by pegs in the roof rafters.

The first mechanism will develop only partially if there are sufficiently wide masonry piers, at the side of the *dalan*, to withstand the lateral overturning thrust. Otherwise, as is often the case, this mechanism will have very low collapse load factor and hence will be critical. This type of failure involves the whole façade and, once triggered, it will result in total collapse, unless there are other buildings to prevent it. Figure 9b shows the range of collapse load factor associated with the *dalan*. None is greater than the reference design acceleration 0.32g, provided by the code. In fact the majority has a collapse load factor smaller than 0.15 and in 63% of façades with a *dalan*, the soft storey mechanism with lateral overturning, becomes the critical one, i.e. the one yielding the highest value of vulnerability for the façade.

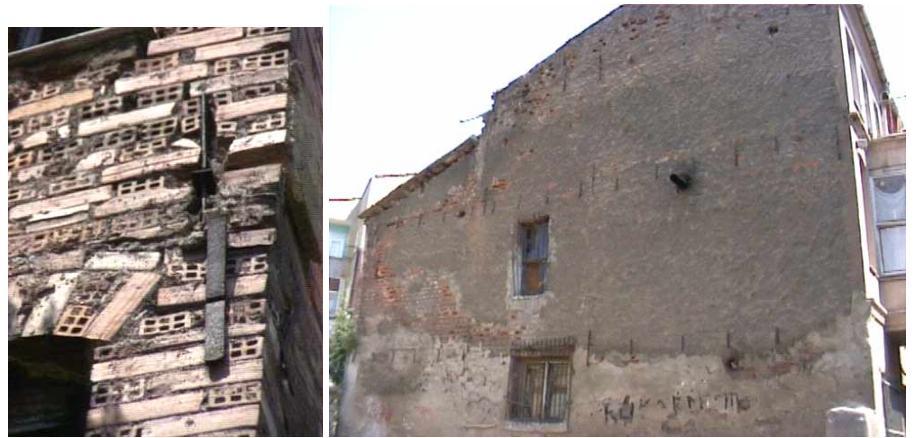
Figure 10 a) example of wall to wall anchor; b) example of floor to wall arrays of anchors at each floor level

Given the particular construction typology used and the layout of the floors structures, spanning between party walls, facades of the Istanbul sample can only relay on the frictional restraint provided by the party walls themselves if the tooting of the brickwork is adequate. While this can be sufficient in preventing overturning in modest tremors, it becomes ineffective for higher shaking, especially at the upper storey, were vertical load is modest. Hence in this sample the most common chosen solution to the problem of out-of-plane restraint of the façade is the introduction of iron ties. The high occurrence in the sample (almost 70% of facades surveyed, see figure 11a) and the orderly and uniform distribution on facades and party walls shows clearly that this was a design choice implemented at the time of construction. Two types of anchors can be identified. One is the tie from façade wall to back wall, running underneath the floor structure an anchored to the wall by a vertical key slot through a hole at each end of the tie (Figure 10a). The second type is made of flat metal plates nailed into the joists and then bent at 90 degree over the external surface of the wall (Figure 10b). These are readily visible only on corner buildings, but it is probable that their use extend to other buildings in the sample. The survey shows that typically façades have two arrays of ties, one on each corner, on two levels, typically the roof and the first or second storey, depending on the chumba location. The presence of *ties* at roof level means that the overturning

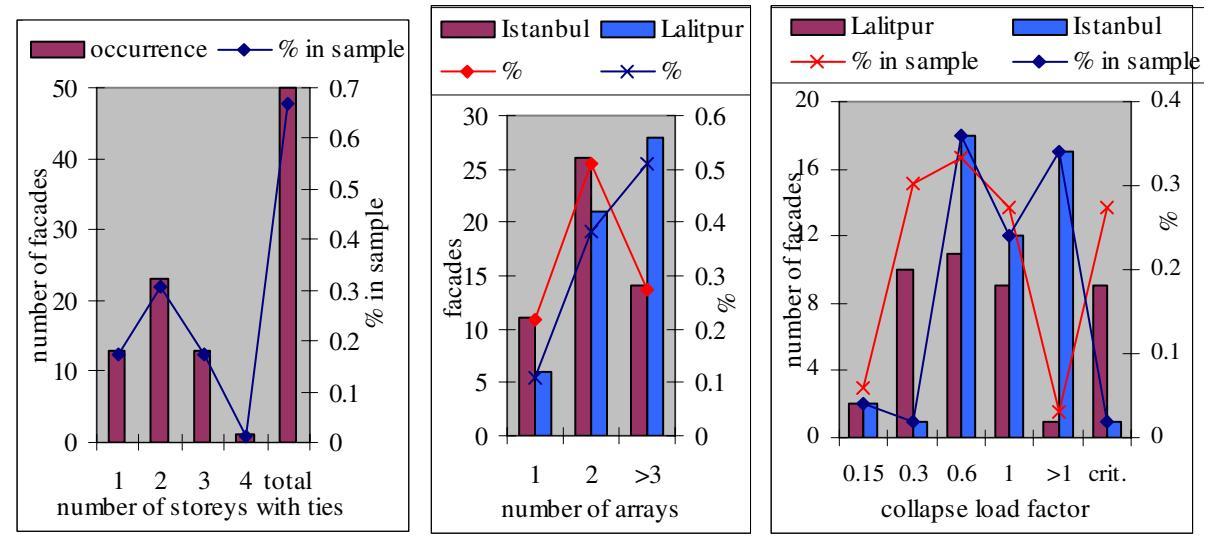
Figure 11 Distribution of ties and chokus in the two samples: a) over number of storeys; b) number of arrays c)associated collapse load factor

mechanism is prevented and a vertical arch effect, in which the top of the wall is restrained from moving out of plane, will form in its place. Figure 11c shows that only approximately 17% of the facades with ties have a collapse load factor smaller than 0.4, the peak ground design acceleration according to the code. Moreover this mechanism determines the vulnerability of the building, only in one case of the entire sample. This is due to the fact that the other mechanisms which might develop in presence of ties, such as partial overturning, in plane failure or spandrels failure, will occur for lower collapse load factors or involving greater portions of the structure.

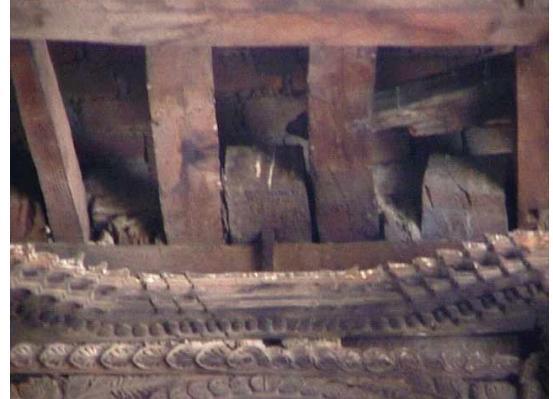
Figure 12 Example of peg

A common feature of Newari traditional construction, surveyed in Lalitpur, is the insertion of pegs, called *chokus*, to restrain floor joists from sliding over walls (Figure 12). Two vertical pegs are usually inserted through a joist on each side of the wall. According to the survey 51% of the sample has *chokus*, the most common case being for two joists only to be restrained, associated with an average width of façade of 4.5 m, while four *chokus* are found on wider façades. This device, readily visible at roof level, plays a role analogous to the ties. The analysis shows that the majority of buildings with pegs at roof level (63%) have collapse load factor greater than 0.3 and that this mechanism is critical only for 27% of the set with pegs, equivalent to 8.5% of the entire sample. Most commonly, the pegs butt on a timber wall plate running

along the width of the façade, on which the joists sit. While the best traditional practice uses wall plates on both leaves of the façade, connected by transversal struts dovetailed into them, as can be seen in some of the oldest and better built examples, nowadays the common practice is for only one wall plate spanning over the internal leaf of the wall. From a structural point of view the double wall plate is not only effective in redistributing the vertical loads more evenly across the wall, but, in the original arrangement has the double function of tying together the two leaves of the wall and, in presence of lateral load preventing shear cracks in the masonry from running from one floor to the next. A similar function is played by the timber bands included in the masonry at mid height of the wall within the masonry piers (Figure 13). Their presence is most effective when they run the entire length of the façade and continue around the corner, so as to form an effective hoop tying together orthogonal walls. They are rather uncommon in the sample studied.

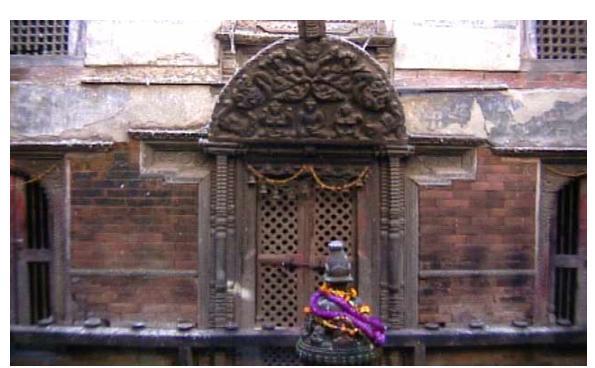
Figure 13 Example of timber bands at mid height of wall

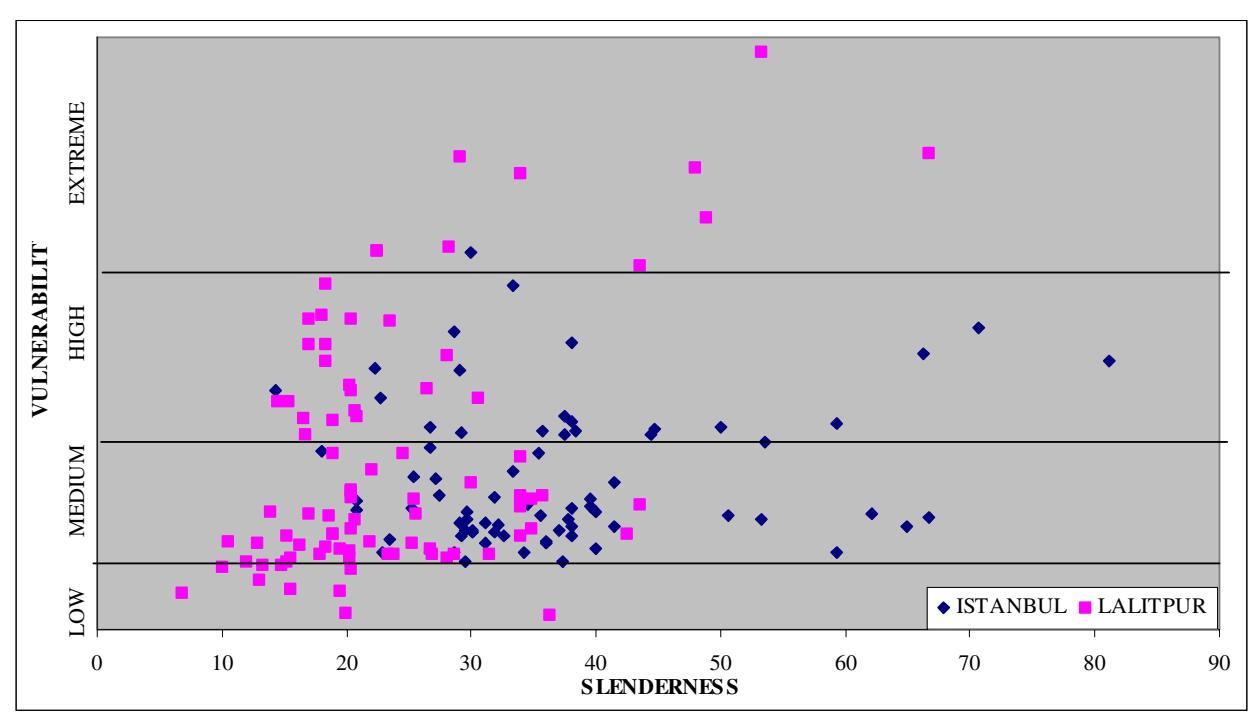
Figure 14. Distribution of façade mechanism by slenderness and vulnerability classes

An analysis of the data by failure mechanism shows that in the Lalitpur sample the most common mechanism is the soft-storey in plane failure in presence of *dalan*, followed by overturning of unrestrained façades, either partial or complete, and collapse of the upper spandrel. The "*dalan*" mechanism is associated with the class of *extreme vulnerability*. This is due to the fact that the mechanism is triggered for low levels of the lateral acceleration, typically lower than 0.15 a/g and once triggered leads to total collapse. However the two façades with highest vulnerability, associated to high slenderness, are affected by partial overturning mechanism. These are very thin buildings of five storeys of which the lower two are built in the original masonry and the upper three in concrete and infill masonry. These prove to be the most dangerous buildings in the sample. The buildings in this class show average collapse load factor of 0.08 a/g and are likely to be damaged by an earthquake of MMI VII.

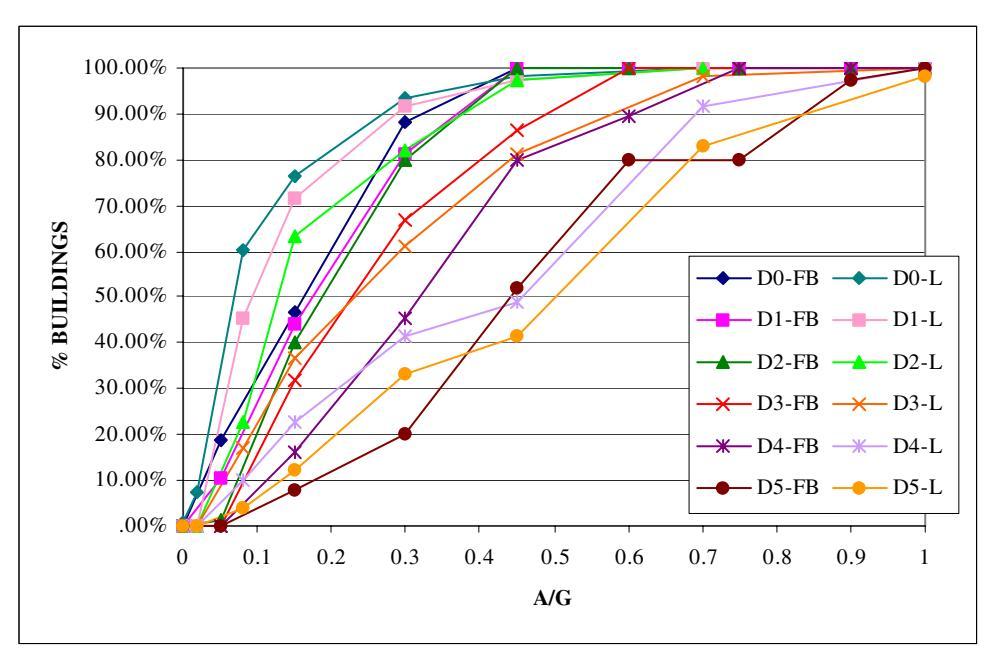
Figure 15 Cumulative damage distributions for values of peak ground acceleration

In Figure 15 the curves of cumulative distribution for each damage state are plotted against different level of expected ground acceleration. These curves show the percentage of the building sample, which would reach or overcome a given state of damage. Of particular interest to the present discussion are the values of the curves in correspondence of 0.32 a/g (seismic acceleration), corresponding to the level of design acceleration for new masonry structure prescribed by the Nepalese code. In correspondence to this value more than 90% of the buildings will be damaged and 80% will have at least damage level D2; about 62% of the buildings will suffer heavy damage, level D3, 35% will experience partial collapse, D4, and 11% will collapse, D5. Most importantly, if the level of peak ground acceleration expected for 50 year return period is considered, i.e. a/g = 0.4, it emerges from the diagram that at least 20% of the buildings will

collapse, 45% will experience partial collapse, up to 70% will be seriously damaged and only 5% will survive unscathed. In the case of Fener-Balat, are of interest the values of the curves in correspondence of 0.25 to 0.33 a/g corresponding to the level of design acceleration prescribed by the Turkish code, but also to the expected spectral acceleration in Istanbul. In correspondence to 0.3g Figure 16 shows that slightly less than 90% of the buildings will be damaged and 80% will have at least damage level D2; about 65% of the buildings will suffer heavy damage, level D3, 45% will experience partial collapse, D4, and 20% will collapse, D5. For 0.33g 70% of the building will have damage level D3, 50% D4 and 25% level D5.

In comparing the two samples, can be noted that the two curves for level D3 are more or less coincident especially if the value of acceleration corresponding to 50% of buildings being damaged is considered. This is of relevance as it is on this value that general macroseismic intensities and other less detailed vulnerability analysis are conducted. However the procedure applied here is able to highlight differences in behavior of the samples based on their peculiarities. For instance the curves of low damage states (D0-D2) show that higher percentages of buildings will be damaged for lower acceleration in Lalitpur as opposed to Fener-Balat. This is to be ascribed to the fabric and quality of the masonry and to the general level of maintenance of the two samples. On the other hand, the curves for partial and total collapse highlight the higher number of collapses for low acceleration in Lalitpur, associated with the dalan structure, while the lower proportion of collapses at higher acceleration is to be related to the low percentage of 4 and 5 storeys buildings in this sample.
