EXPERIMENTS ON THE SEISMIC PERFORMANCE OF HOLLOW-CORE FLOOR SYSTEMS IN PRECAST CONCRETE BUILDINGS

SUMMARY

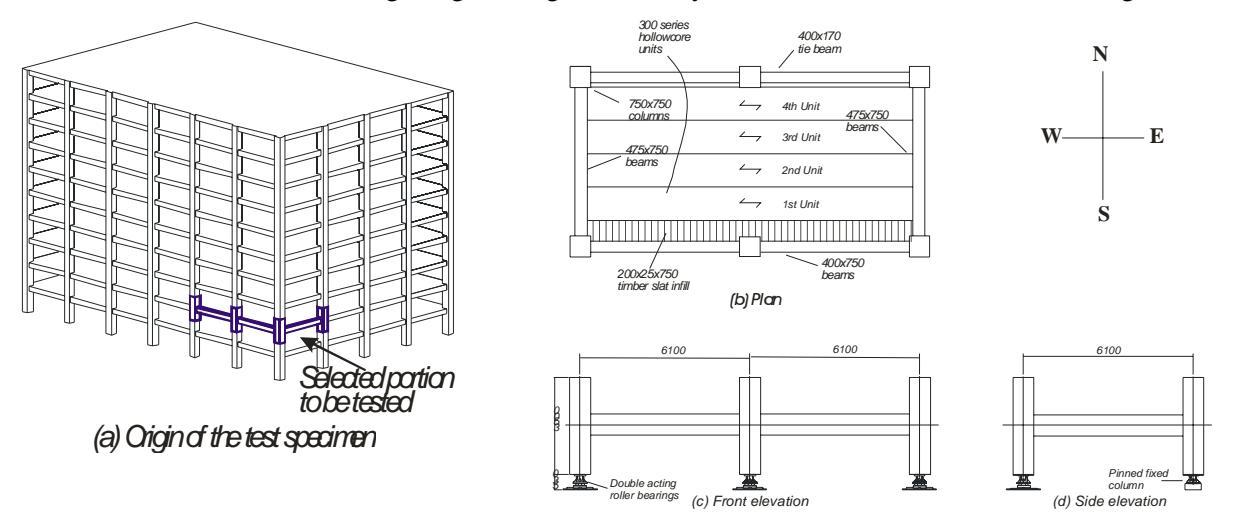
The entire experiment set-up was based on the Matthews [1] testing rig with connection modifications to improve the performance of the hollow-core units. The building was a two-bay by one-bay section of a lower storey in a multi-storey precast concrete moment resisting frame. The floor units were pretensioned precast hollow-core and were orientated so that they ran parallel with the long edge of the building, past the central column. The buildings origin along with the layout and dimensions are shown in Figure 1.

Figure 1. Origin, Layout and dimensions of the Stage 2 (Lindsay) super-assembly.

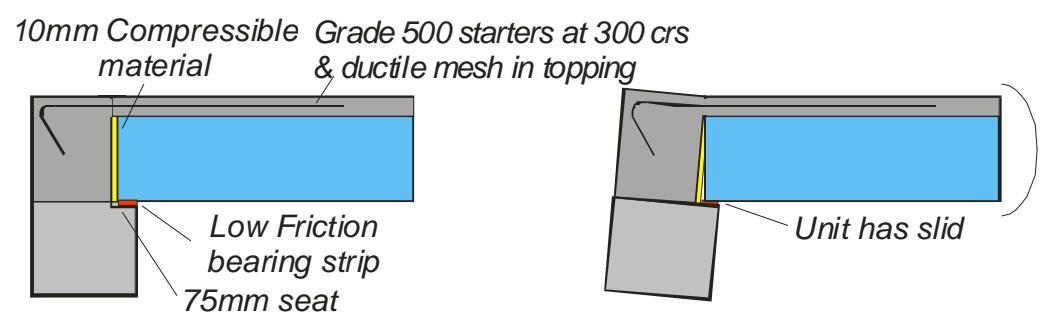
The seating connection between the hollow-core unit and the supporting beam consisted of replacing the plastic dam plug in the ends of the unit with 10mm of compressible material fully across the end of the unit and seating the unit on a low friction bearing strip. This detail is shown in Figure 2 along with how the floor unit is expected to rotate relative to the beam. The low friction bearing strip allows the floor unit to slide as designers had previously assumed it would. The compressible material is assumed to reduce the compression forces applied at the bottom of the unit under negative moments as well as restricting concrete from entering the cores of the units. If the large compression force forms between the bottom of the unit and the face of the supporting beam it is transferred at a relatively flat angle to the topping concrete. A perpendicular principle tensile force then forms, causing splitting of the webs at very early stages of the test.

When the unit is seated on a low friction bearing strip, the seat length becomes very important; it must be placed back from the face of the beam so that as the unit tries to rotate it does not dig into the bearing strip. The draft 2003 amendment to the New Zealand Concrete Structures Standard NZS3101:1995 (Standards New Zealand [3]) has amended the required seat length of hollow-core floors to span/180 or 75mm based on Matthews' recommendations. A seat length of 75mm was used in this test.

Figure 2. Seating connection detail with expected performance.

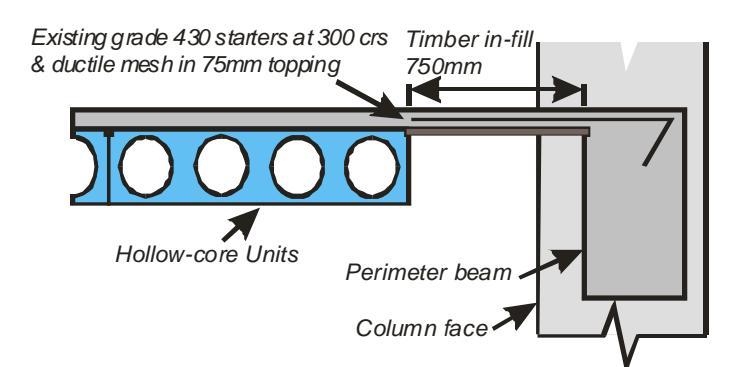
This connection consisted of moving the first unit away from the perimeter beam and replacing it with a 750mm timber infill with 75mm insitu concrete topping (Figure 3(a)). The infill allows a more flexible interface between the frame and southern hollow-core unit. Some cracking is expected in this interface due to the displacement incompatibility but it is anticipated that the more flexible interface will accommodate this while allowing the beam to deform in double curvature and the hollow-core unit in single curvature, (Figure 3(b)) leaving the floor essentially undamaged. Ductile reinforcing mesh was used in the topping to aid in the performance of the floor by helping to ensure that any damage and cracking would not result in such an early failure of the floor system.

(a) First hollow-core unit to perimeter frame connection.

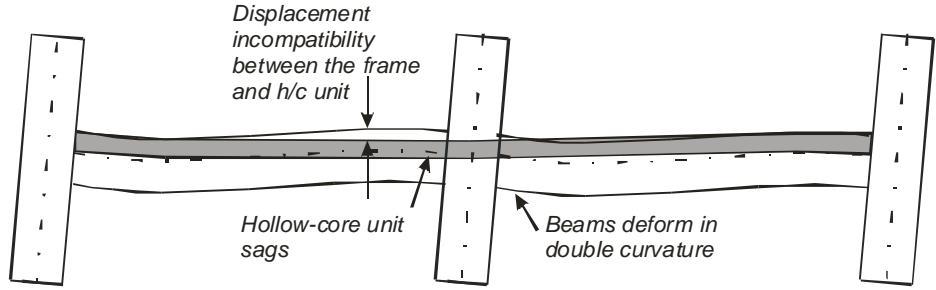
(b) Expected displacement incompatibility between the hollow-core floor units and the perimeter frame.

Figure 3. Displacement incompatibility and connection between hollow-core unit and perimeter frame.

- Isolating the first hollow-core unit spanning parallel with the perimeter beams from the frame due to displacement incompatibility. This displacement incompatibility was caused by the units being forced to displace in a double curvature manner due to being effectively connected to the edge of the perimeter beam, when hollow-core units are not designed for such displacement profiles.

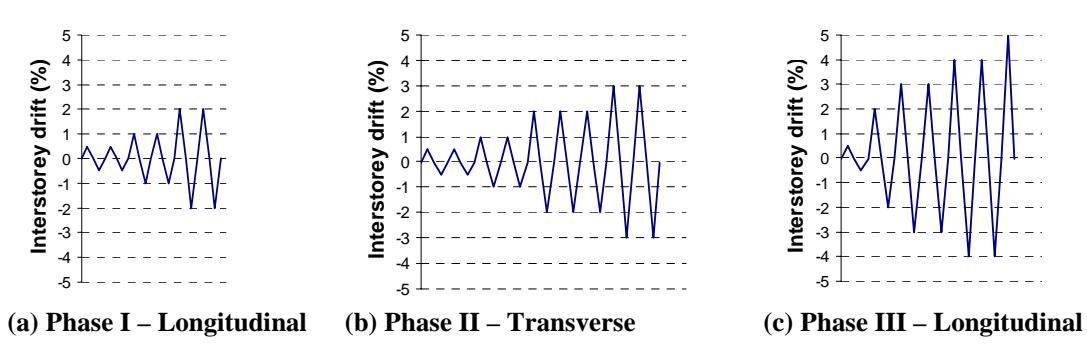
The super-assemblage loading was conducted in drift control. Displacements were applied to the specimen through the form of horizontal shear forces to the top and bottom of each column. The load frame set-up design is explained in Matthews [1]. Three different displacement histories, corresponding to different phases of loading, were applied to the super-assemblage as shown in Figure 4.

Figure 4. Loading histories applied to the super-assemblage.

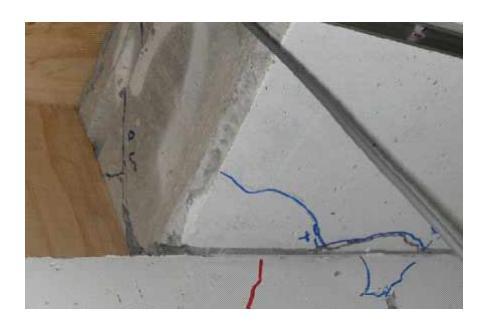
(a) Corner crack in first hollow-core unit at +2.0%

Figure 5. Damage to super-assemblage after Phase I loading.

The super-assemblage performed well in this phase of loading. The yield drift was determined to be 0.5%. The key results are shown in Figure 5. Diagonal cracks in the infill appeared at +1.0% and extended in the second $\pm 1.0\%$ cycle reaching the infill/hollow-core interface and running along the interface for almost the entire floor length, except around the central column where the drag bars appeared to tie the infill and floor together. By the end of Phase I this crack was 2mm wide with a vertical displacement of 2mm, in the west end (Figure 5(c)). A crack in the south corner of the first unit (ref Figure 1 for layout) developed at +2.0% and extended into the second core of the unit. There was 10mm of hollow-core pull-off in the $\pm 2.0\%$ cycle with the low-friction bearing strip sliding out in some places instead of the unit sliding on the bearing strip (Figure 5(a) and (b)). Some spalling occurred in the later cycles of this phase on the seat of the first unit due to the unit bearing on the unreinforced cover concrete. The economic consequences to an owner of a building with damage like this may become an issue. However, the cracks are considered to be repairable with the only permanent damage being the residual interstorey drift of the building (about 0.8% drift).

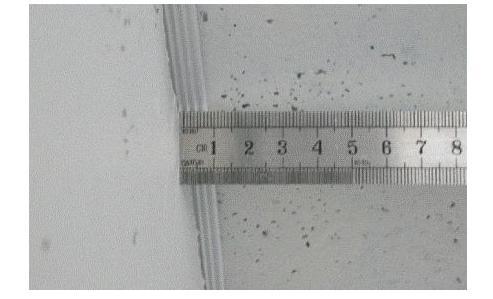
(b) Bearing strip sliding out at +2.0%

It is clear from the photos (Figure 5(b) and Figure 7(a & b)) that the low friction bearing strip did not perform how it was designed to. The bearing strip has teeth on one side and is smooth on the other allowing the hollow-core unit to slide on the smooth surface. In this case there was not enough bond/friction between the toothed surface and the floor supporting seat and in some places the bearing strip slid with the floor unit instead. By designing a bearing strip that has bigger teeth, to grip the beam better, or bonding the underside of the bearing strip to the beam should stop this movement.

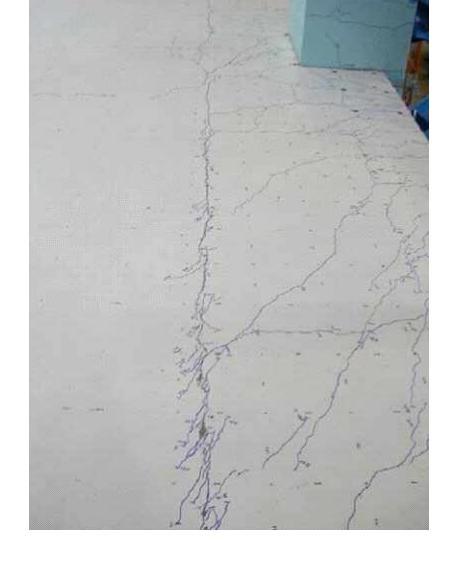
(c) Crack at hollow-core/infill interface at ±2.0%

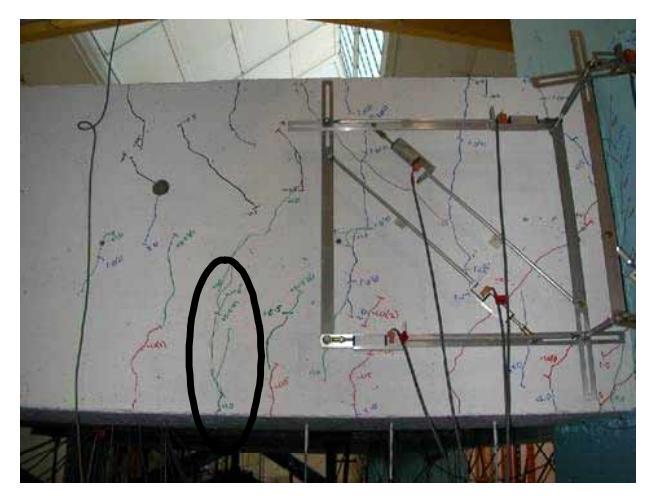
(a) Large crack forming in transverse beam, 1.0m from column face at +1.0%.

Figure 6. Significant damage in the transverse loading cycle

Very little new cracking occurred in the early stages of the transverse loading. This was because the transverse beams were pre-cracked from the longitudinal loading and these cracks simply opened during transverse loading. Key behaviour photos are shown in Figure 6. In the $\pm 1.0\%$ cycle a crack (2mm at this stage, opening to 6mm at $\pm 2.0\%$) opened up in the ends of both of the transverse beams about 1.0m from the column face as indicated Figure 6(a). It appeared that the weight of the hollow-core units caused the transverse beams to sag, accentuated by the cracked section, and in turn formed a uni-directional hinge at about 1.0m from the column face at both ends. The north side corner of the fourth hollow-core unit at both ends formed a corner crack at -1.0% drift that progressed up from the bottom of the unit to run along the web (Figure 6(b)).

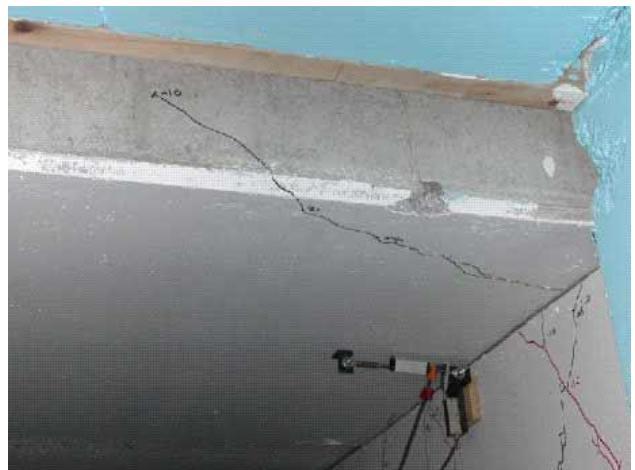
(b) Corner crack in north side of fourth hollow-core unit developing into a web-split at +1.0%.

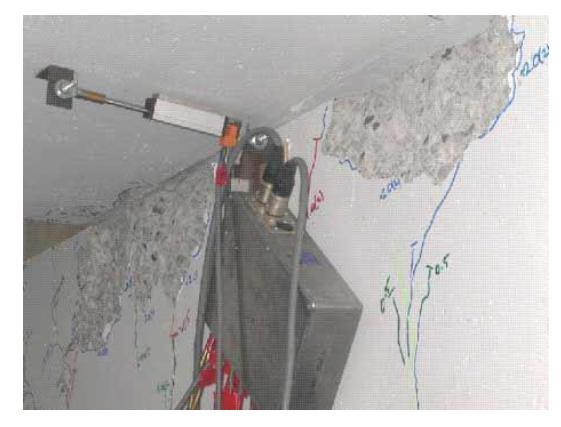
(a) Underside of first hollow-core unit, west end, +3.0% drift.

Figure 7. Damage in Phase III testing

Early in the Phase III testing, beam spalling at the west end of the first hollow-core unit left the unit with almost $\frac{3}{4}$ of its length with at least 20mm of seat spalled off (Figure 7a) and (b)). At +2.25% drift, on the way to +3.0% drift, the first crosswire of mesh fractured at the hollow-core/infill interface about 2m west of the central column. This first fracture was followed by nine others on the way to +3.0%. Once the mesh had fractured it could be seen that the fracture was due to two mechanisms. Firstly, the tear was due to the floor diaphragm restraining the frame from elongating causing a transverse tension force as the beam tries to translate outwards instead; this produced a horizontal east-west dislocation between the infill and topping of the first hollow-core unit (15mm) once the mesh fractured (Figure 7(d)) as well as accentuating the transverse north-south displacement (i.e. crack width, 10mm) (Figure 7(c)). Secondly, the tear was due to the displacement incompatibility. This caused a vertical offset of 10mm once the mesh had fractured (Figure 7(e)). The crack was 3m long at this stage but the central column was still adequately tied into the building. The transverse beams showed significant amounts of torsion due to degradation of the PHZs accentuated by the hollow-core load eccentricity.

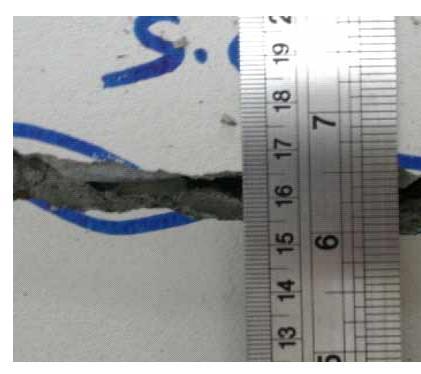
(c) Crack width of 10mm in places after mesh fractures (+3.0%)

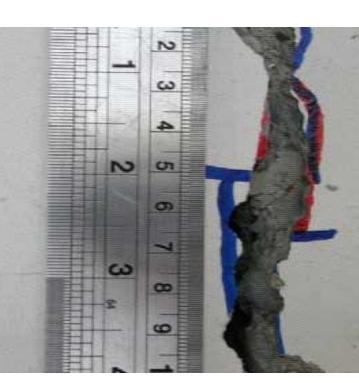
(d) Displacement of 15mm after mesh fractures (+3.0%)

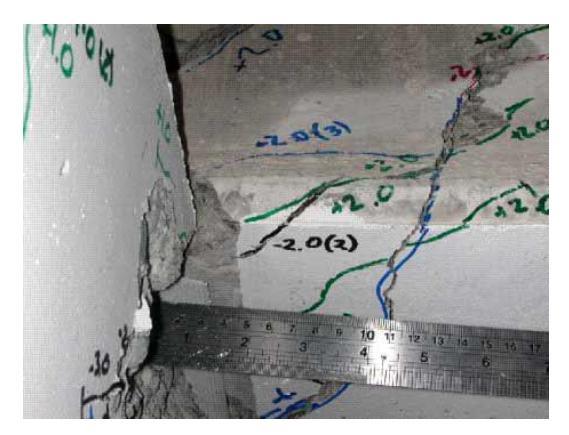
(b) 45-50mm of seat exposed of first unit, west end, +3.0% drift

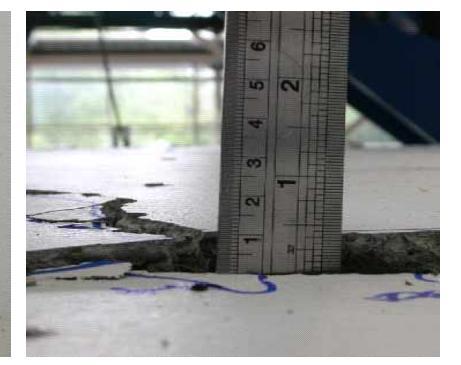
(e) Vertical offset of 10mm after mesh fractures (+3.0%)

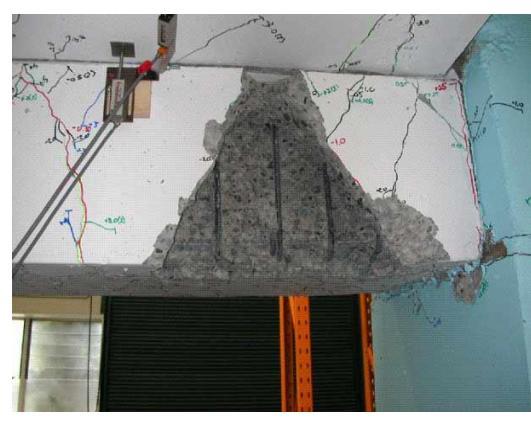
(f) Section of unreinforced seat fallen out at +4.0%

A large section of the unreinforced seat of the fourth hollow-core unit at the west end began to drop away showing the necessity of reinforcing the seat to tie it to the beam. The load carrying capacity of this seat/cover concrete was lost at 3.0% drift (first cycle). The concrete fell out during the second +4.0% cycle (Figure 7(f)). It was during these $\pm 4.0\%$ cycles that the PHZs showed some sign of distress with large sections of cover concrete falling off. The first main longitudinal bar fractured at +3.56% in the second $\pm 4.0\%$ cycle (Figure 7(g)) in the west PHZ in the southern beam with the remaining bars in that PHZ fracturing in the following cycles. A final +5.0% cycle was performed and during this cycle further seat damage was observed along with the main bars and topping mesh fracturing. A photograph of the infill section of the floor at the end of test is shown in Figure 7(h). It was at this stage that life safety became a concern, enough of the hollow-core seat had been damaged to question the stability of the floor diaphragm and nine main bars had fractured in total leading to concern about the stability of the frame elements.

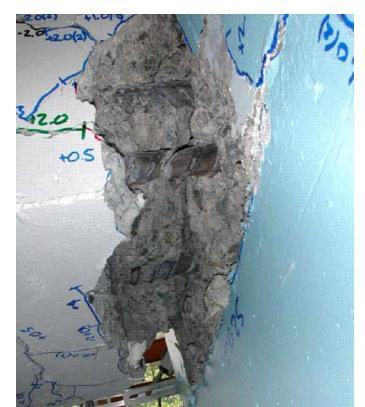
(g) Fractured main bar at +3.56% on 2nd cycle to +4%

The failure of the longitudinal reinforcing bars can be predicted by low cycle fatigue theory (Dutta and Mander, [8]). As this failure is a function of material properties and overall plastic rotation it is not a parameter that can be altered and therefore becomes the defining failure point for the super-assemblage.

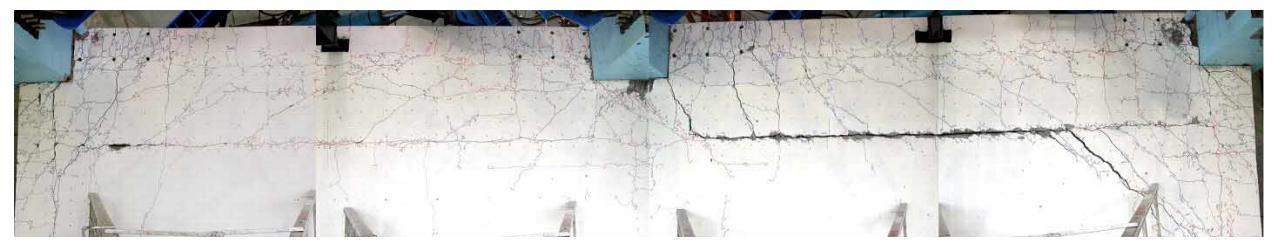
(h) Floor damage at end of test (5.0% drift).

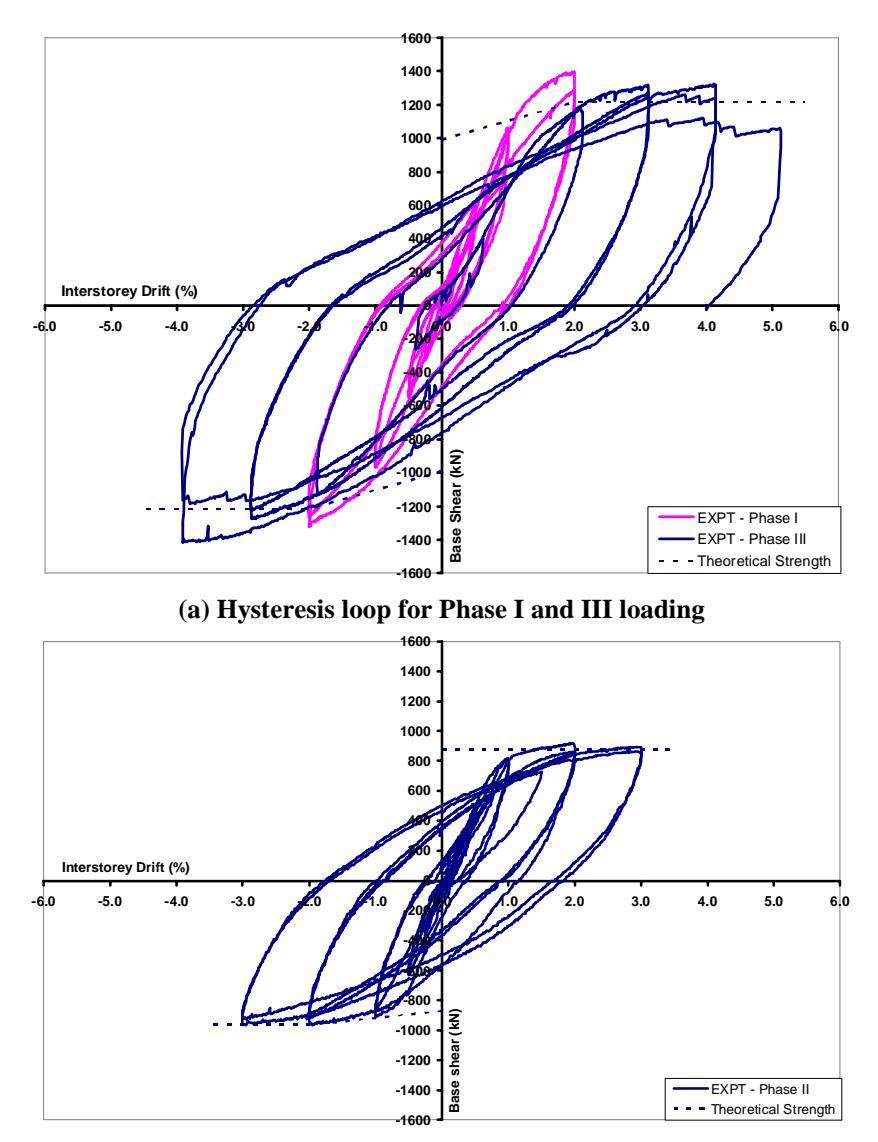
The base shear versus interstorey drift hysteresis plots for Phase I and III are shown in Figure 8(a) and Phase II in Figure 8(b). In Phase I, the hysteresis loop has a little pinching arising from a self-centring effect due to the PHZ cracks not opening and a large part of the deformation occurring at the beam/column interface which acted almost like a self-centring rocking connection. The maximum positive base shear was 1390kN while the maximum negative was 1320kN which both occurred in the first cycle to $\pm 2.0\%$. It can be seen that in the second cycle of loading very little loss in base shear capacity was observed. The overall theoretical base shear capacity was determined to be 1220kN at 2.0% drift onwards, once the entire floor had been activated. The theoretical mechanism assumes that as the interstorey drift increases more of the starter bars along the transverse beam are activated by flange action and these contribute to the negative moment capacity of the exterior hinges, up to a drift of 2.0% when all of the starters have been activated. The interior hinge capacity is made up of a contribution from the infill slab in the form of a yield line mechanism and activated mesh as well as the longitudinal beam bar capacity.

(b) Hysteresis loop for Phase II loading

Figure 8 Hysteresis loops for the three phases of testing

Phase I loading appeared to have no effect on the performance of the super-assemblage in Phase II. The hysteresis loop had less pinching than Phase I which is because the transverse beams were reconstructed entirely and therefore there was more distributed cracking and less of a self-centring rocking connection effect at the face of the columns in the hinges as seen in the southern hinges. The maximum positive base shear was 920kN which occurred in the first cycle to +2.0% drift. The maximum negative base shear for Phase II was -970kN which occurred in the first cycle to -3.0% drift. The theoretical mechanism for Phase II assumes that relocated positive moment hinges are at the nominal moments because the hinges are forming in sections of the beams that have not pre-yielded. In the areas where the bars have pre-yielded compensation was made for the effect that the heat treatment had on the bars. Starter bars in the interface between the infill and perimeter beam are also activated in the negative drift direction. This mechanism predicts a positive base shear of 880kN and a negative of -970kN which agree with the experimental data.

The difference in base shear capacities between the positive and negative base shears in Phase II is due, in part, to the non-symmetrical reinforcing layout. On the northern side of the super-assemblage the floor is not tied to the tie beam with starters therefore these can not be activated in a negative hinge moment cycle. A crack line also forms at the beam/infill interface through the starter bars. These reasons also account for why the base shear in Phase II is considerably less than Phase I as well as the use of the nominal yield stresses for the positive moment hinges in Phase II due to these hinges forming in steel that was not pre-yielded and subsequently heat treated.

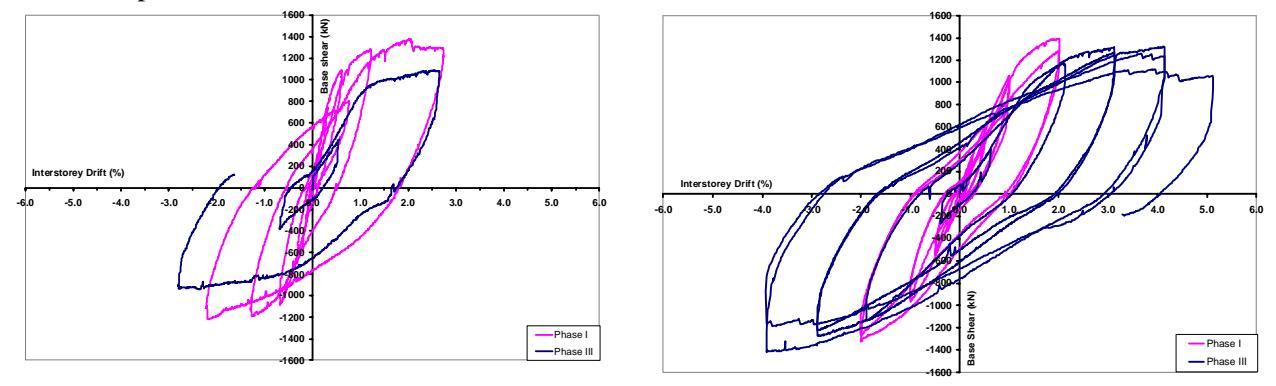
(b) Stage 2 hysteresis loop for Phase I and III

Figure 9. Hysteresis loops for Stage 1 and 2 for comparison of performance.

It should also be noted that although hysteresis loops are beneficial in determining the overall capacities of test super-assemblies their usefulness is limited when looking at the performance of individual elements. As can be seen by the graphs in Figure 9, the overall comparison of the two super-assemblies would be that similar overall base shears were observed, the Stage 1 (Matthews [1]) super-assembly was slightly stiffer than Stage 2 (Lindsay) and the Stage 2 super-assembly was loaded to higher drifts and therefore underwent more plastic deformation. What is not known is that the hysteresis loops are dominated by the performance of the perimeter concrete frame, and in Stage 1 the overall performance of the super-assembly was vastly inferior to the Stage 2 testing due to premature failure of the hollow-core flooring system. Therefore hysteresis loops should be used only to determine the overall capacities of systems and the individual performance should be assessed in a different manner.

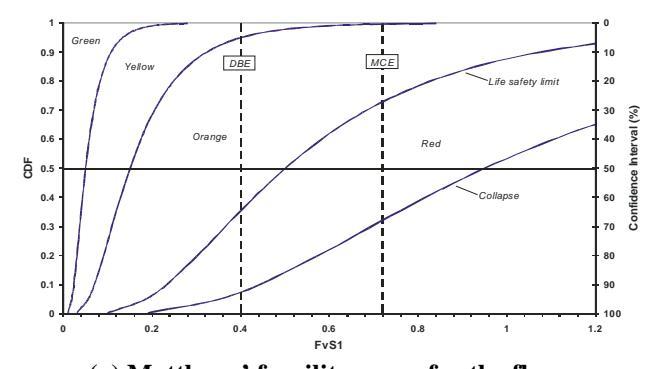
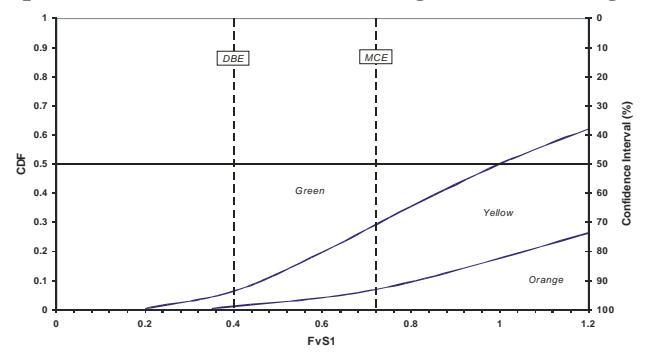
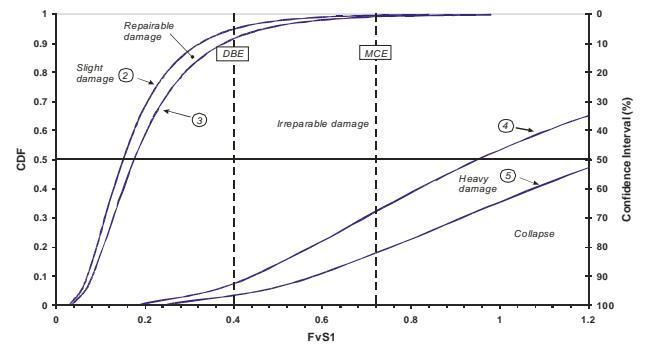
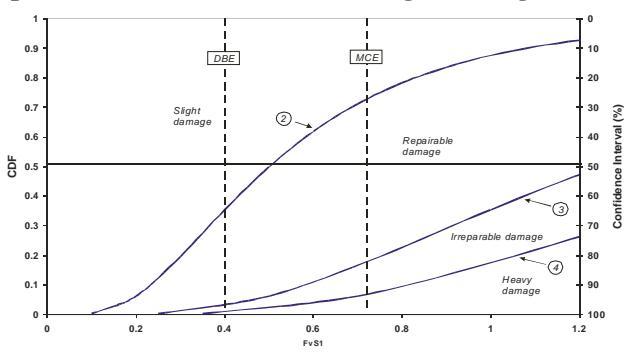
(a) Matthews' fragility curve for the floor performance when rated according to colour coding

(c) Matthews' fragility curve for the frame performance when rated according to colour coding

(e) Matthews' fragility curve for the floor performance when rated according to damage states

Figure 10 Fragility curves for both stages of testing using both colour-coded and numbered format for quantifying building damage.

Figure 10 shows the fragility curves for the floor and frame performance when classified under the colourcoded and numerical schemes for the two stages of testing. On each of the graphs the 10% in 50 years, Design Basis Earthquake (DBE), $F_{\nu}S_{I} = 0.40g$ for Wellington, New Zealand is shown, as well as the 2% in 50 years, Maximum Considered Earthquake (MCE), $F_{\nu}S_{I} = 0.72g$, for Wellington, New Zealand. If the structure is classified in terms of the critical element (floor or frame) then it can be seen that if the damage to the two structures (Matthews and Lindsay) was classified in terms of colour-coding under a MCE then in Stage 1 72% of structures would be expected to be red tagged or have collapsed (Figure 10(a)), whereas in Stage 2 only 23% would be expected to sustain damage such that the building could not be entered (Figure 10(b)). Both of these performances are dictated by the performance of the floor. Under a DBE, in Stage 1, every building would still sustain some form of damage to the floors whether it be moderate (5%), heavy (60%), near collapse (27%) or total collapse (8%) (Figure 10(a) and (c)). In Stage 2, 65% would sustain no damage allowing immediate occupancy and 29% would sustain moderate damage to the floors while only 5% of floors would be red tagged. No buildings would collapse from inferior floor or frame performance (Figure 10(b) and (d)).

If the damage is classified in terms of different damage states, then for a MCE, in existing structures with conventional precast floor seating details (Stage 1), only 2% of structures would be expected to sustain slight or repairable damage. The remaining 98% of the structures would be demolished due to irreparable damage or collapse, of these some 32% of floors would be expected to partially or entirely collapse leading to possible loss of life (Figure 10(e)). Even under a DBE, 92% of structures would sustain irreparable damage with 8% leading to possible loss of life (Figure 10(e) and (g)). In this research, testing a structure with the proposed seating details (Stage 2), under a MCE, 71% of the buildings would sustain repairable damage to the frame or floor, of the remaining 29% irreparable damage, 23% of floors and 5% of frames would sustain major damage (Figure 10(f) and (h)). Under a DBE, 94% of buildings would sustain repairable damage to the floor and frame with 5% of the remaining 6% of floors sustaining heavy irreparable damage while none of the remaining 6% of frames sustains heavy irreparable damage (Figure 10(f) and (h)). This is almost a complete reversal of the damage states identified during Stage 1 testing and shows the improved performance due to the enhanced details.

As can be seen, in Stage 2, the performance of both the frame and floor are very similar whereas in Stage 1 the performance of the floor is vastly inferior to the performance of the frame and therefore the overall performance is dictated by the poor performance of the floor. The findings from Stage 2 adhere to the expectations of ductile structures designed and detailed in accordance with the principles of capacity design as well as meeting the target objective that the confidence interval at the onset of irreparable damage under a DBE exceeds 90%. It is clear that similar conclusions can be drawn whether the building damage is rated by the colour-coded or damage state format.

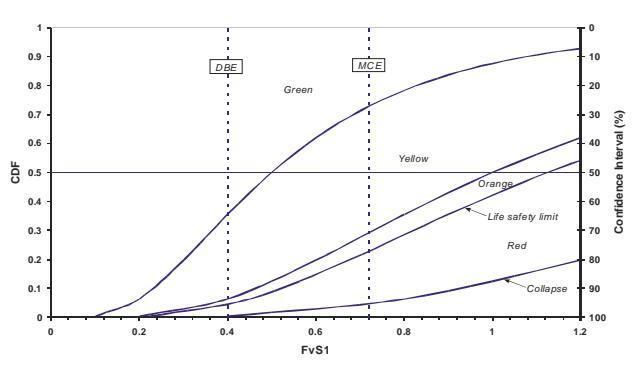
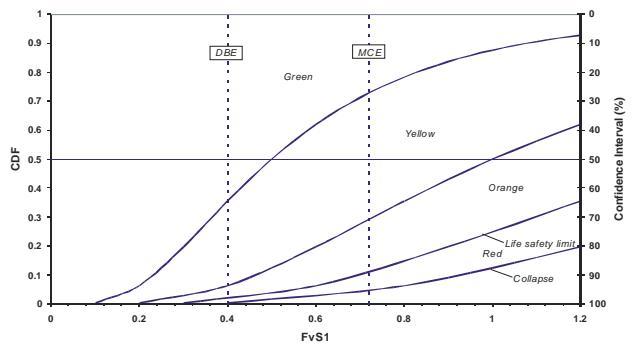
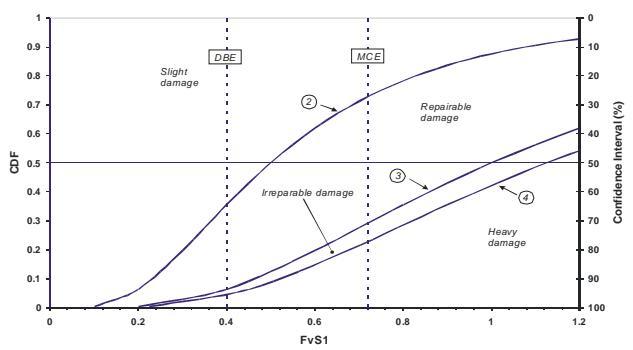
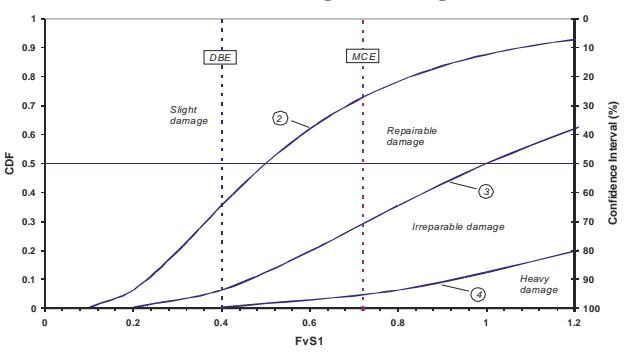
(b) Stage 2 fragility curve for the floor performance when rated according to colour coding

(d) Stage 2 fragility curve for the frame performance when rated according to colour coding

(f) Stage 2 fragility curve for the floor performance when rated according to damage states

(h) Stage 2 fragility curve for the frame performance when rated according to damage states

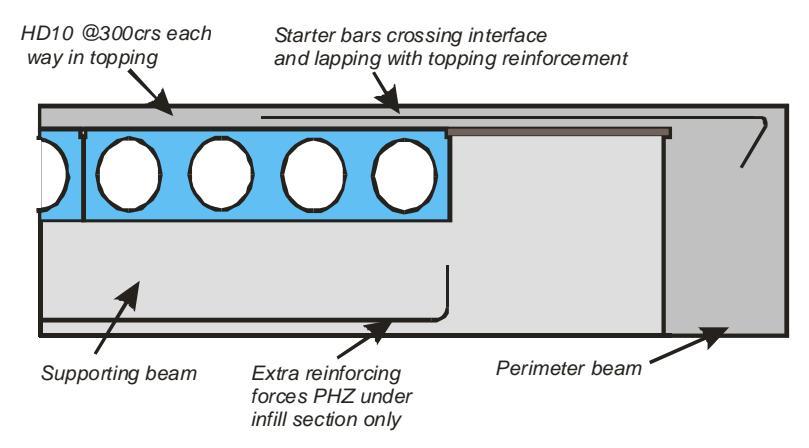
By using the detail shown in Figure 11 on either side of all columns, the plastic hinge zones are forced into the area under the infill rather than underneath the hollow-core unit. The extra bar cast into the beams achieves this. The starter bars extend across the hollow-core/infill interface and are lapped with the HD10 topping reinforcement at 300 centres each way.

Figure 11. Recommended detail to reduce damage to hollow-core units
