A STUDY ON DAMAGE OF TRANSMISSION STEEL TOWER WITH UNEQUAL LEGS IN THE CHI-CHI EARTHQUAKE TAIWAN

SUMMARY

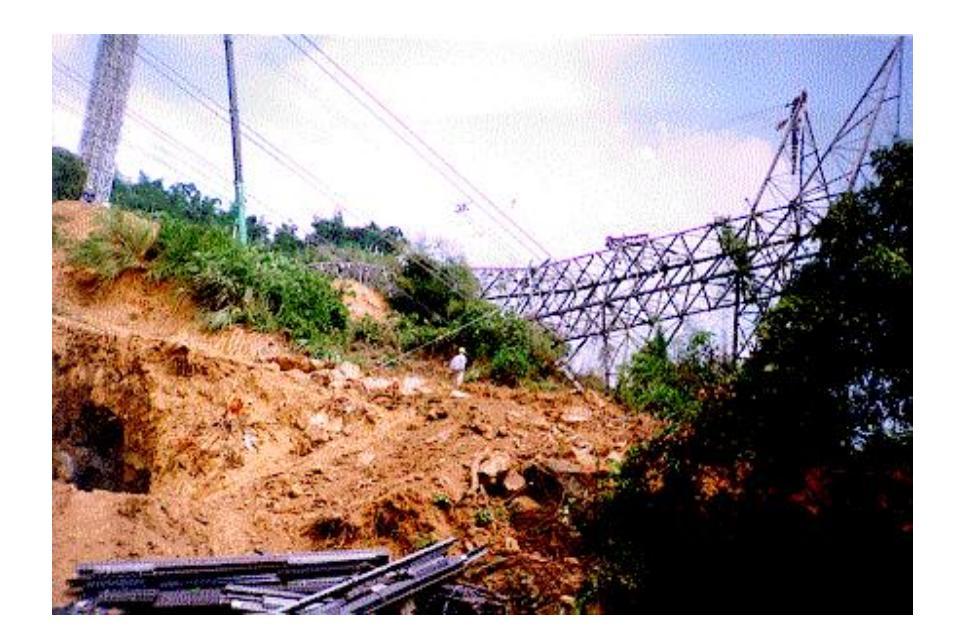
Fig.1 Collapsed steel tower for extra-high voltage power transmission

electric power consumption in the northern region. The two routes were extended along the earthquake fault. For this reason, the damage of the steel towers was serious, especially near the Chungliao switching yard. It was reported that inclination and deformation of steel tower, destruction and displacement of foundation of steel towers caused by landslides¹). The outline of the damage was announced on October 8 in 1999 by Taiwan Power Company. Generally in the design of a steel tower, wind load is larger than ordinary seismic load, so the wind load controls the structural profile. The consideration on the seismic load was not important except for the design of well type foundation in Taiwan. Compared with the wind load in Japan, the average standard wind velocity V₀ in Taiwan is 44.9m/s for the important route in the eastern district, 54.4m/s in western district considering the typhoon, while V₀ in Japan is 40m/s. Generally tensile strength of a cable is larger than that of a steel tower, Tensile load is transmitted to the steel tower from the cables in both sides in the longitudinal direction when the foundation moves in landslides by the earthquake. Fig.1 shows collapsed #203 steel tower that is the largest scale in Taiwan. Judging from the photograph, the steel tower was collapsed toward the valley side. However, the steel towers of #202 and #204 standing on the both sides of #203 had no damage according to the report of Taiwan Power Company. The height of the steel tower is about 62.95m, as it is shown in Fig.2, and the distance between the legs at the foot is 12.8m. The steel tower is mostly built on the slope of mountainous area. The report says the difference of elevation of legs is about 10m. According to the earthquake observation record of Taiwan Central Meteorological Observatory, the east side of the fault was shaken hard. So it is also considered that the damage of the steel tower was possibly caused by the strong vibration.

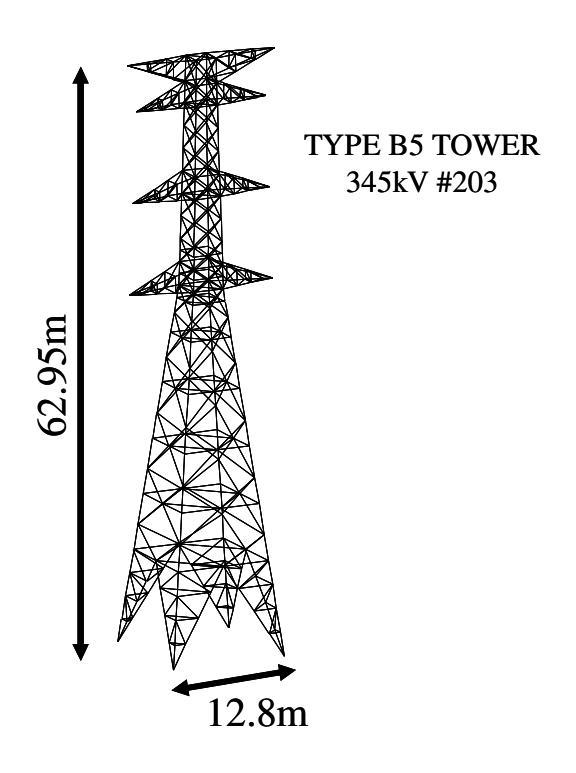
Fig.2 Structural outline of 345kV steel

According to the past researches, the effect on power lines to the dynamic response of steel tower in the earthquake is not so influential in transversal direction. But, it is influential in longitudinal direction. Considering this knowledge, the steel tower was modeled based on the draft obtained from Taiwan Power Company. We prepared four types of analysis model. Model A is a three tower model consisting of one detailed tower model in the center and two simplified beam towers on each side considering the effect on power lines. The distance between two towers was assumed 550m from the information of Taiwan Power Company. The precise behavior of central tower during the earthquake can be simulated using this model. Model B1 is a single detailed tower model not considering the effect on power lines. Model B2 is a single detailed tower model considering 50% of total weight of power lines on each side. The weight of power lines is directly put on the end of the arm of the tower in this model. Model B3 is a single detailed tower model considering 50% of total weight of cables on each side too. In this model, the weight of power lines is attached to the top of the arm through the spring considering the natural period of power lines. The gross weight of the steel tower in model A and B1 is about 357kN not considering the weight of power lines. On the other hand, the gross weight of the steel tower in model B2 and B3 is about 572kN considering the weight of the power lines. Analysis models are shown in Fig.3. The foundation of the steel tower was assumed as rigid. Main members of the steel tower were modeled by three-dimensional beam element. Additional members of the steel tower were modeled by the three-dimensional truss element. The power lines were modeled by the cable element. The design criterion of a steel tower in Japan follows JEC-127, the design of a steel tower in Taiwan is in accordance with this design criterion. The spring constants of model B3 in x and z directions were estimated from the natural period of the power lines. Therefore, the mass of the power lines was considered as the concentrated mass on the node of support position of the arm in model B2 and B3. The damping ratio of steel tower in a large earthquake has not been made clear, the value of damping ratio varies from 1% to 10%. In this study, the damping ratio of members was all assumed 2%. And the damping ratio of power lines was assumed 0.4% from the past experiment. In this study, Rayleigh damping was used in the analysis. The dimension of the power lines is shown in Table 1.

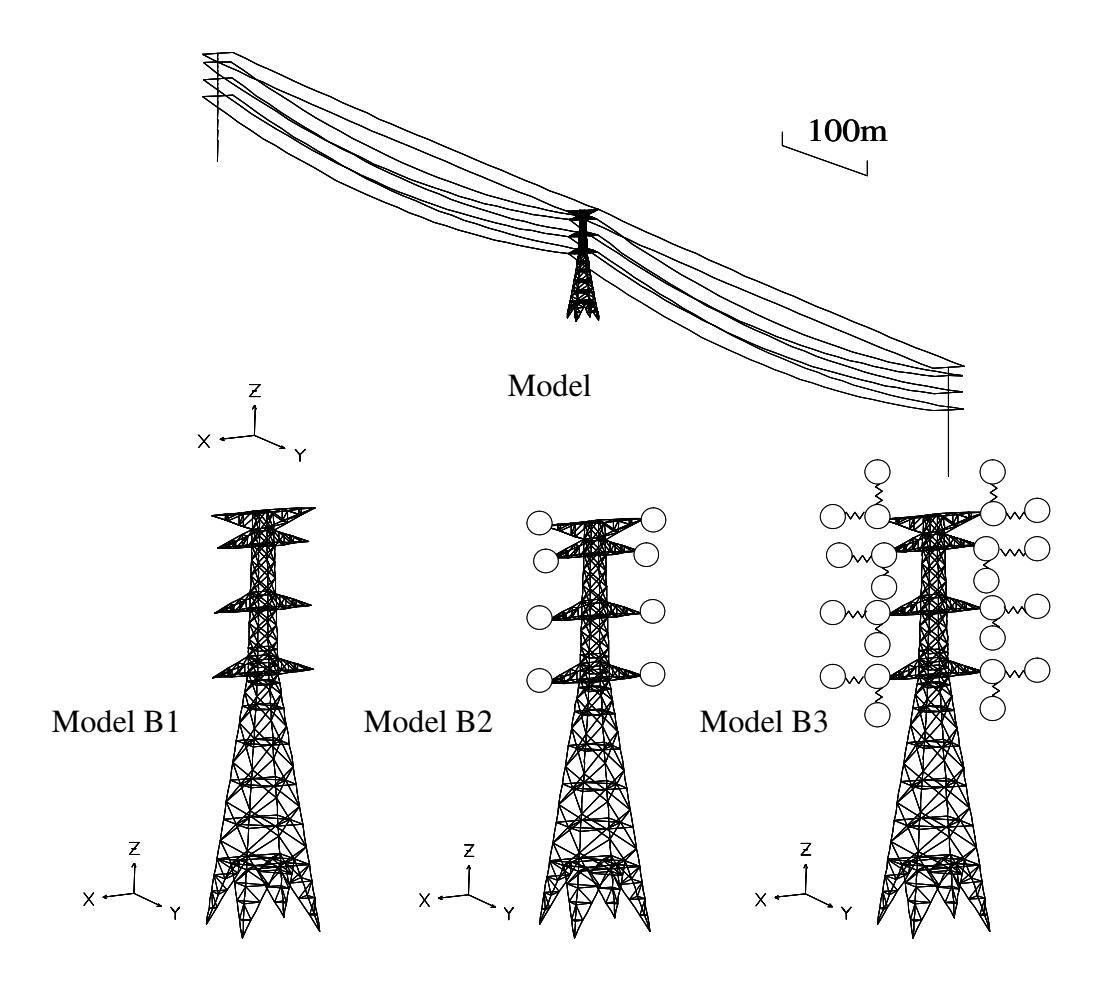
Fig.3 Analysis model

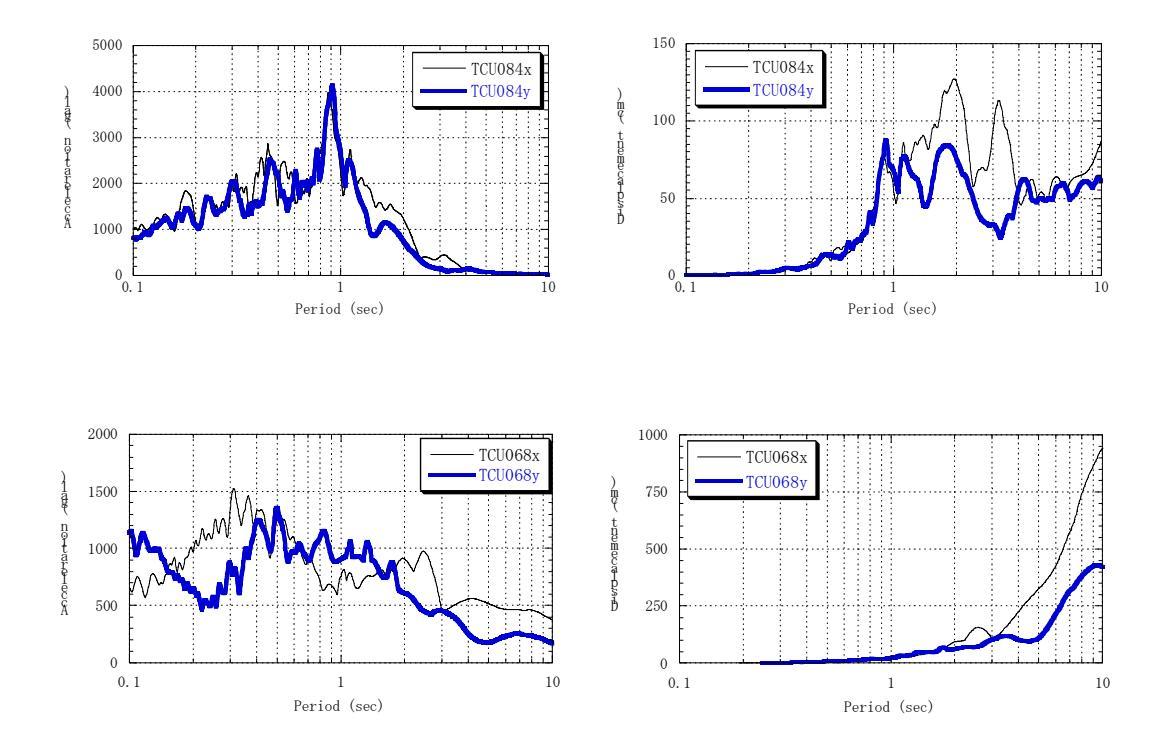
Fig.4 Acceleration and displacement response spectrum (h=2%)

The seismic waves used in the analysis are the record of TCU084 and TCU068 observed near #203 steel tower. Observed point of TCU084 is about 10 kilometers far from the epicenter and is 20 kilometers far from #203 steel tower. Maximum acceleration of TCU084 is 989gal. Large displacement of the ground induced by the fault occurred at observed point of TCU068. So long period components are prominent in this seismic wave. Fig.4 shows an acceleration response spectrum with damping ratio 2% of TCU084 and TCU068 in each direction.

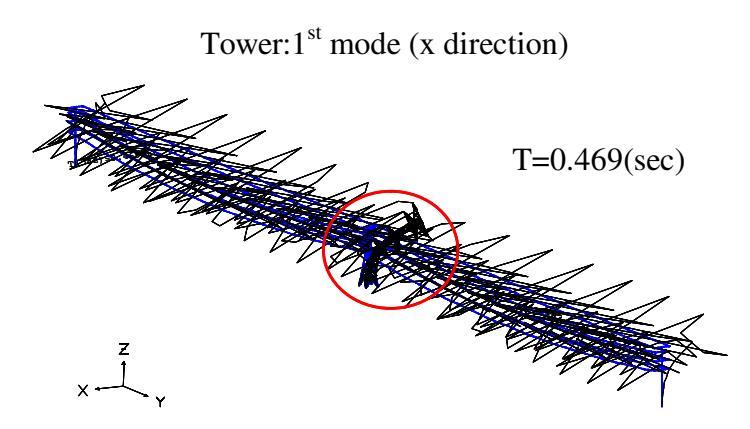
Fig.5 Results of eigenvalue analysis

Before dynamic response analysis, eigenvalue analysis was conducted. Table 3 shows the results of eigenvalue analysis. Principal modes of model A are shown in Fig. 5 and Fig. 6. Comparing with Model A, Natural periods of model B3 approximately agrees with that of model A in each direction. On the other hand, natural period of transversal direction in model B1 approximately agrees with that of model A. But natural period of longitudinal direction is shorter than that of model A. Reversely natural period of longitudinal direction is longer than that of model A. But natural period of transversal direction is longer than that of model A. From above results, the steel tower and the power lines shake independently in transversal direction by the difference of stiffness. However, the steel tower and the power lines shake together in longitudinal direction. Therefore, the inertia force of power lines affects on the response of the steel tower.

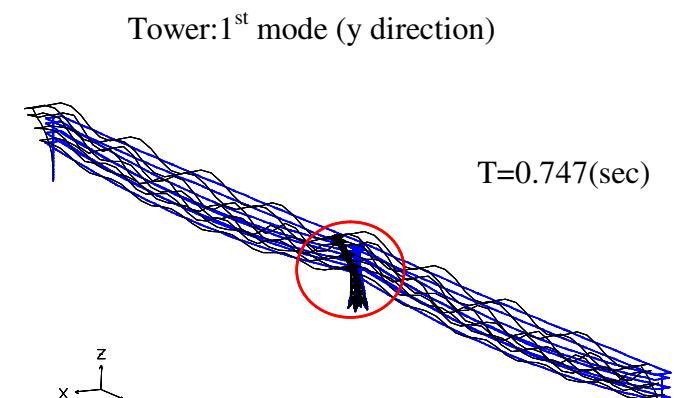
Fig6 Results of eigenvalue analysis

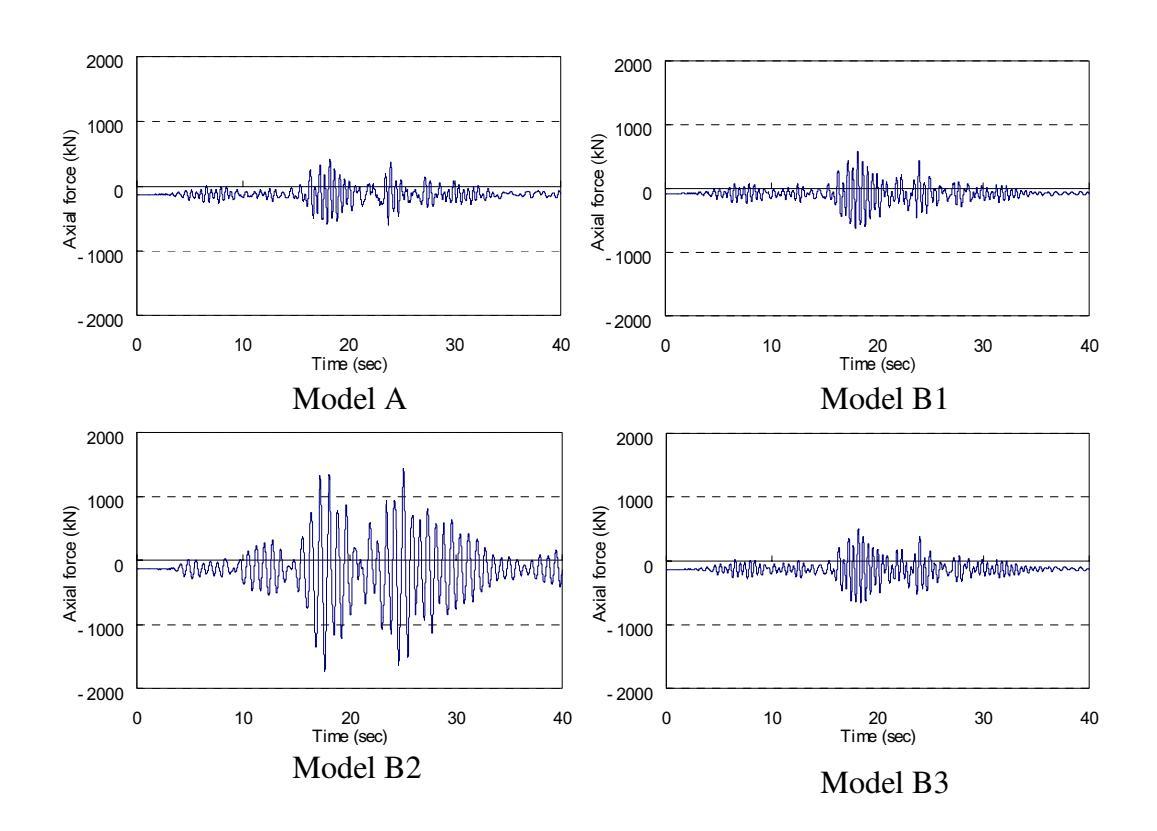
Fig.7 Time history of axial force of main member 1 (Input TCU084x)

After reproducing initial stress state by dead load, dynamic response analysis was conducted. Seismic waves were inputted in each direction separately. From dynamic response analyses using each model, time histories of axial force of main member were obtained and are shown in Fig.7, Fig.8 and Fig. 9. Maximum value of compressive axial force normalized by that of model A is shown in Fig. 10. From Fig. 7, first mode of the steel tower in transversal direction is prominent in model A. Same behaviors are confirmed in Model B1 and model B3. But the behavior of model B2 is different from other models. Judging from Fig. 10, the response is overestimated due to fixing the weight of power lines in model B2. From Fig. 8, first mode of the steel tower in longitudinal direction is prominent in model A. Same behaviors are confirmed in Model B2 and model B3. But the behavior of model B1 is different from other models. Judging from Fig. 10, the response is underestimated due to neglecting the weight of power lines in model B1. From Fig. 9, first mode of the electric wire in transversal direction is prominent in model A. Same behavior is confirmed in model B3. But the behaviors of model B1 and model B2 are different from other models. It is difficult to estimate the effect on the power lines in model B1and model B2. The result of TCU068y is omitted, because the tendency is the same as that of TCU084y. Examining the effect on power lines to the behavior of the steel tower under various conditions, it developed that model B3 can simulate the dynamic behavior of the steel tower during the earthquake as accurately as model A. The error to the response of model A was 20% in maximum.

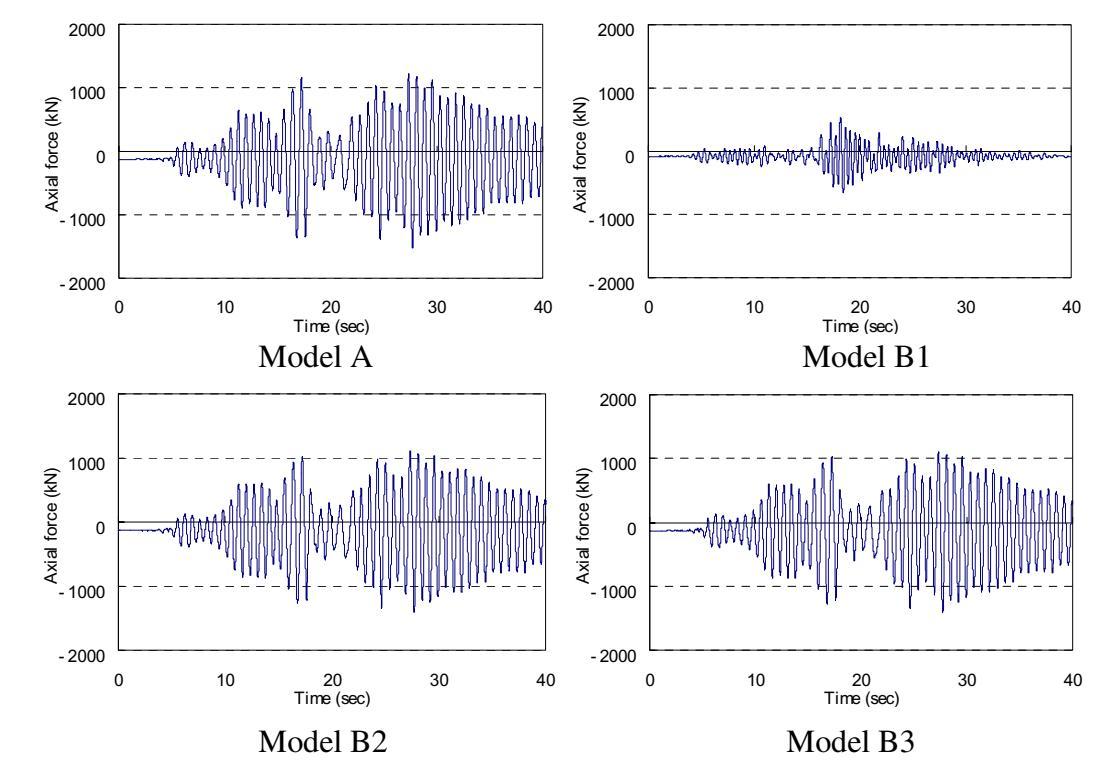
Fig.8 Time history of axial force of main member 1 (Input TCU084y)

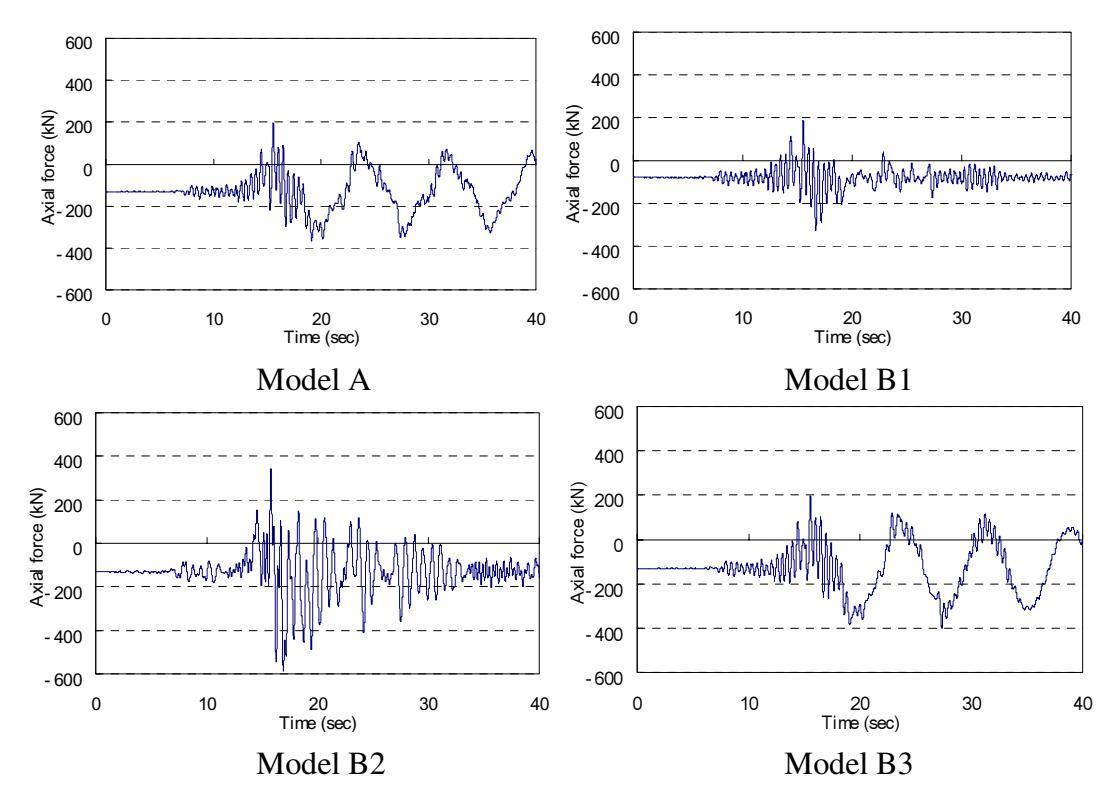
Fig.9 Time history of axial force of main member 1 (Input TCU068x)

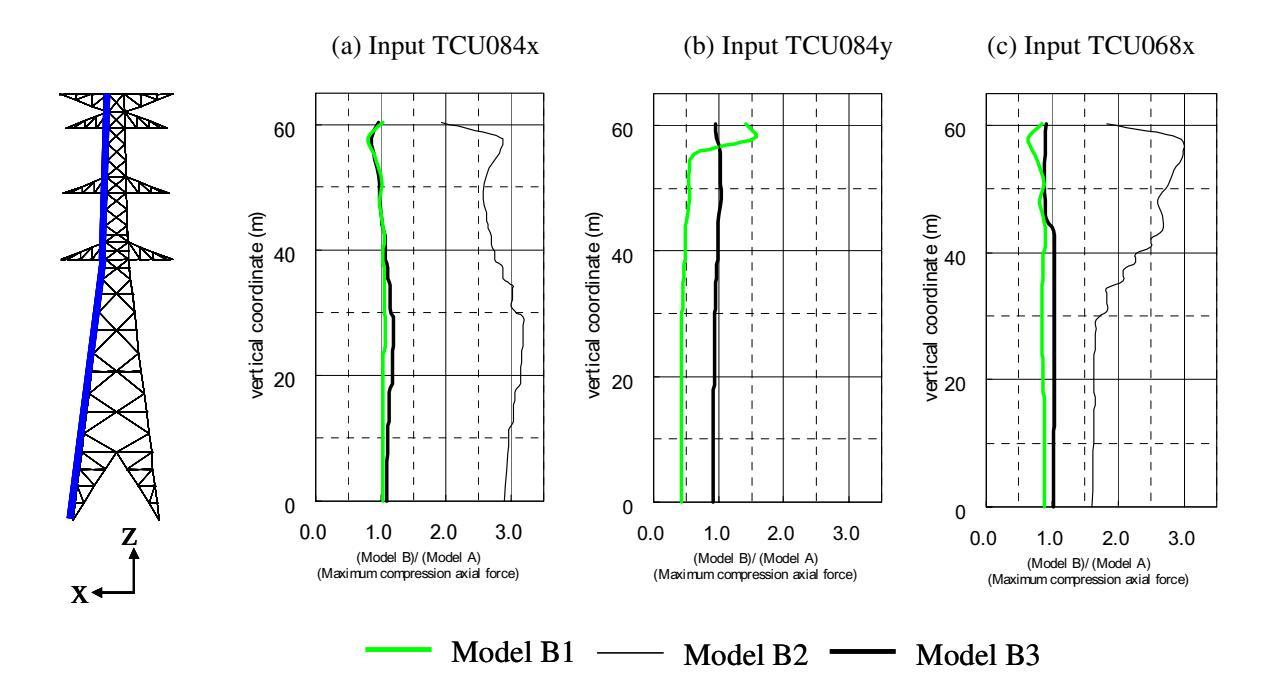
Fig.10 Maximum value of compressive axial force of main member
