PERFORMANCE OF OFC'S IN EARTHQUAKES BY SHAKE TABLE TESTS

SUMMARY

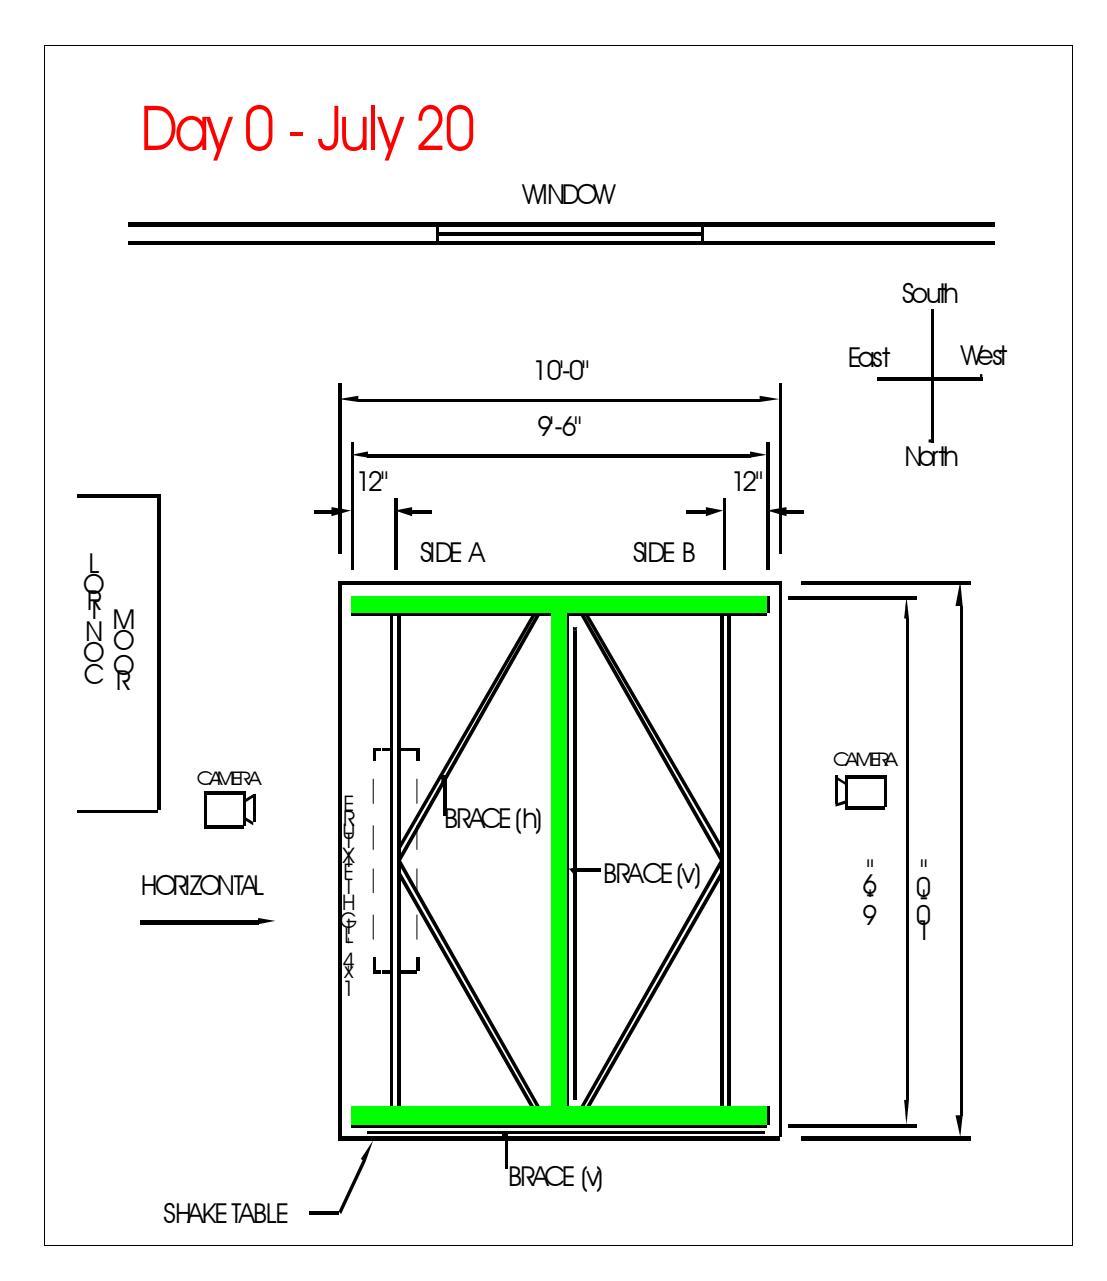
Figure 1. Setup of Drywalls Supporting Tested Equipment.

Every test in a session was referenced to the earthquake used for the shake table simulation and was catalogued with a unique code. Out of thirteen sessions, Session 3 is given as an example here (see Figures 1 and 2). The setup of Session 3 was used for Test T105, in which record A1 was used.

For side A in Figure 1, the setup included restraining the 83x18x36 (large) file cabinet to the wall using fasteners and installing two lag to studs at the top; and restraining a 62x18x36 (small) file cabinet to the wall and installing lag studs at the top of the cabinet. A top heavy dead load was used for the file cabinets (restrained to dry wall). For side B, the setup included restraining the 72x12x33 (large) bookshelf to the

wall and installing lag studs at two top locations. A 47x12x36 (small) bookshelf was restrained to the wall and shelf grip strips were used to restrain the books on the shelves. A top heavy uneven load was placed on the bookshelves (which were restrained to dry wall). Detailed descriptions of the test setup and the sessions are given in the report by Horyna et al. [1]. This report, and a companion report by Ventura [2] include detailed analyses of the data gathered during the tests and detailed analyses of the performance of the tested components.

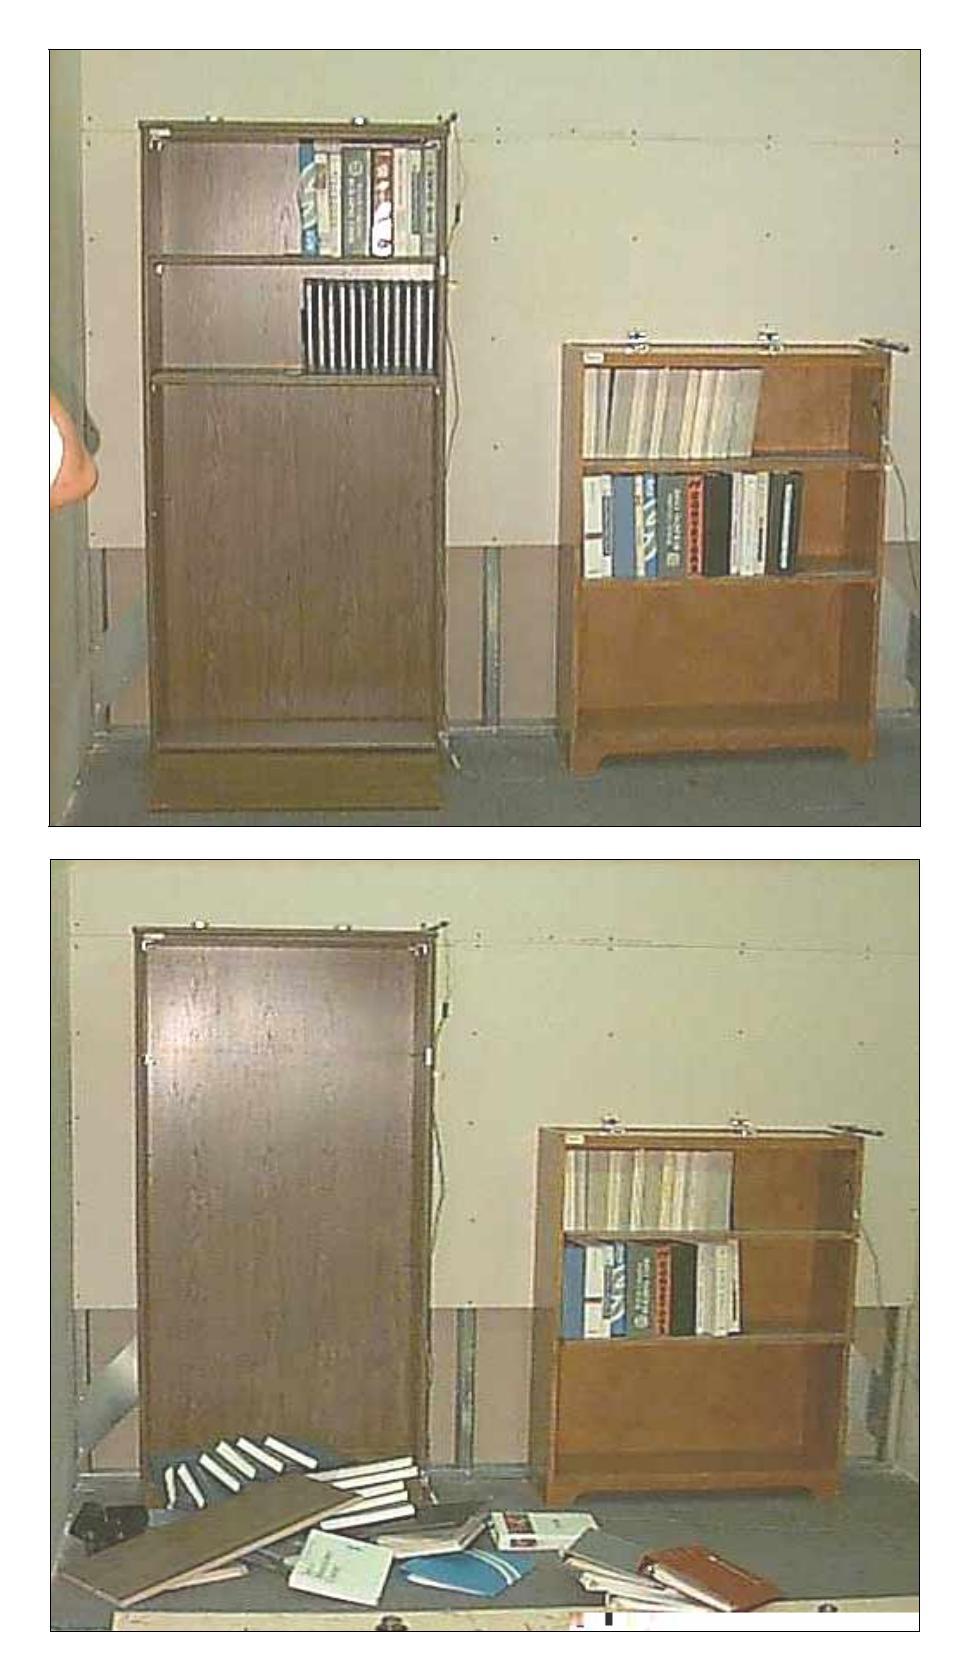
Figure 2. Large and Small Bookshelf Setup in Session 3, before test (top), and Shelving and Books Fallen from Large Bookshelf during Test T105 (bottom).

6	Small File Cabinet	T105	A1	6.03	1.10	64.56	0.37	NM	0.64	13.99	5.87	0.1	0.6	Books and shelves of the large bookshelf fell out. No	19.37	5.34	0.54
7	Large Book Shelf	T105	A1	6.03	1.10	64.56	0.50	NM	1.67	17.93	6.02	0.1	1.5	other damage.	3.49	4.42	3.60
8	Small Book Shelf	T105	A1	6.03	1.10	64.56	0.22	NM	0.36	4.89	6.00	0.0	0.3		13.66	9.44	0.79
9	Large File Cabinet	T106	A2	6.48	1.00	52.60	0.67	NM	1.16	19.83	6.16	0.1	1.2		17.55	4.24	1.06
10	Small File Cabinet	T106	A2	6.48	1.00	52.60	0.20	NM	0.74	9.93	6.22	0.0	0.7	Shelves without books of the large bookshelf fell out. No	7.38	6.70	1.72
11	Large Book Shelf	T106	A2	6.48	1.00	52.60	0.46	NM	0.91	16.60	6.37	0.1	0.9	other damage.	17.79	4.34	1.34
12	Small Book Shelf	T106	A2	6.48	1.00	52.60	0.16	NM	0.35	5.29	6.25	0.0	0.4		9.69	22.06	1.19
13	Large File Cabinet	T107	A1	6.04	1.10	64.42	0.78	NM	1.12	29.57	5.48	0.1	1.0		18.66	3.08	0.66
14	Small File Cabinet	T107	A1	6.04	1.10	64.42	0.37	NM	0.67	13.37	5.91	0.1	0.6	No damage observed.	21.12	5.15	0.68

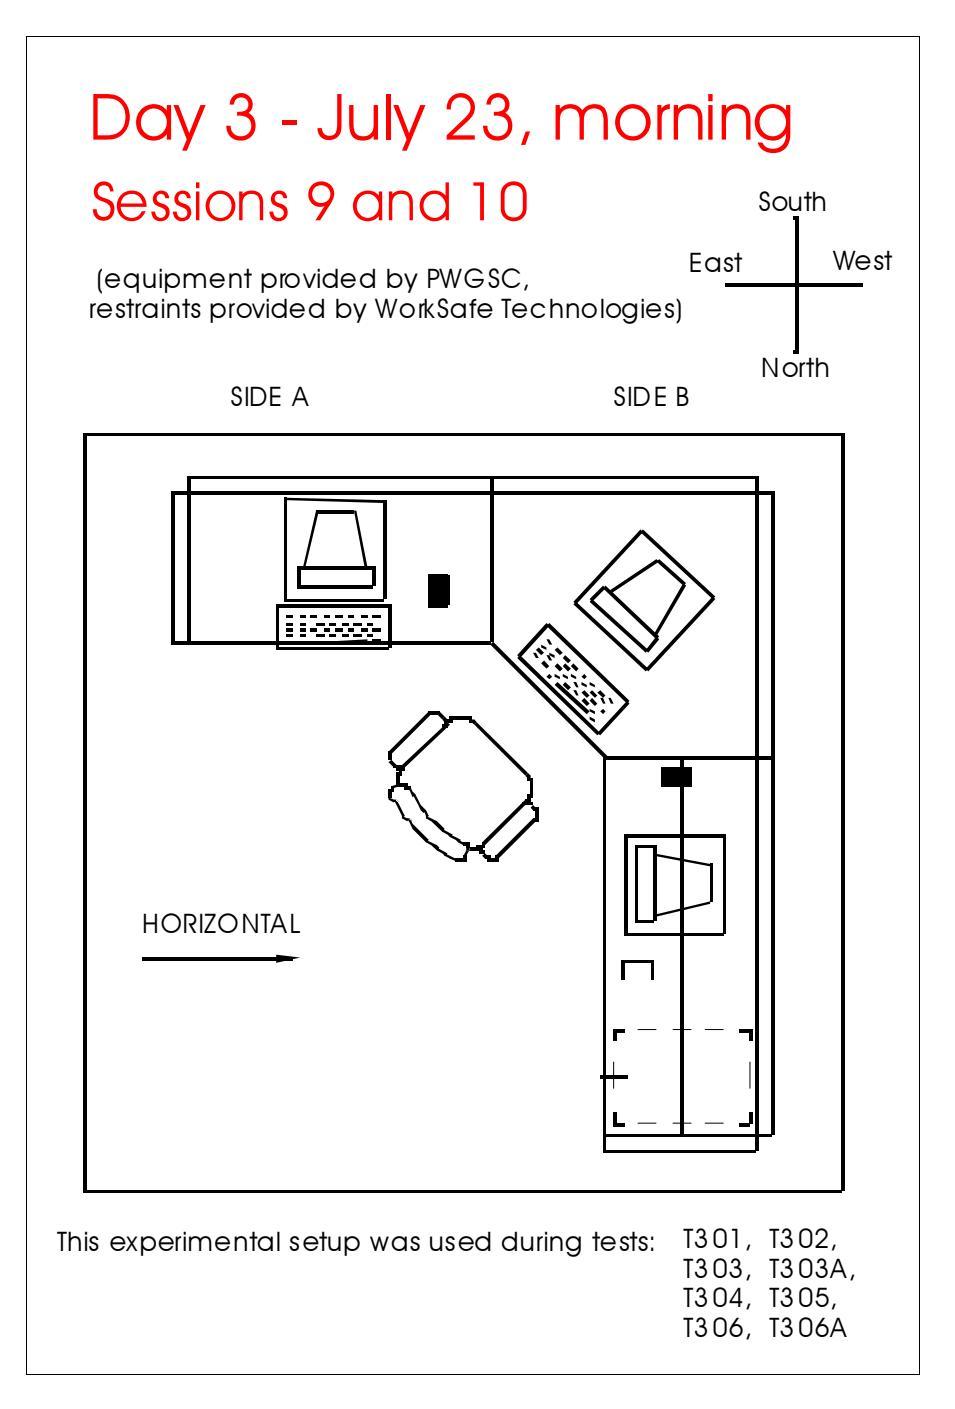
Figure 3. Setup of Office Cubicle and Tested Equipment for Sessions 9 and 10

The tests were classified into thirteen groups or sessions. Each of these sessions had similar experimental setup and testing procedures. This included building an I-shaped drywall assembly on the shake table for placing cabinets and bookshelves, restraining file cabinet and bookshelves to the wall, setting a library shelving and video cameras (see Figure 1). Other setups such as locating the communication rack, LAN rack, seven CPUs and monitors in different locations were also included in this project (see Figures 2, 3 and 4).

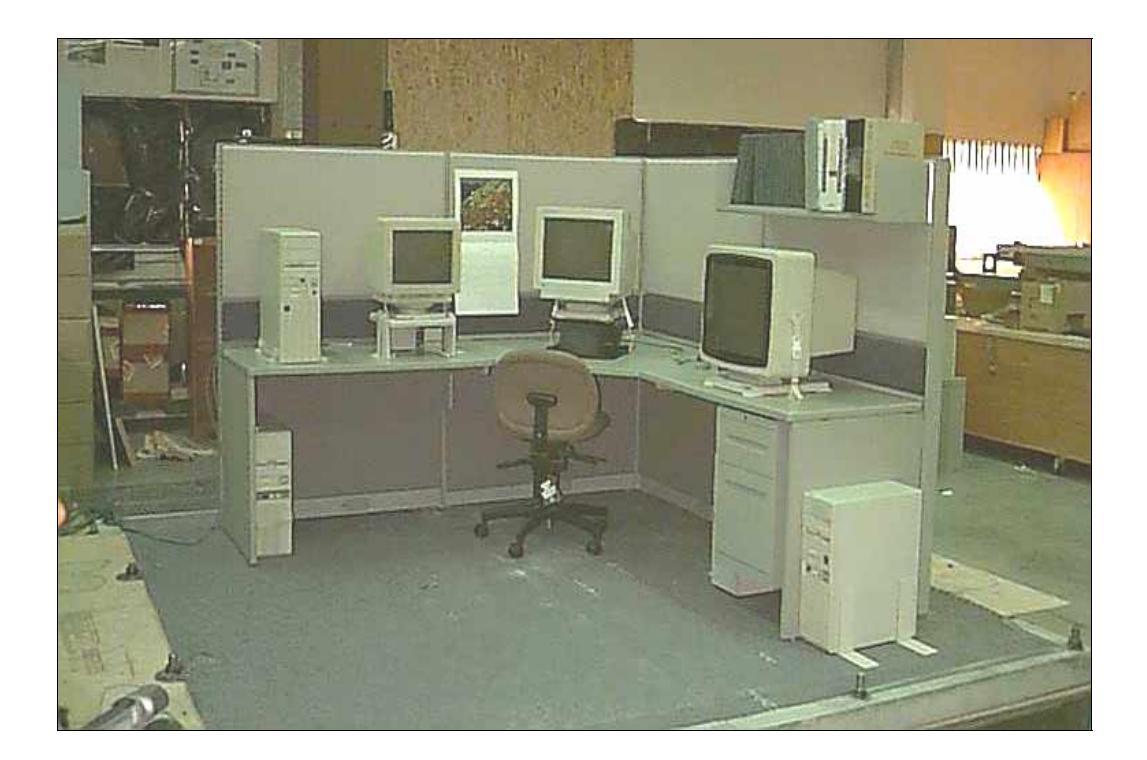
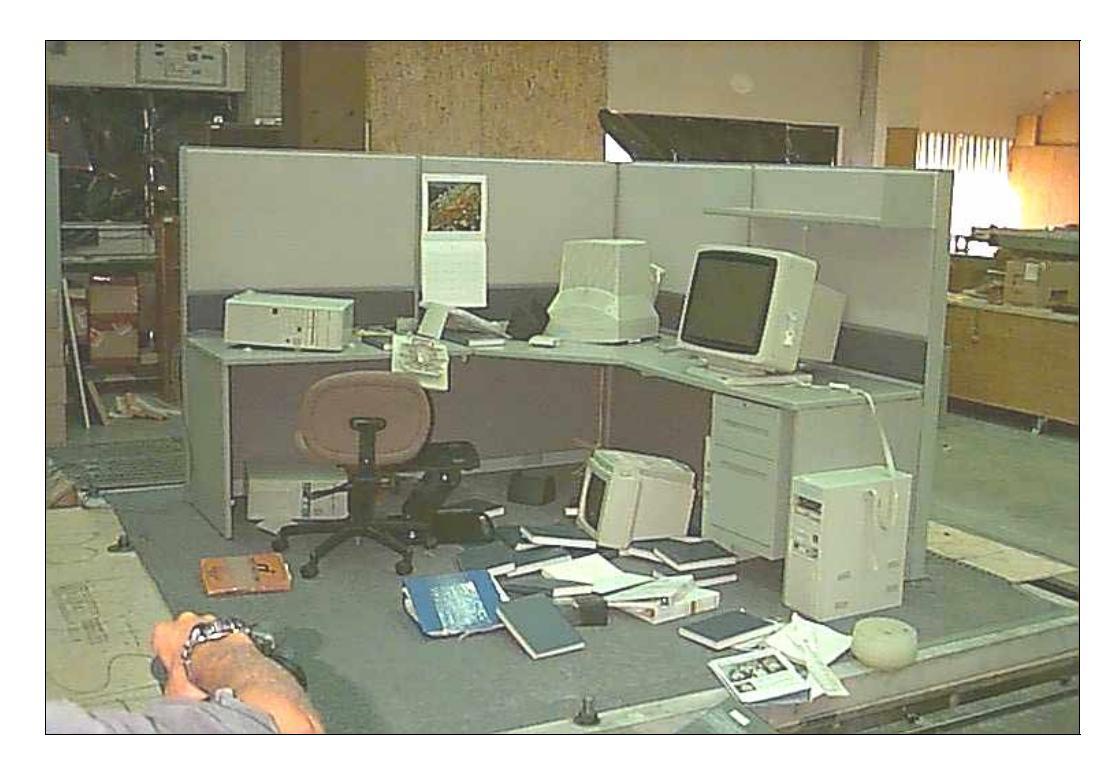
Figure 4. Office cubicle setup for Sessions 9 and 10 before the test (top) and after the test (bottom)
