# DAMAGE MITIGATION USING A PASSIVE ISOLATION SYSTEM

# L.A. Wipplinger<sup>1</sup>, K.K. Hu<sup>2</sup>

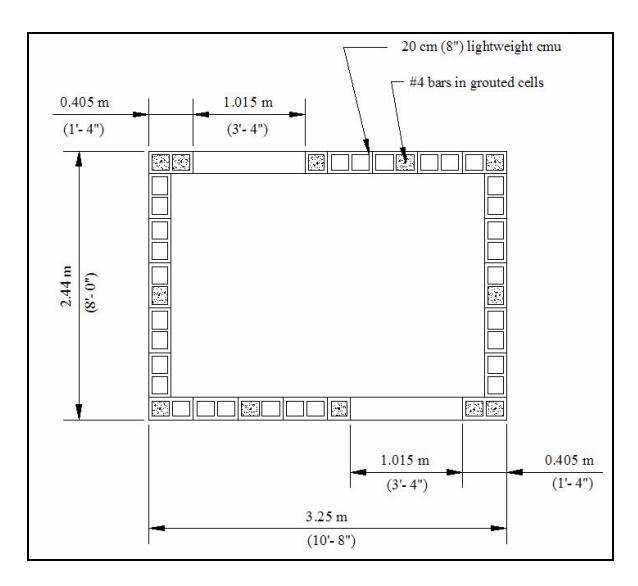
Figure 1: Plan of Masonry Model Structure Wipplinger [6], by permission of ASCE

A full-scale, one-story, lightweight cmu structure reinforced to comply with the minimum seismic zone 2 (PGA=0.15g) reinforcing required by the 1994 edition of the United States Uniform Building Code was used for the testing. The model structure was constructed of 20.32 cm (8 in) cmu and had plan dimensions of 2.44 m (8'-0") by 3.25 m (10'-8"). The structure was 4.47 m (14'-8") high to represent more slender walls common in one-story commercial applications. The plan dimensions were limited by the shaking table size. The structure was constructed with one standard window opening in the north wall and one standard door opening in the south wall. The openings were located in the walls parallel to the applied ground motions and were placed in opposite walls to minimize torsion. A plan view of the structure is shown in Figure 1, and Figure 2 shows the completed walls before the application of the roof diaphragm (Wipplinger[5]). The steel frame seen in Figure 2 was part of a previous testing program left in place for future testing and was not attached to the cmu building in any way. Clearances were left around the cmu structure to ensure it would not interact with the steel frame during testing. The steel frame added weight to the system, which was included in the design of the SDBIS bearings, but did not affect the results reported here.

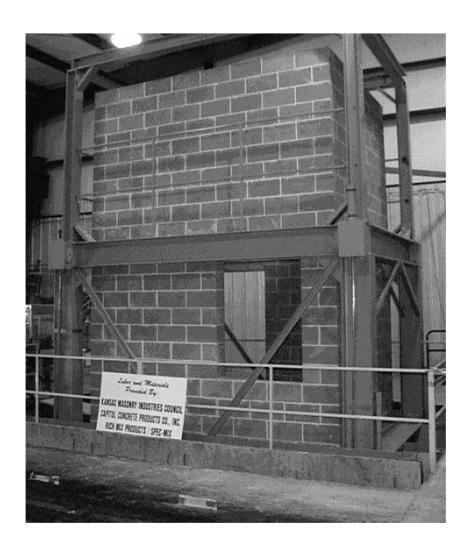
Figure 2: Masonry Model Structure

Certified masons constructed the masonry walls using lightweight Grade N cmu with a minimum specified compressive stress of 13.1 MPa (1900 psi) and Type S mortar. Grout with a minimum specified compressive stress of 13.79 MPa (2000 psi) was placed in the reinforced cells an in lintels and bond beams. Number 4, Grade 60 deformed vertical reinforcing bars were placed at wall corners, adjacent to openings, and at a maximum spacing of 1.22 m (4'-0") on center. Dowels were welded to the steel base of the shake table and lapped with the vertical reinforcing bars to simulate real construction as closely as possible. Bond beams were constructed at the base and top of the walls and were reinforced with two number 4 bars. Standard number 9 k-web joint reinforcing was placed every other course (0.405 m, or 1'-4" on center) to provide horizontal reinforcing.

The building model roof structure was constructed of standard 2x6 wood joists supporting a  $\frac{3}{4}$ " thick blocked plywood diaphragm. Standard plywood diaphragm nailing was used and the diaphragm was bolted to the masonry wall with  $\frac{1}{2}$ " diameter bolts cast in the bond beam. This was intended to represent a common construction type and provides a flexible diaphragm for the structure.

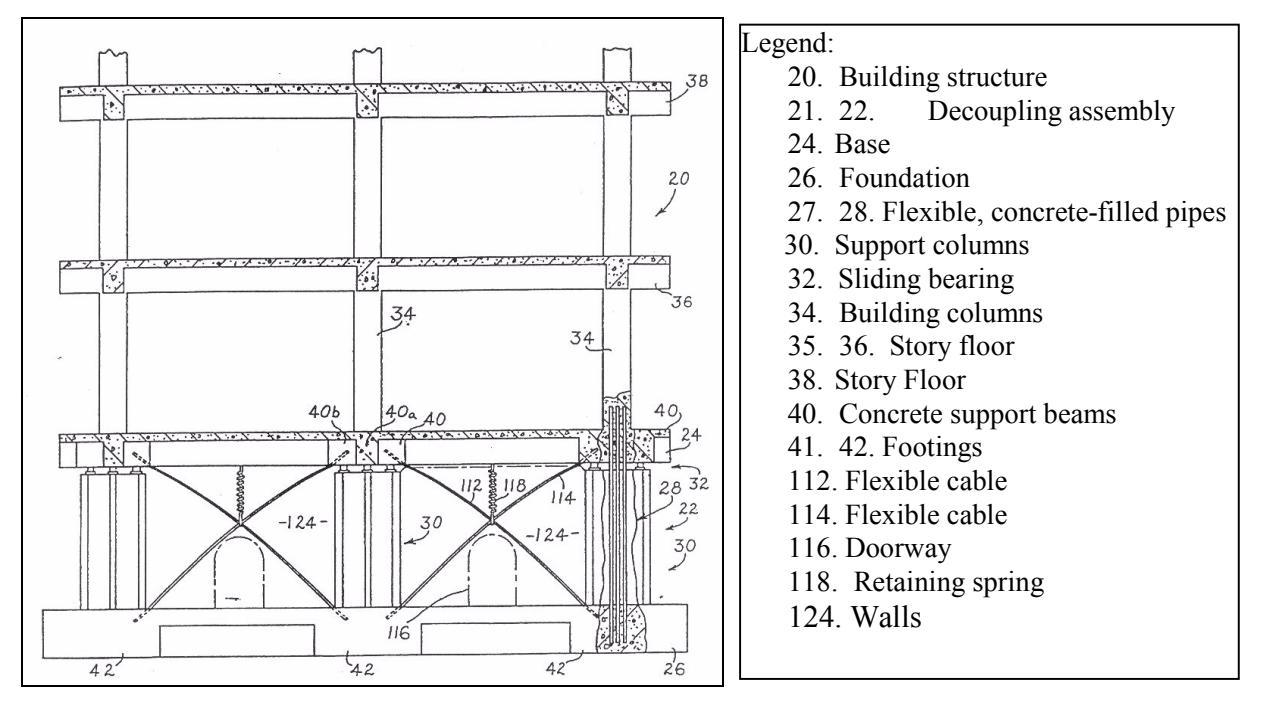
**Figure 3:** Schematic Drawing of Stiffness Decoupler for the Base Isolation of Structures (Hu, United States Patent Numbers 5386671 and 5660007, Wipplinger [6], with permission)

The SDBIS system is composed of friction-type sliding bearings, interior supports, exterior supports, flexible coupling elements, optional loose cable bracing, and optional gapped bearing walls. The three elements used in this research are discussed below. A schematic representation of the system is shown in Figure 3.

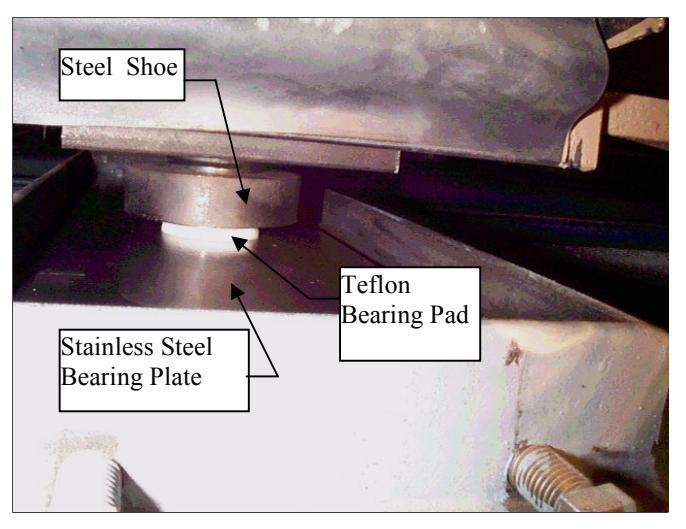
Figure 4: Bearing Pad Under Structure Wipplinger [6], by permission of ASCE

The friction-type sliding bearings are designed using a filled or unfilled polytetrafluoroethylene (PTFE or Teflon) bearing pad recessed and attached into a steel bearing shoe. The Teflon bearing slides on a stainless steel bearing plate sized to accommodate the maximum system displacement. The stainless steel had a #8 mirror finish as defined by the American Society of Testing and Materials (ASTM) and was coated with graphite before testing began. The stainless steel plate was attached to the shaking table under the base of the structure. The bearing used in the testing program is shown in Figure 4.

The model structure was supported on four 1.27 cm (0.5 in) thick, 4.44 cm (1.75 in) diameter Teflon bearing pads, resulting in a bearing stress of 23.65 MPa (3.43 ksi). The pads were placed under the base of the structure at each corner, between the structure and the shaking table, bearing on the stainless steel bearing plates attached to the shaking table as shown in Figure 4 (Wipplinger [5]).

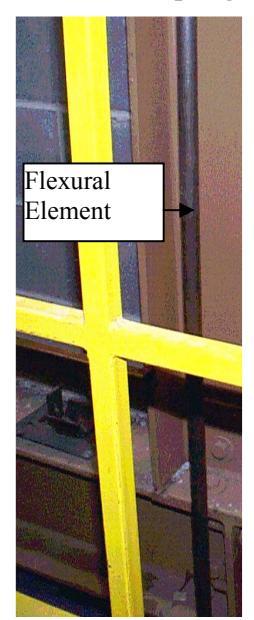
Figure 5: Steel Rod Flexural Element

Flexural elements composed of concrete-filled steel pipes for large structures, or steel rods for small structures, are designed to span between the non-isolated base and the isolated structure, and perform several important functions. These flexural elements act as springs to provide a restoring, or re-centering, force to the structure through their flexural stiffness. As the structure displaces relative to the base, the flexural elements begin to resist the motion and apply an opposing force to the isolated structure. The effective stiffness is adjusted by varying the size of the pipe or rod and by adjusting the end conditions. The flexural element is provided with a free travel distance to allow the design displacement to occur before additional axial stiffness is mobilized. Once the design displacement has been exceeded by an extreme event, a nut and bolt assembly gradually brings the axial stiffness of the rod into play, limiting the maximum displacement of the system under severe loadings. This allows the system to be tuned to a maximum displacement.

The flexural elements used for the testing program were composed of 2.54 cm(1in) diameter rods spanning from the shaking table to the first level of the steel frame surrounding the masonry structure (see Figure 5). The rods had fixed ends with a

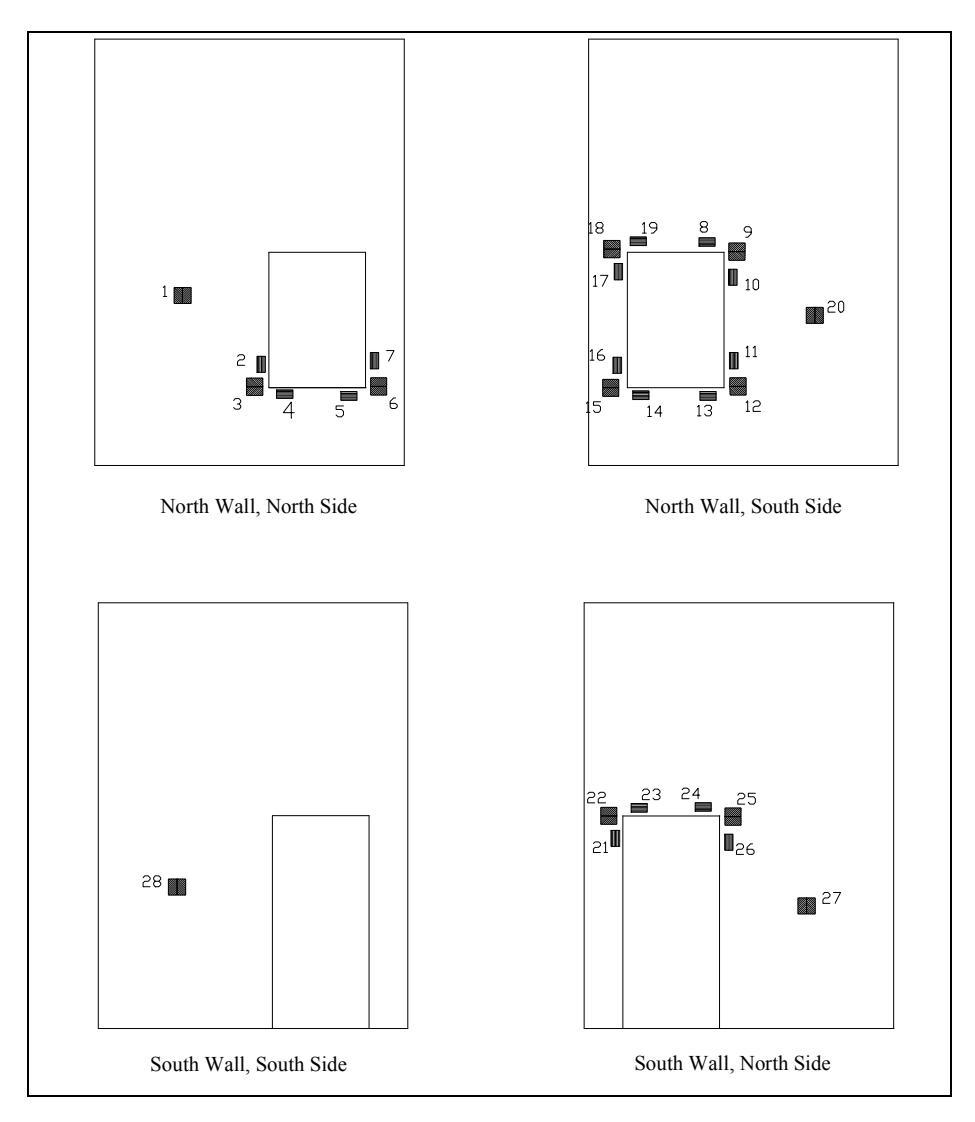
Figure 6: Strain Gage Locations on Masonry Walls

In addition to the accelerometers, strain gages were placed at selected locations on the masonry shear walls (parallel to motion) to determine strain levels in the masonry during testing. Strain gages were located at mid-wall and at opening corners. The gages were placed on both faces of the wall when possible. Since the joints are most often where cracks originate, the strain gages were placed in the mortar joints. This caused the gages to be curved and induced an initial strain in the gages. The strain gages were balanced as much as possible and initial values were subtracted out of the strain response records. Strain gage locations are shown in Figure 6, Wipplinger [5]. The strain output data (time-histories) were recorded to computer files. Background noise levels in the multi-channel data acquisition system were too high to record the low levels of strain present in the isolated structure, so standard strain boxes were used to record the data. This resulted in recording only two strain gages at a time, requiring numerous test runs to acquire all the acceleration and strain time-histories. The Each set of tests was performed three times to verify reliability. This resulted in subjecting the isolated structure to over 200 full-scale earthquakes.

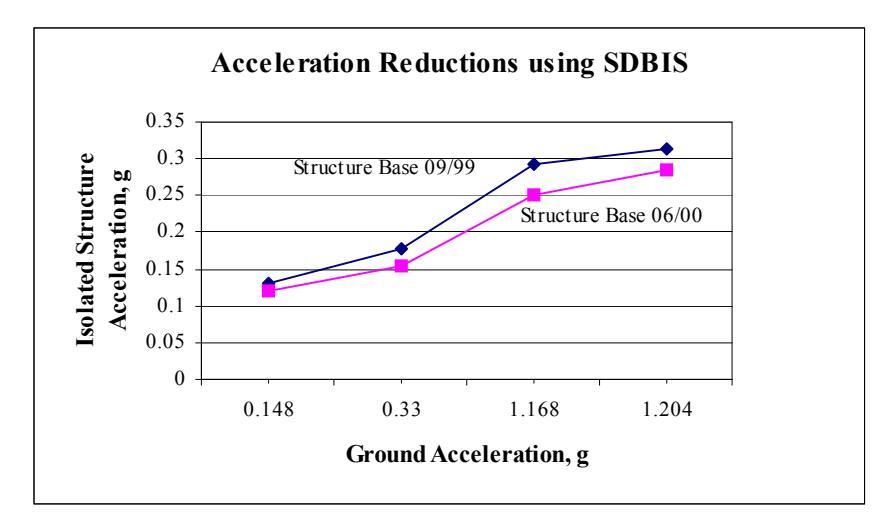
Figure 7: Average Acceleration Reductions using SDBIS Wipplinger [6], by permission of ASCE

The dynamic tests performed verify that the SDBIS system is very effective in reducing the accelerations transmitted into the structure and reducing the strain levels experienced in the masonry walls. A summary of the base acceleration results can be seen in the graph shown in Figure 7, Wipplinger [5]. The input motion peak accelerations for the Taft, El Centro, 77% Northridge and Pacoima Dam earthquakes are shown along the horizontal axis of the graph, and the peak accelerations at the base of the isolated structure are shown along the vertical axis. The graph indicates that the SDBIS system is more effective at isolating the structure from strong ground motions than from weak or moderate ground motions. This is the expected and desired result. Two sets of results are shown in the figure. The upper curve represents tests performed in September 1999 and the lower curve represents tests performed in June 2000. The September results were obtained after about 5 months of testing had worn the graphite coating off the stainless steel bearing plates, resulting in a slightly higher transmission of accelerations into the structure. The June 2000 tests were performed after new bearing plates, giving slightly higher reductions than the September results. In addition, the free travel distance for the flexural rods was

increased in November 1999 to help reduce the response of the isolated structure. The two sets of results shown in Figure 7 are reasonably consistent and show the same general trend.

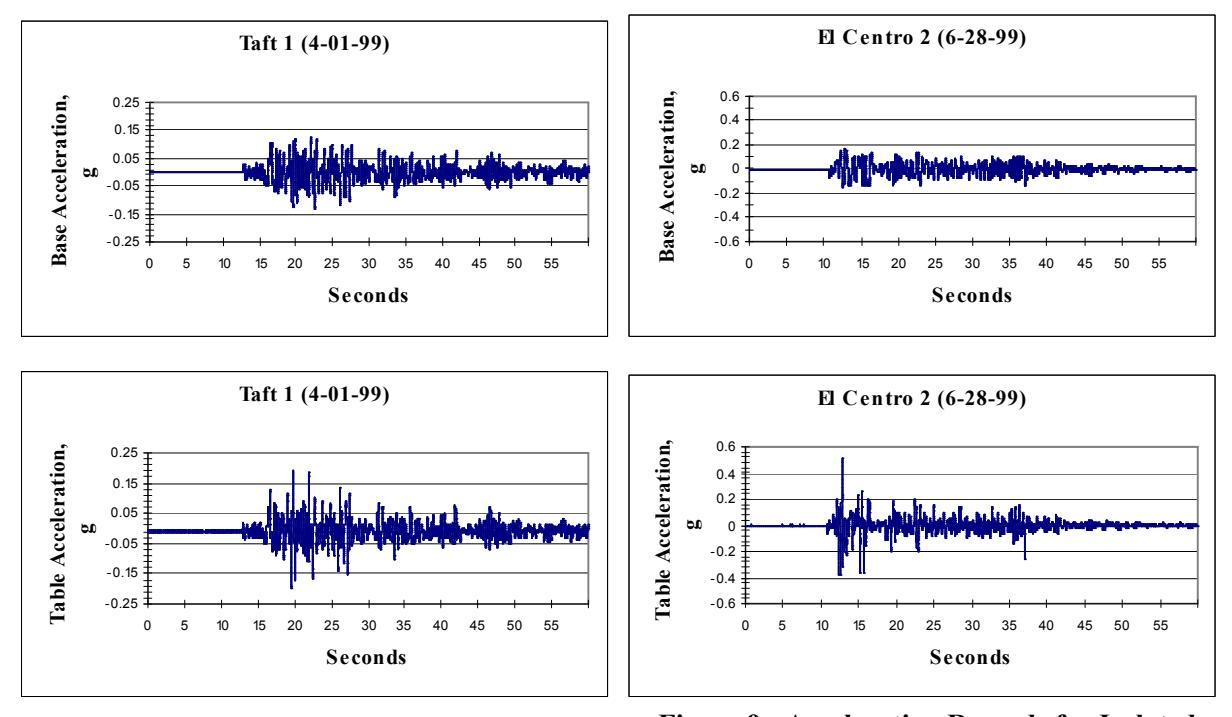
Figure 8: Acceleration Records for Isolated Structure with Taft Ground Motion Wipplinger [6], by permission of ASCE

Figure 9: Acceleration Records for Isolated Structure with El Centro Ground Motion Wipplinger [6], by permission of ASCE

Representative time-history acceleration results for each of the individual earthquakes are shown in Figures 8, 9, 10, and 11, Wipplinger [5,6]. The top graph in each figure shows the acceleration record at the base of the isolated masonry structure. The lower graph in each figure shows the acceleration record for the shaking table as produced by the actuator. These figures again confirm the effectiveness of the SDBIS system in reducing the accelerations transmitted into the structure. In addition, the isolated response does not have the sharp acceleration peaks present in the input ground motions.

Acceleration reductions across the SDBIS system averaged 34.5 percent for the Taft record, 64.2 percent for the El Centro record, 76.5 percent for the reduced Northridge record, and 77.8 percent for the Pacoima Dam record (Wipplinger [5]). Initial tests produced larger acceleration reductions due to the fresh coating of graphite applied to the stainless steel bearing plate. The graphite coating was not reapplied after each test. Even with the degradation of the graphite coating, the system remained effective in reducing accelerations transmitted into the structure for over 200 dynamic runs. The degradation in the system's performance was minor and verifies the system remains effective with little or no maintenance.

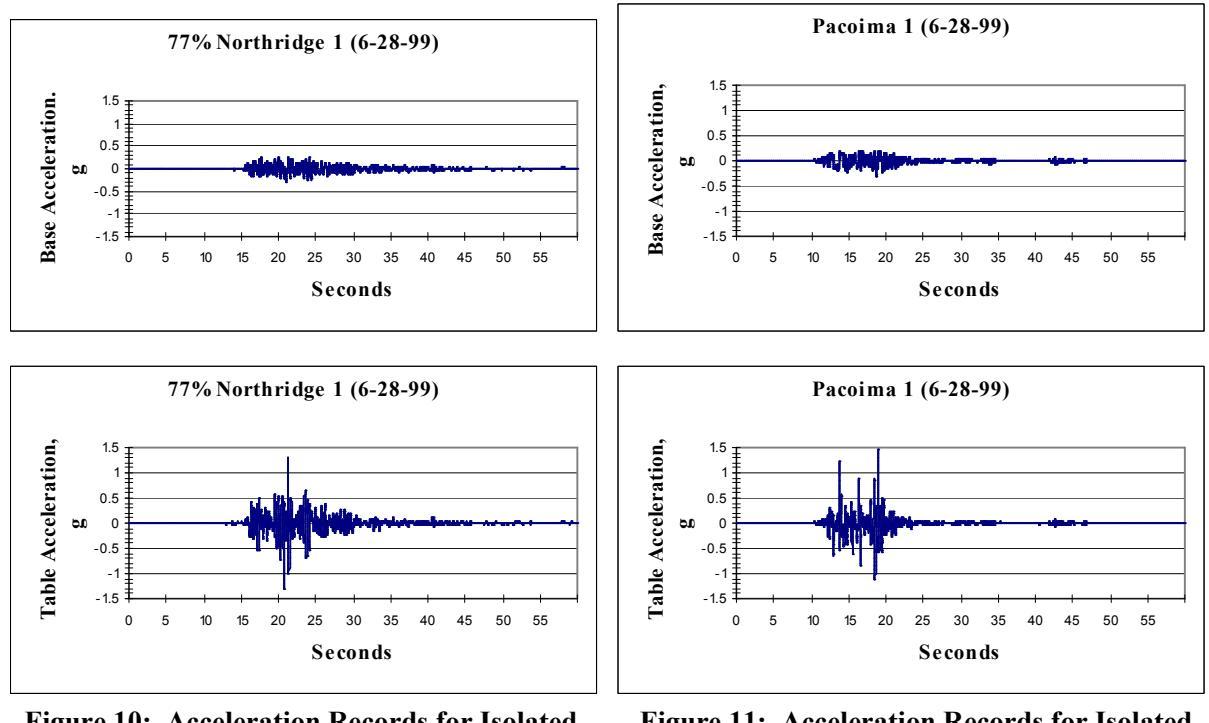
Figure 10: Acceleration Records for Isolated Structure with Northridge Ground Motion Wipplinger [6], by permission of ASCE

Figure 11: Acceleration Records for Isolated Structure with Pacoima Dam Ground Motion Wipplinger [6], by permission of ASCE

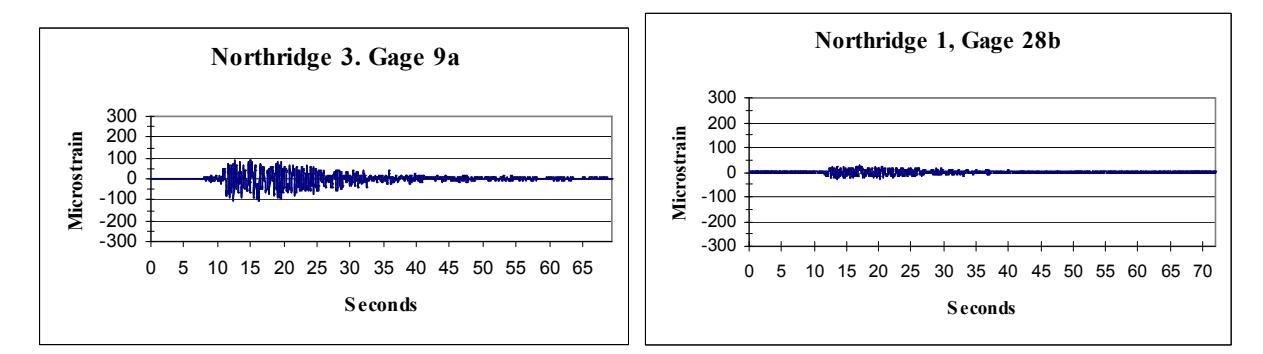
# Figure 12: Strain at Window Corner in Isolated Structure for Northridge Ground Motion

# Figure 13: Strain at Mid-Wall in Isolated Structure for Northridge Ground Motion

Representative time-history strain responses recorded at the window corner and at mid-wall are shown in Figures 12 and 13. The strain time-histories compare well with the acceleration time-histories. Strong peaks in the strain response of the masonry walls have also been eliminated by the SDBIS system.

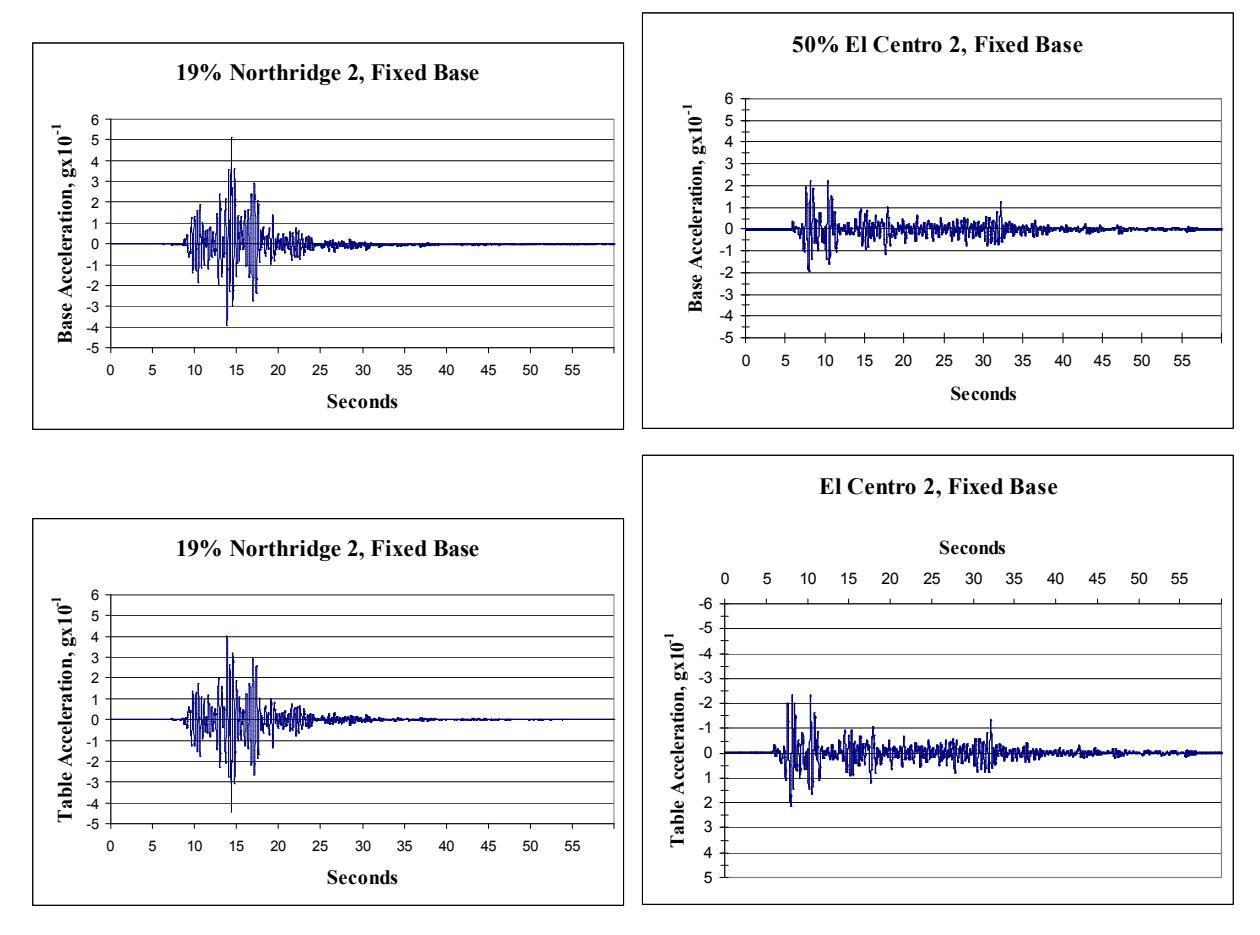
Figure 14: Acceleration Results for Non-Isolated Structure with 19% Northridge Ground Motion

In order to prevent damage to the table or testing facility, the non-isolated structure was tested using only 50 percent of the El Centro ground motions and 19 percent of the Northridge ground motions. Even with the reduction in input ground motions, the peak accelerations for the non-isolated structure were higher than the peak accelerations produced by the full-scale ground motions in the isolated structure. The accelerations in the non-isolated structure essentially matched the input ground accelerations generated by the shaking table, with some slight amplification for the Northridge ground motion. Visual observations confirmed that the structure shaking for the non-isolated tests was much more severe than for the isolated structure supported on the SDBIS system. This comparison further verifies that the SDBIS system is very effective in reducing the ground accelerations transferred into the structure. Representative time-history acceleration results for the non-isolated structure are shown in Figures 14 and 15.

In addition to higher peak values, the time-histories for both the accelerations and strains show that the strong peaks in the ground motion are transmitted directly into the structure and that the response of the stiff structure looked very similar to the input ground motions, with some small amplification.

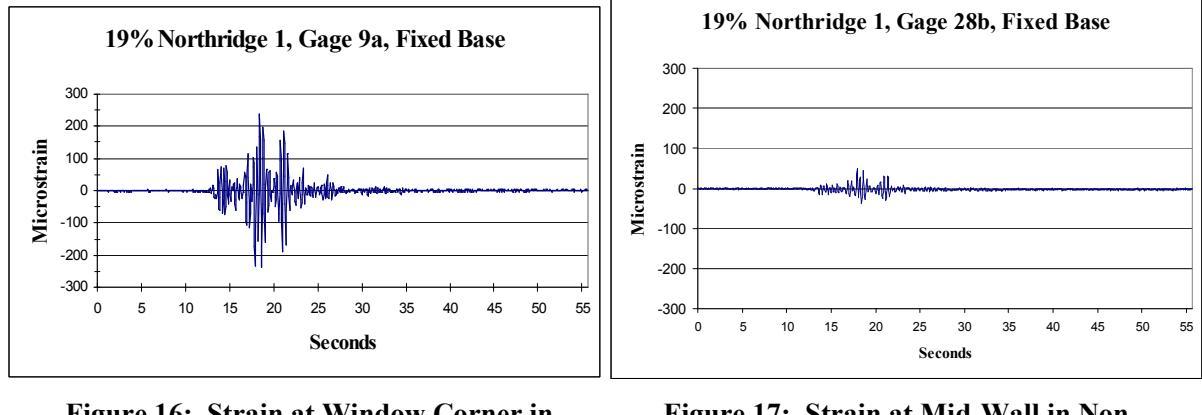
Figure 16: Strain at Window Corner in Non-Isolated Structure for 19% Northridge Ground Motion

The strain results for the non-isolated structure follow the same trend as noted for the acceleration results. Higher strains were recorded for the non-isolated structure subjected to significantly reduced ground motions than were recorded for the isolated structure subjected to full-scale ground motions. Representative time-history strain results are shown in Figures 16 and 17. The peak strain in the wall was

recorded as approximately 376 micro-strain. The walls remained elastic throughout the testing and did not develop any stress cracks. The severity of the motion for the non-isolated structure to the reduced ground motions was remarkable and would likely have caused stress cracks had the input motion been stronger.
