17th World Conference on Earthquake Engineering, 17WCEE Sendai, Japan - September 13th to 18th 2020

SEISMIC DESIGN AND EXPERIMENTAL INVESTIGATION OF A NEW TIMBER HOLD-DOWN CONNECTION

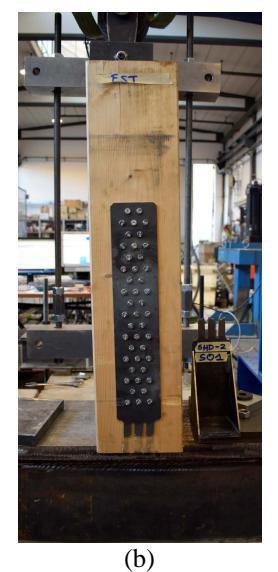
In Figure 1 two different hold-down prototypes are shown after tensile test execution. In the first case, in the following named "as-built" (see (a)), the failure is characterized by the break of the flange's section hosting the holes for the screws. In the second case, in the following named "optimized geometry" the failure concentrates in the reduced cross-section, with no evidence of damage both at screws and at the concrete side. The first case can be considered as "classical" hold-down configuration. The vertical flange is characterized by the rectangular cross-section having height (h) and thickness (t). The holes hosting the screws are characterized by the diameter (Φ_{holes}) and the base has a square plan having the dimension equal to (b). In most of the cases the base hosts an additional steel plate (named also "thick washer") to stiffen the base behavior.

Figure 1 - Hold-down after test execution: (a) Prototype As-Built; (b) Prototype Optimized

It is worth mentioning that in the as-built condition, the vertical flange failure is achieved only when the hold-down is fastened to the strong floor, as constantly adopted in experimental campaigns mentioned in the literature survey. Conversely, anchor's failure was achieved when a post-installed anchor was used to fasten the hold-down to the concrete member. In this paper the performance of an optimized geometry, promoting the ductile behavior (steel failure), addressing the use of post-installed fasteners.

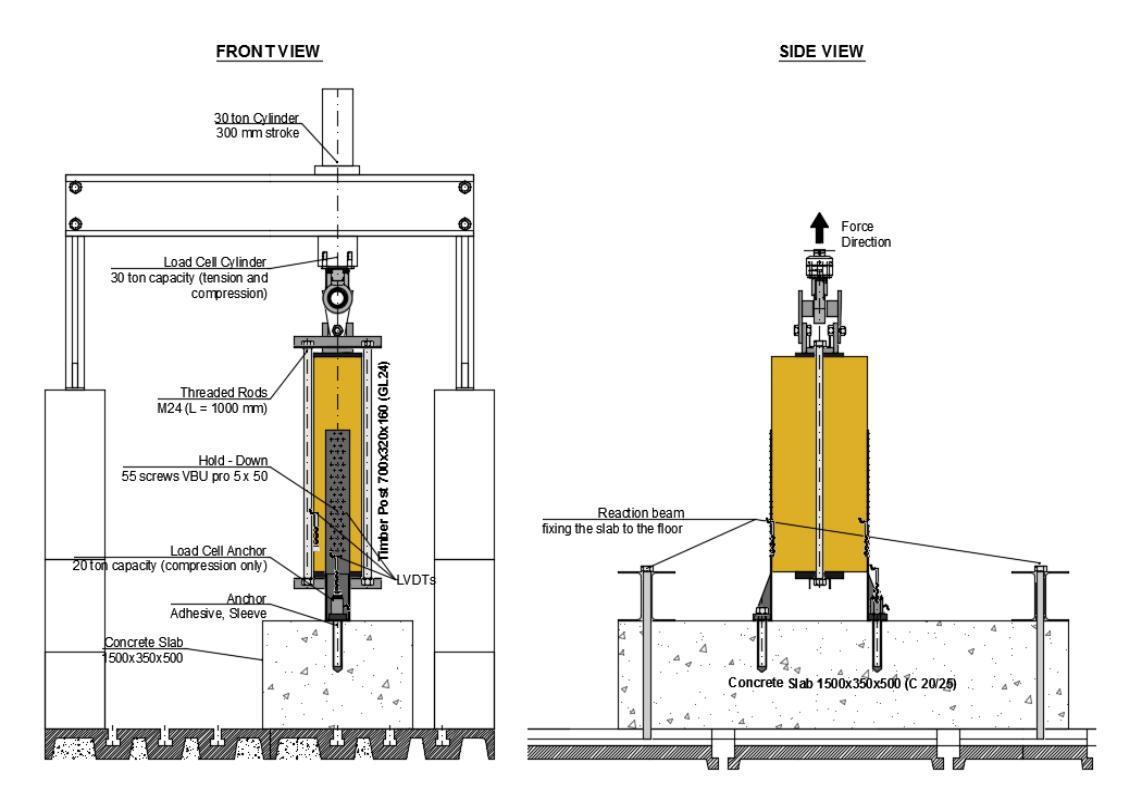
In Figure 2 the test setup is shown. A timber post having dimensions 720x320x160 mm is connected to a concrete slab 1600x750x500 mm, using two hold down devices. For the timber post a glulam GL24 class is used. Concrete is C20/25 class. Anchors are installed in un-cracked configuration.

Figure 2 – Test Setup

The test configuration having two hold-down, symmetrically installed, can be reliable in simulating the behavior of a shear panel under rocking movement for the following reasons: (i) the out-of-plane restraint degree is guaranteed; (ii) considering the low level of variability characterizing the steel yielding point and steel failure, a symmetric behavior during the test execution can be pursued; (iii) in case of failure at the anchorage to concrete such configuration provides enough safety to control the post-failure, preventing the occurrence of unpredicted shear loading the cylinder shank. Nevertheless, tests with single hold-down installed have been performed too.

The load is applied using a hydraulic cylinder of 30 ton capacity, with the load axis lying in the symmetry axis of the connections. The test is carried out in displacement control, i.e. the stroke of the cylinder is set as a control variable applying a rate of 0.08 mm/s in case of monotonic test. LVDTs measure the displacements of two point per sides, i.e. (i) the steel flange and (ii) the corresponding timber fiber as it is shown in Figure 3. During the execution of the test, the vertical flange undergoes in large displacement having a deformed shape which is characterized by the bending of the flange and consequently, the occurrence of a surface pressure loading the vertical flange sheet. Being the configuration symmetric, the occurring actions equally counter-balanced. However, this parasitical effect might affect the lateral-load-carrying capacity of the steel-to-timber connection in terms of enhanced resistance due to the activation of friction steel-to-timber. Comparing the results obtained in trial tests with single configuration, this effect should be considered negligible in the overall evaluation of the connection behavior.

The mechanical behavior of the connection is characterized by a kinematic variable (s, conventional slip) which does not coincide with the cylinder's stroke, but it follows the trend proportionally. Such behavior is obtained, providing that the load equipment provides enough stiffness during the loading path.

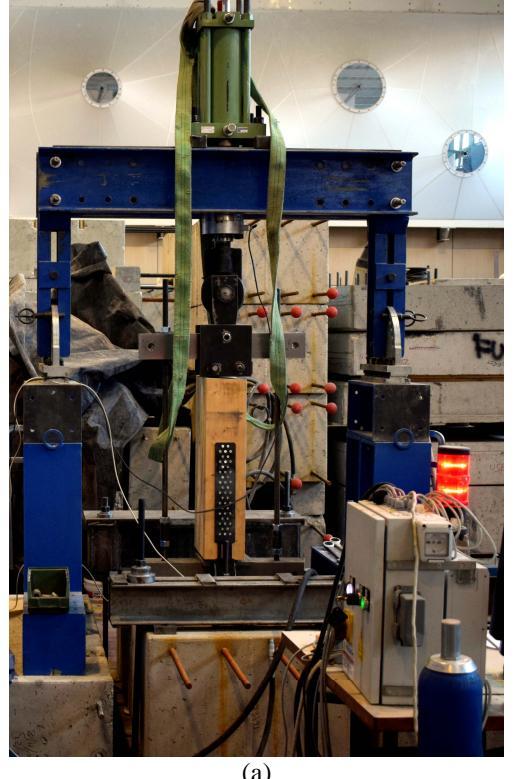
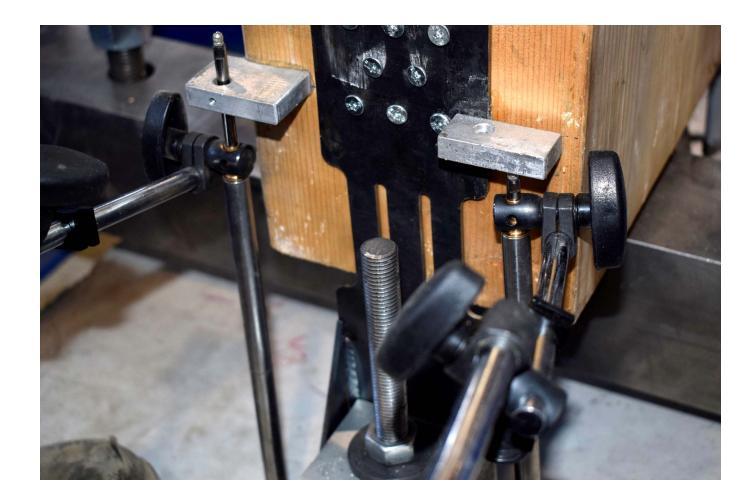
(a) (b) Figure 3 – Test Setup photo: (a) frontal layout and (b) LVDT's position measuring conventional slip

- 1. The displacement of the steel flange and the corresponding timber fiber is measured, and the slip is evaluated. The anchor's displacement is not measured continuously. In the test with the optimized geometry, a dial gauge has been installed at the anchor's head.
- 2. The displacement of the steel flange is considered as the reference kinematic variable.
- 3. Considering the behavior of the hold-down connection, a tension-only constitutive law is recognized. In fact, the compression phase (due to rocking) is completely taken up by the contact between the timber panel and the foundation. For this reason, in this test campaign, the displacement protocol does not include the sign change.

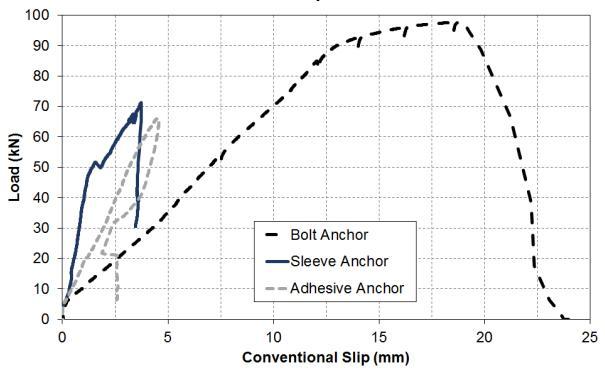
In the as-built condition, different types of anchors are tested using the same hold-down. Results show that sleeve anchor and bonded anchor are not able to reach the steel failure. However, in case of anchoring the hold-down at the strong floor the yielding of the vertical flange is reached at the cross section with reduced area (due to the presence of holes). The load-displacement plot for the three different anchors types are presented in Figure 4. Ductile behavior is obtained only in case of anchor fastened to the strong floor (named "anchor bolt"). In the other two cases the behavior is characterized by an abrupt loss of strength after reaching the point of maximum load. This kind of behavior is rather typical in brittle mechanisms involving the formation of concrete cone [19]. In particular, the following mechanisms are observed: (i) in case of bonded anchor the combined Pullout and Concrete cone failure is obtained with the contemporarily presence of a splitting crack. In this cases, the non-symmetric behavior is experienced quite suddenly with respect the case of steel failure. The concrete cone develops at one side of the double configuration.

Figure 4 – Results for the monotonic tests in case of as-built geometry

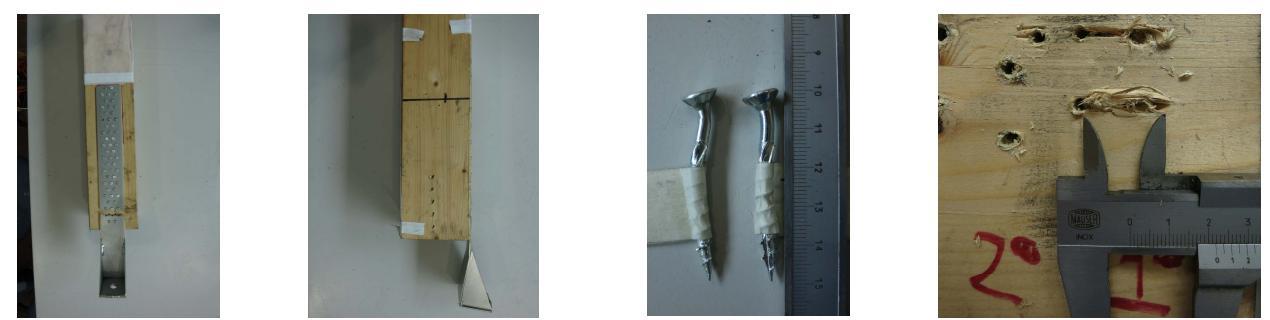
Only in the case of the fastening to the strong floor, the formation of plastic hinges to the screws were observed to the first row of screws as can be observed in Figure 5. Additionally, it is proven that the group of anchor has as higher load-carrying capacity with respect the estimated one, barely evaluated considering the summation of the capacity of a single fastener extended to the whole number of the screws, in this case the number is equal to 53.

Figure 5 – Mode of failure in case of As-built geometry with anchor fastened to the strong floor.

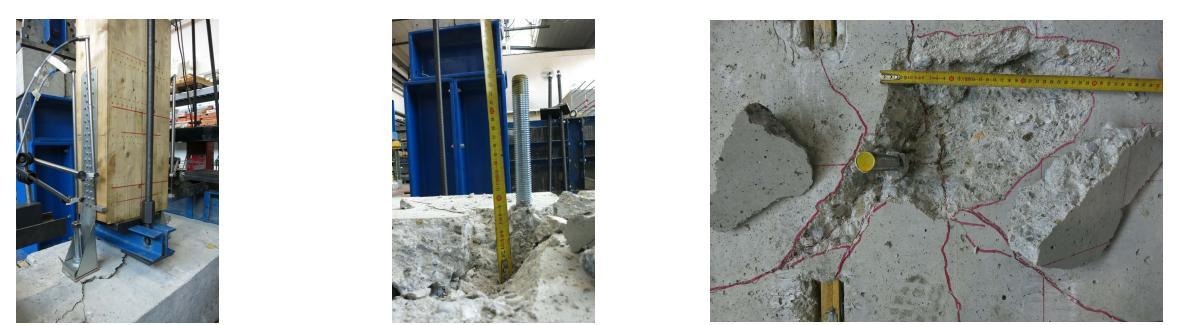
Figure 6 – Mode of failure in case of As-built geometry with bonded anchors.

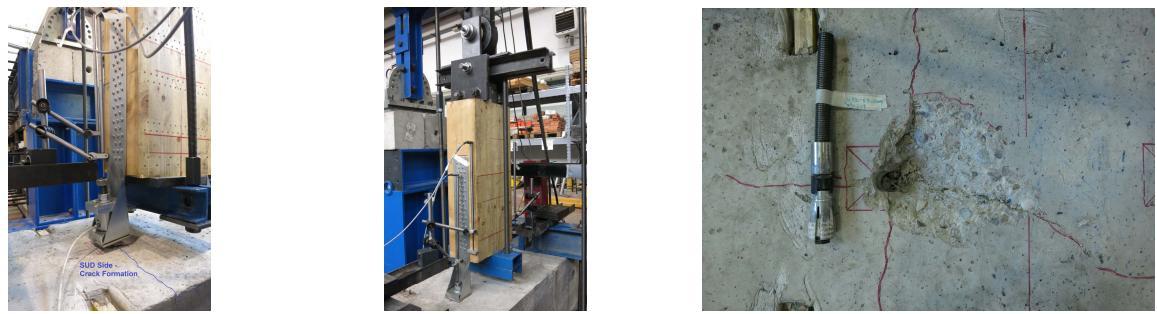
Figure 7 – Mode of failure in case of As-built geometry with sleeve anchor anchors.

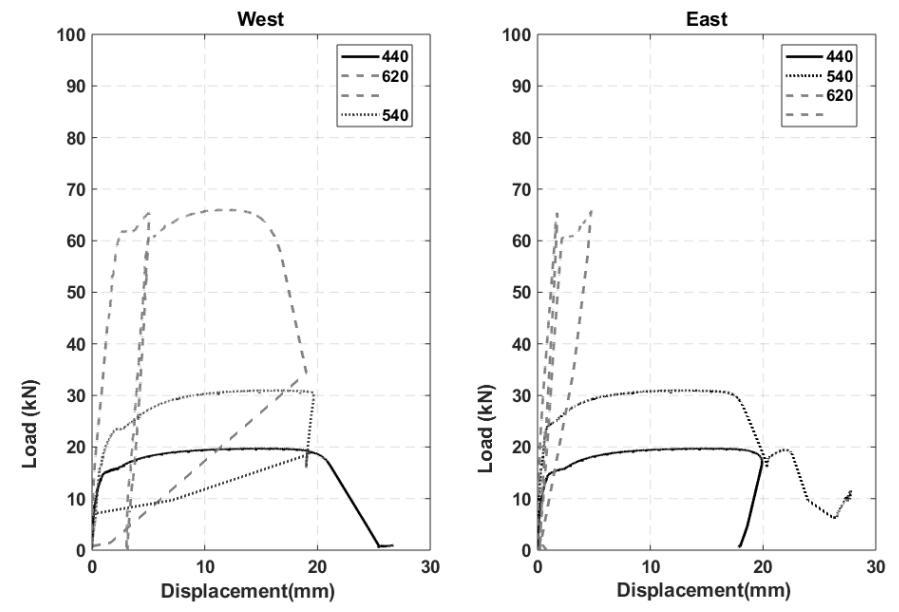
The optimized prototypes are characterized by three different levels of the peak loads, i.e. 66 kN, 31 kN and 20 kN for the OPT-640, OPT-540, OPT-440, respectively. The load-displacement curves, differentiating the two sides of the test configurations, are reported in Figure 8. For all the cases, the load-displacement behavior shows (i) a well discernible yielding point and (ii) e pronounced plastic plateau with hardening. Notwithstanding the non-symmetric behavior that occurs once one side reaches first the failure, the yielding of the both sides has been observed in all the cases except for OPT-620.

Figure 8 - Results for the monotonic tests in case of optimized geometry

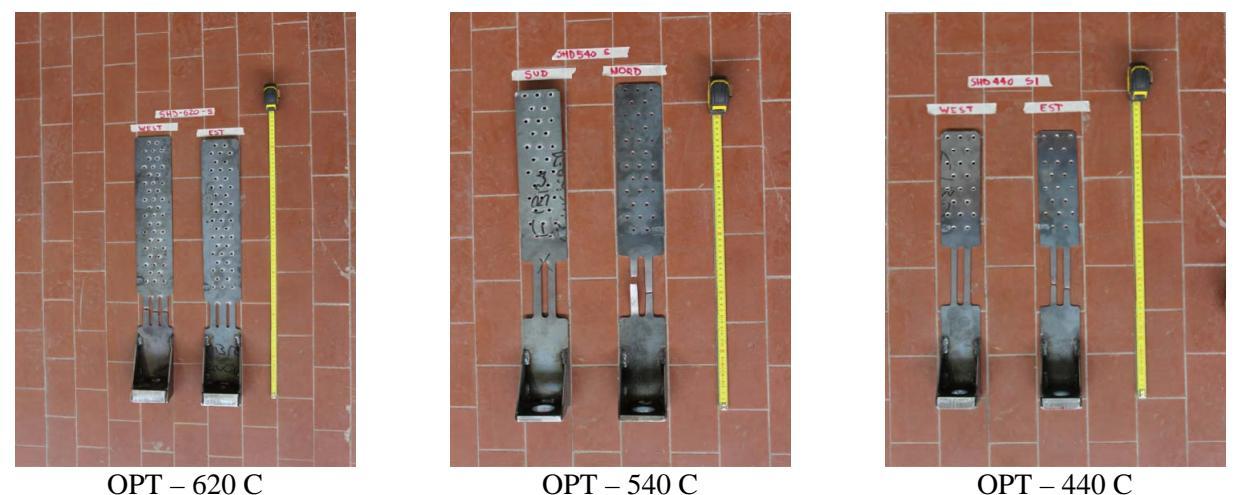
In all the tests, the break-out of the steel flange (at least in one side of the tested double configuration) has been reached as shown in Figure 9. Moreover, both the hold-down (placed in different side of the test configuration) are characterized by a non-recovered deformation within the stretch length

Figure 9 – Mode of failure in the case of the optimized geometry for the different hold-down prototypes

Results of the monotonic tests in the case of the optimized geometry, clearly show that ductile steel failure is reached. The failure, as expected, concentrates in the reduced area region of the hold-down's vertical flange. The values of the peak loads are comparable with ones (F_{uk}) obtained through analytical evaluation as shown in Table 2. In case when the optimized geometry is adopted, the failure of the anchor has been prevented and there is no evidence of surface crack pattern for the concrete slab.

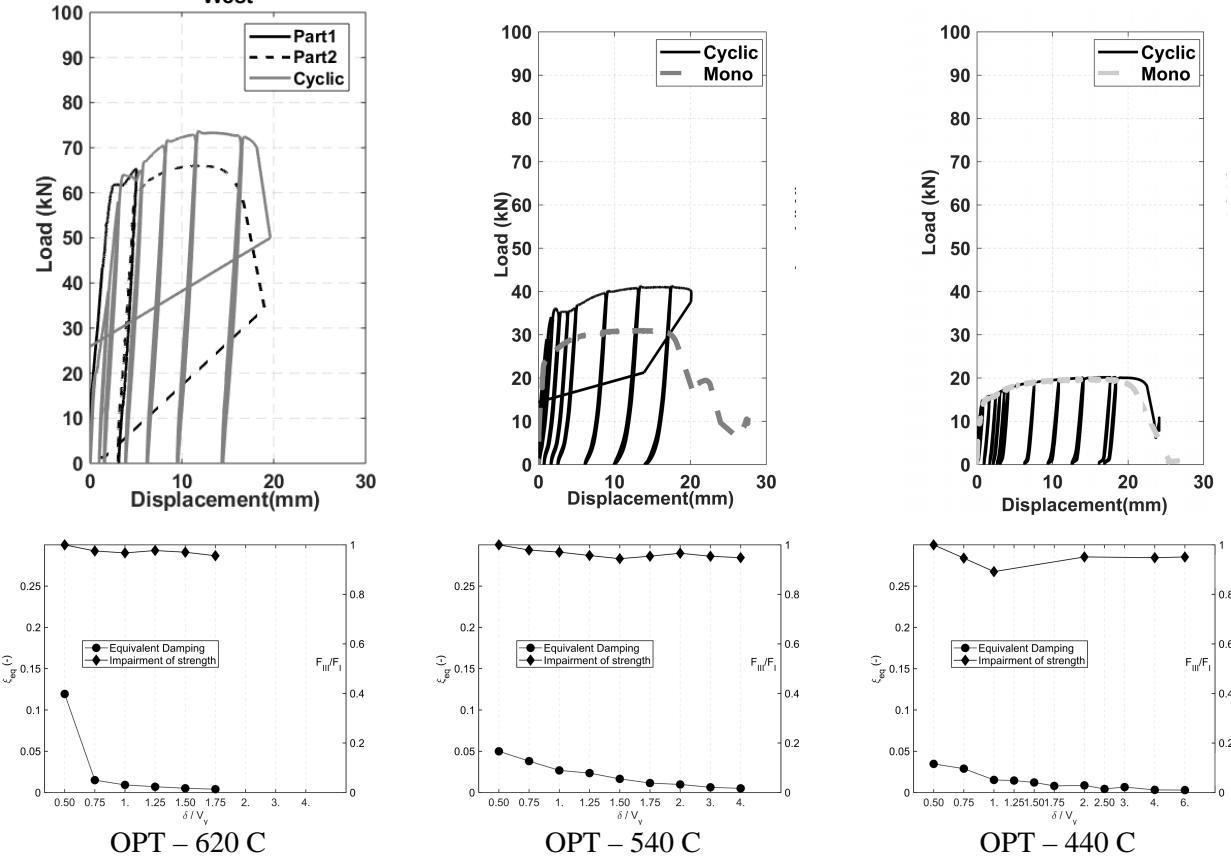
The results for cyclic tests are shown in Figure 10, for OPT-440, OPT-540 and OPT-620, respectively. For the OPT-440, at each level of the displacement, performing the cyclic protocol, the load level is comparable with the one obtained for the monotonic tests. However, the same cannot be stated for the OPT-540 and OPT-620 where higher values of the load are obtained. In all the tests, the failure mechanism confirms the one obtained in the case of the static, i.e. break-out of the steel flange.

Figure 10 – Results for cyclic tests in case of optimized geometry. (Top) Load displacement curves. (Bottom) Parameters of cyclic behavior, i.e. impairment of strength [diamond mark] and equivalent hysteretic damping [round mark].

The evaluation of the parameters for the interpretation of the cyclic behavior (impairment of strength and equivalent viscous damping), is carried out according to [16]. It is evident that the trend of strength reduction does not overcome the 10% when the ratio is calculated between the force reached at the third cycle of the target displacement (F_{III}) and (F_I) the one reached at the first cycle. The equivalent viscous damping assumes values less than 5% considering as relevant the cycles after the passing of the yielding point $(1.0 \cdot V_y)$. In fact, the authors feel questionable the definition of the viscous damping for the previous cycles (as defined in [18]), in which, theoretically, the cycle are performed following linear-elastic paths.

Cyclic performances have been evaluated according to [16]. For the same displacement level, the load decreases of the 5% at most when compared to the load level reached at the 1st cycle. This evidence, as expected, confirms the maintenance of the strength characteristic during cycles providing that (i) the number of cycles is not relevant to start fatigue issues and (ii) reverse of the load is prevented and no limitation should be adopted to contrast the Bauschinger effect [21].
