EARTHQUAKE RECONSTRUCTION IN RURAL NEPAL – REBUILDING WITH RESILIENCY

G. Cortés⁽¹⁾, D. Gautam⁽²⁾

Keywords: Reconstruction; Earthquake Resilience; Build Back Safer, Owner Driven Reconstruction

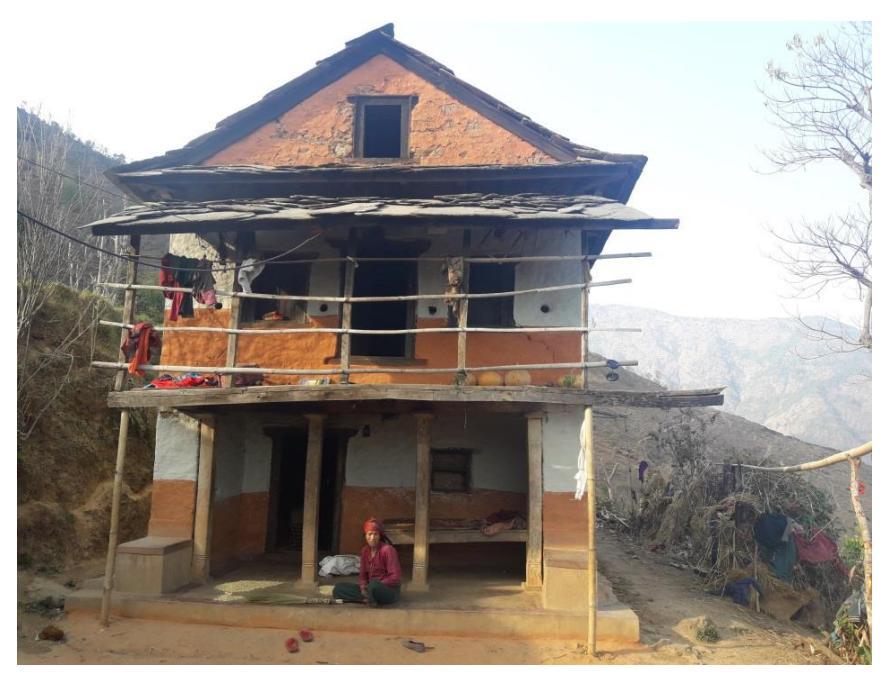
Figure 1. Typical single-family house found in Bijulikot prior to the earthquakes.

Although there are some brick masonry buildings and a few reinforced concrete buildings (confined masonry), the vast majority of buildings in this area are traditional houses 2-story high plus an attic (prior to the earthquake; one-story plus attic after the earthquake) made of stone masonry joined with mud mortar, and with locally sourced timbers for the roof. A typical house can be seen in Figure 1. These houses are built by self-trained masons using locally available materials, often resulting in poor workmanship. The most common problems observed in the buildings were the lack of through stones (wide stones that go through the full width of the wall), lack of bands (sill, lintel and gable) and stitches, improper opening positions and sizes, lack of bonding between masonry units, irregular configuration, and lack of vertical reinforcement at wall junctions. All these structural deficiencies were compounded by other issues such as construction on sloped ground and on unstable slopes, significantly adding to the seismic vulnerability of the structures.

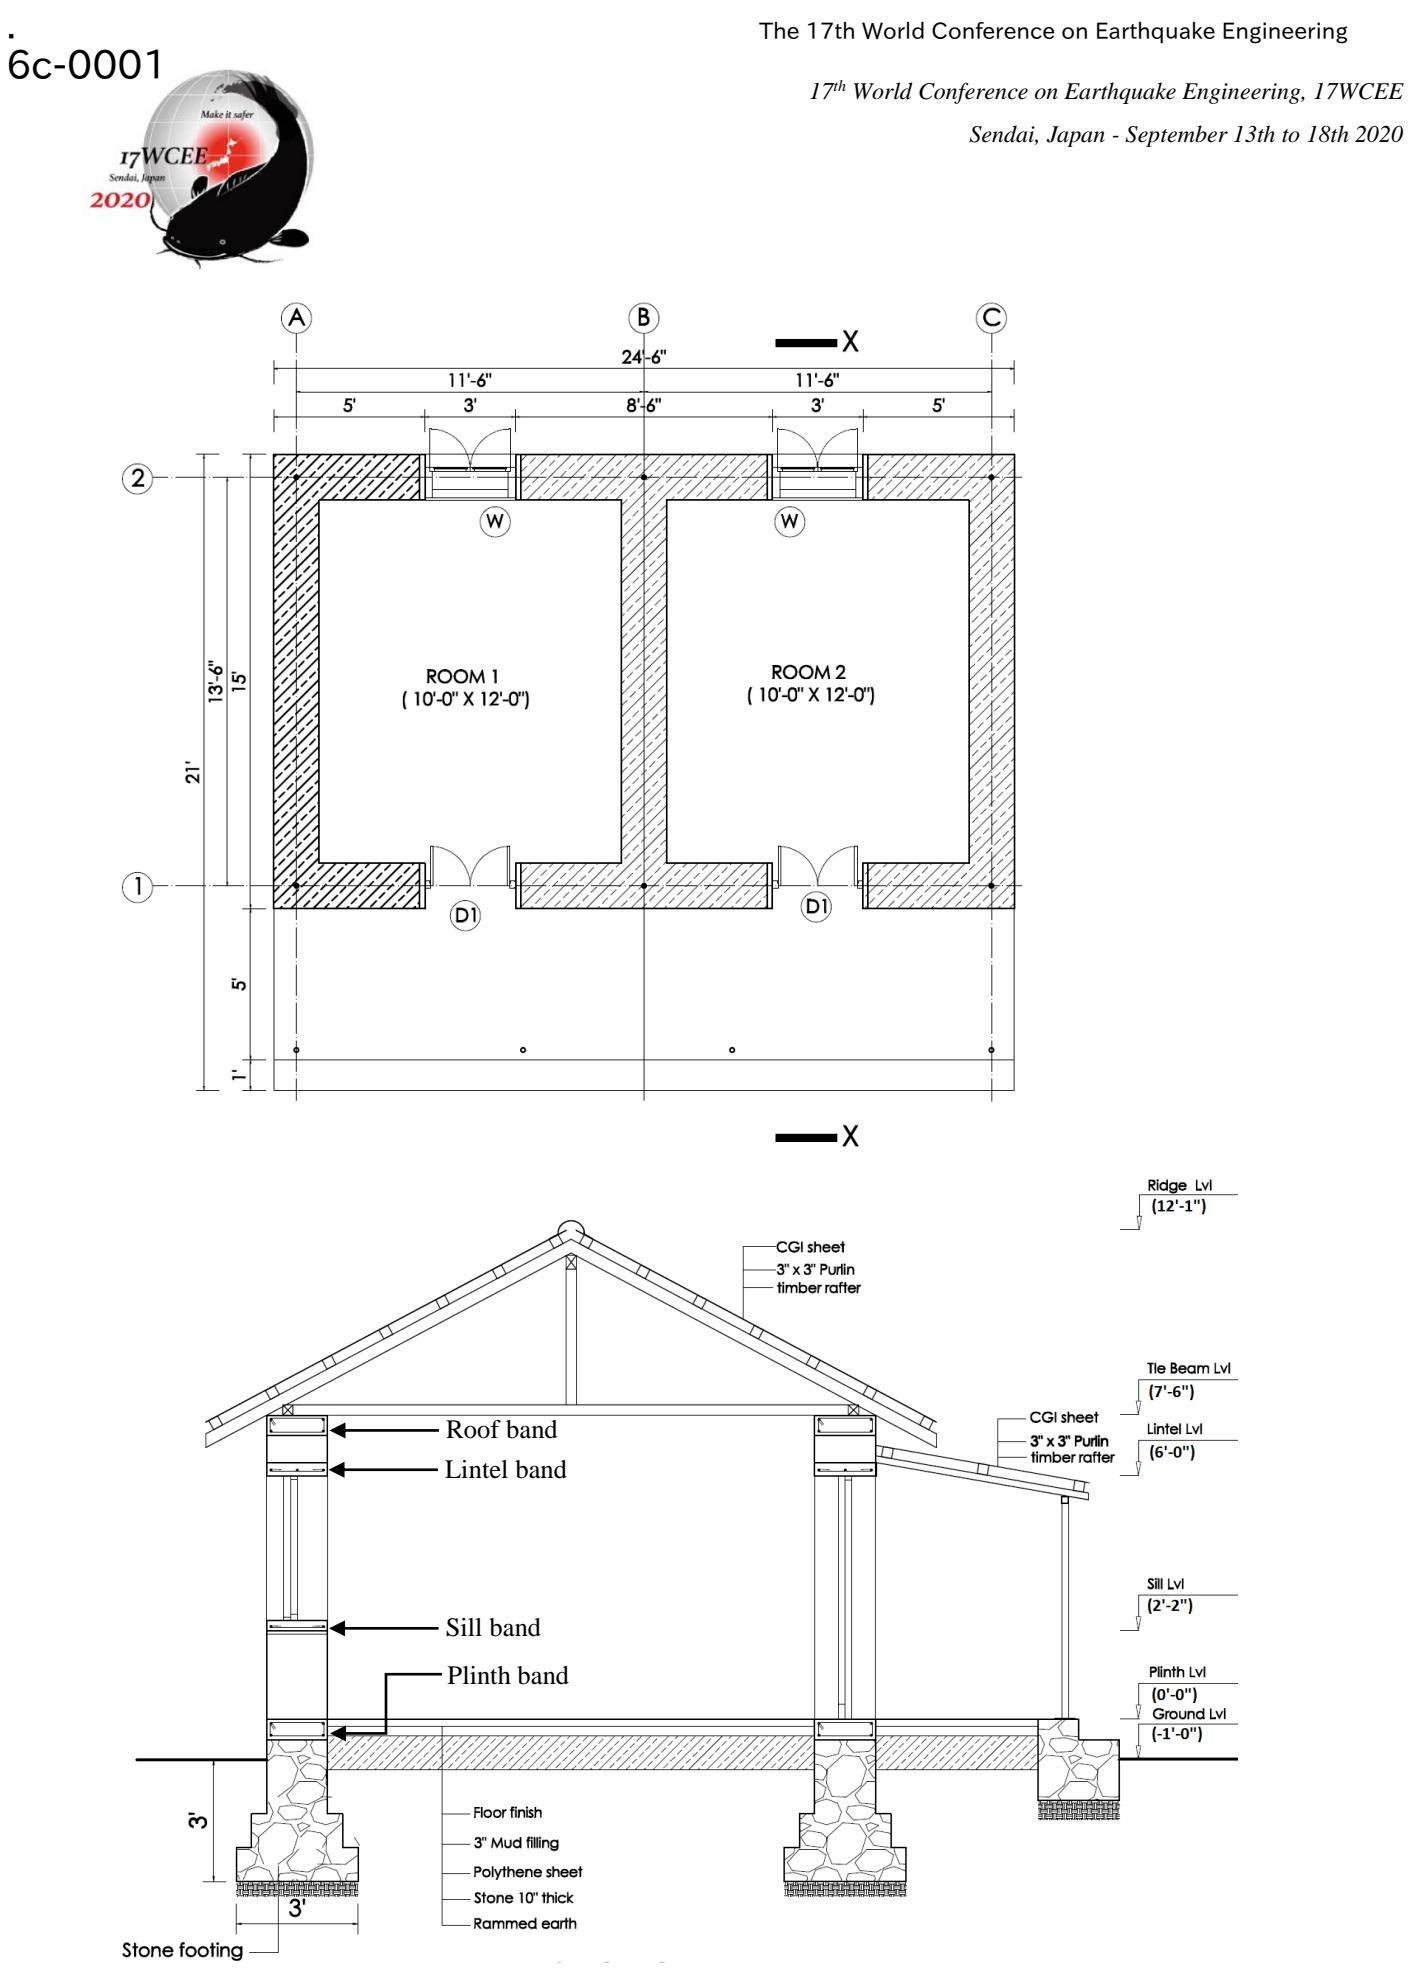
Figure 2 shows the plan view and a cross-section of a typical stone-masonry cement mortar house. Note that the cross-section does not show the attic which nearly all the population included, making the house 1.8m taller at the ridge, and allowing for an extra 24 square meters of space where people could store food. Also note that dimensions are provided in the imperial system as preferred by local masons.

Figure 2. Plan view and cross-section of typical stone masonry house.

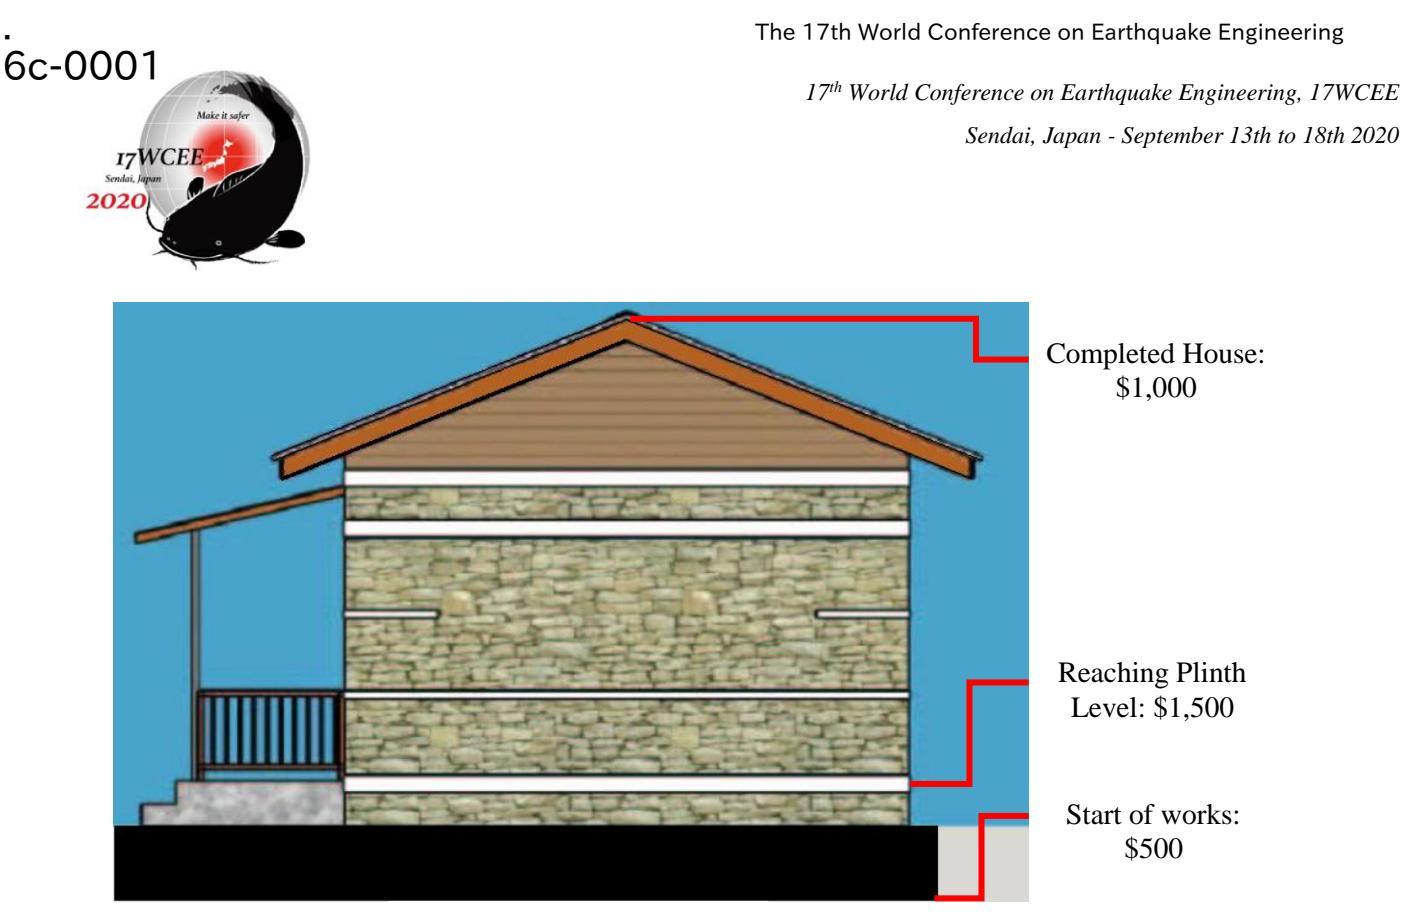
Figure 3. House construction milestones for payment (adapted from [6]).

A major challenge experienced before the works could begin was the fact that banking facilities were not available and people had no previous experience of working with banks. In fact, bank facilities were only available at the district headquarter. Bank accounts were necessary since the assistance by the GoN was provided to beneficiaries' bank accounts by means of direct deposits. In total three installments were provided, each upon completion and government certification of a well-defined milestone: 500 USD were provided for commencement of work, 1,500 USD after completing the plinth band, and a final installment of 1,000 USD after completing the houses. Medair helped the population overcome this challenge by assisting them to open bank accounts. In addition, given that funding was very tight, Medair provided three tractor trips, equivalent to \$350, to help each family with transportation costs. Figure 3 shows an illustration of the three milestones used for payments.

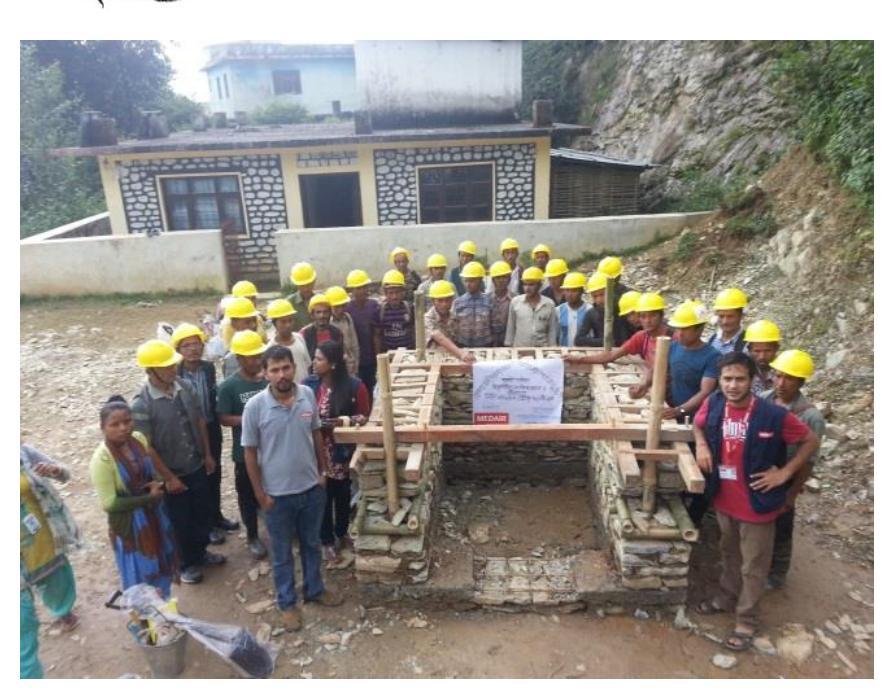
Figure 4. Hands-on training provided to masons.

The training enhanced the knowledge and skill for construction of earthquake resilient buildings, focusing on the use of quality materials and other necessary seismic requirements outlined by the NBC. It also increased the commitment and responsiveness among the participants to enforce the NBC, making the reconstruction process a little easier. As a result, all the houses were approved by the government and received all three installments of construction financial assistance and completion certificates. Figure 4 shows one of the masons' groups at the end of a hands-on training.

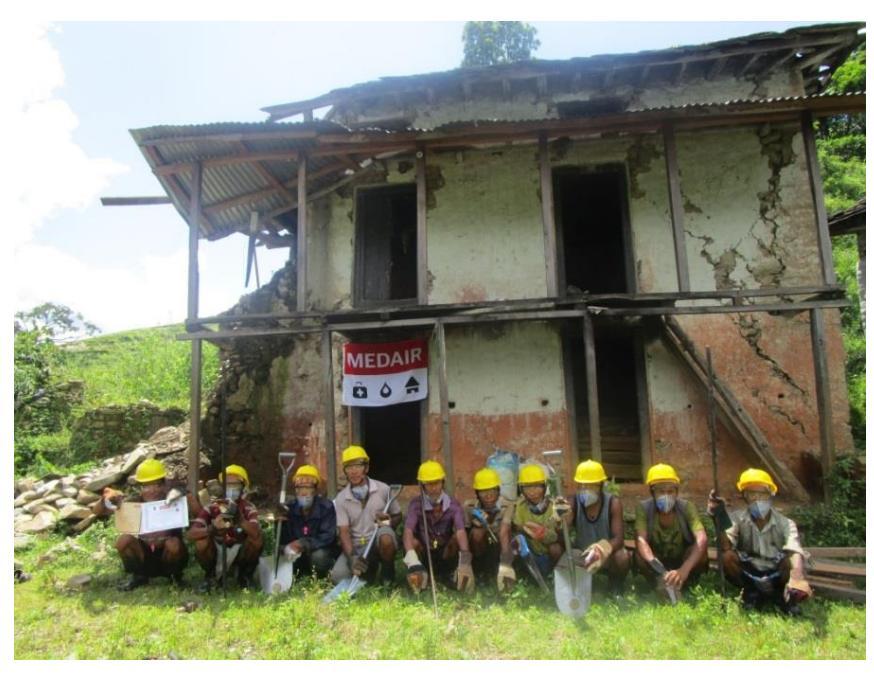
Figure 5. House ready for demolition.

The first step in the reconstruction was to demolish unsafe houses and to classify materials that could be reused such as stone and timbers. Reusing materials played a crucial role in allowing beneficiaries to save money and be able to finish the construction of their houses since the government only provided 3,000 USD per household, which was not sufficient to finish a house. It should be noted, however, that not all beneficiaries chose to demolish their old house as some preferred to keep it for storage and or as cattle shed.

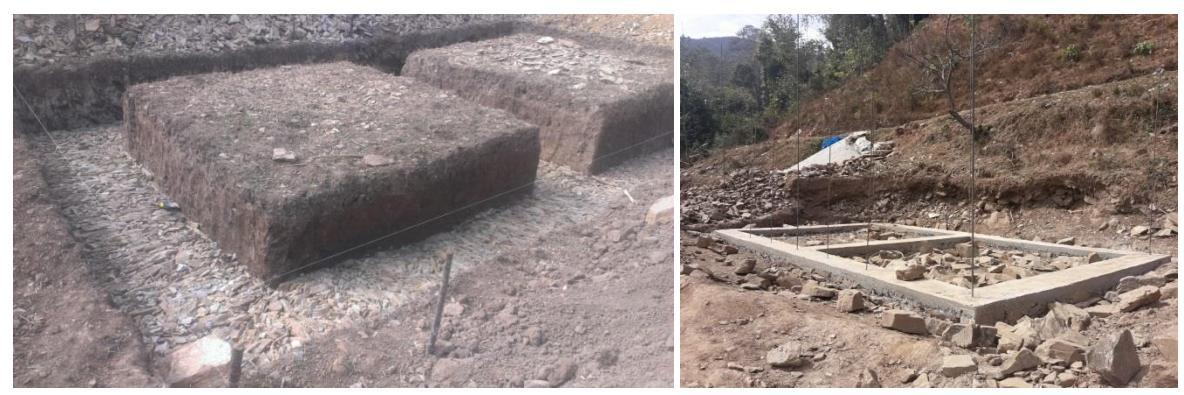
Once construction started, Medair engineers supervised the progress on a daily basis, to ensure quality workmanship and compliance with the agreed standard design. Construction started with the layout, excavation, stone compaction, vertical reinforcement erection, stone laying at foundation, and plinth beam construction. Government engineers would perform an inspection once the plinth beams had been poured, and if the required quality was achieved, the house owner would be eligible to receive the second installment. Figure 6 shows the foundation work, with a layer of compacted stone in preparation for the reinforced concrete footing, on the left, and the plinth level finished on the right.

Figure 6. Excavation for foundations, left; construction up to plinth level, right.

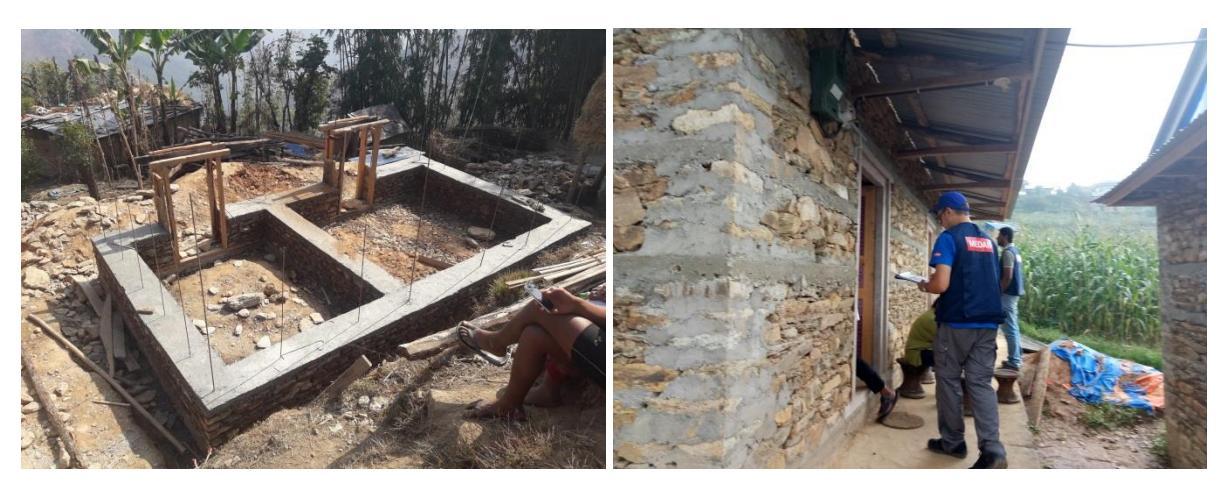
After completing the construction of the foundations, the floor was filled with small stones and compacted. Then, wall construction began by laying stones, ensuring that through stones were properly placed, followed by the sill band, intermediate bands and lintel bands, all placed with proper reinforcement details and a 1:2:4 ratio of cement, sand and aggregate. Figure 7 shows the construction of walls up to sill level, on the left, and Medair engineers performing an inspection of the full wall on the right.

Figure 7. Construction of a house up to sill level, left; inspection of completed walls, right.
