Shaking Table Experiment for Philippine Full-Scale Concrete Hollow Blocks (CHB) Masonry Houses

Hiroshi Imai, Hiroshi Inoue & Chikahiro Minowa National Research Institute for Earth Science and Disaster Prevention (NIED)

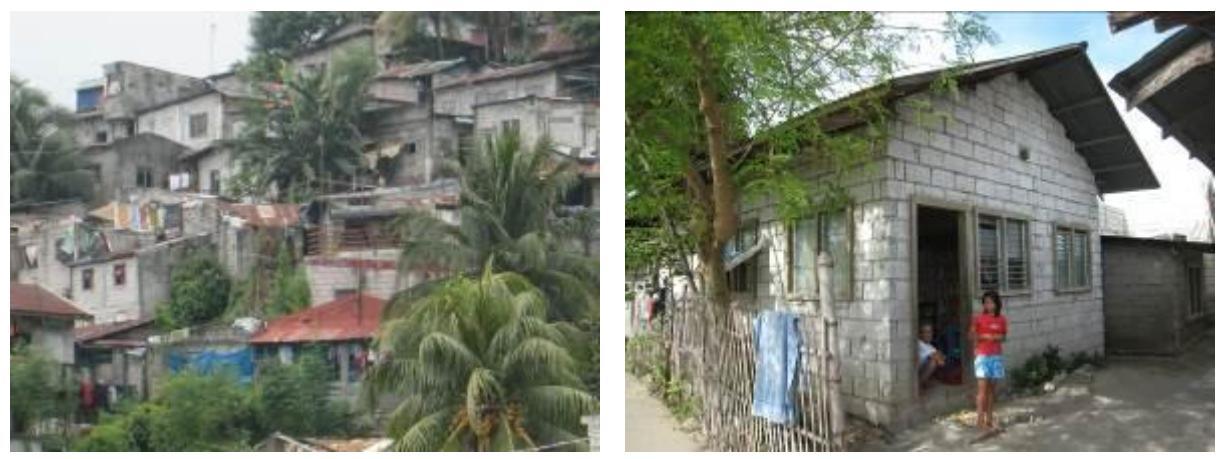
Figure 1. Typical CHB house in Manila

A review of common housing types in the Philippines shows that many non-engineered houses exist on

the ground and are mostly made of concrete hollow blocks (CHB). (Fig.1) With this situation, it is necessary to let the stakeholders and the house owners become aware of the possible behavior and seismic performance of their houses during strong ground shaking.

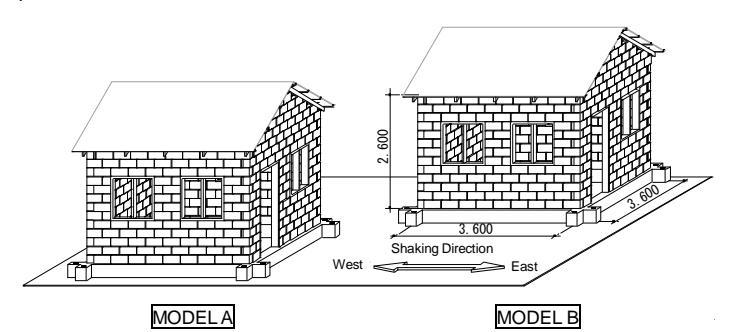
Figure 2. Isometric of two models on the shaking table

The overall dimensions of these two models were similar: 3600mm square plan and 2600mm height plus a 1200mm gable wall. The model structure has load-bearing walls with no RC column and the walls consisted of CHBs which were imported to Japan from the Philippines. Both models have the same roof specification of zinc sheet roof. (Fig.2, Fig.3).

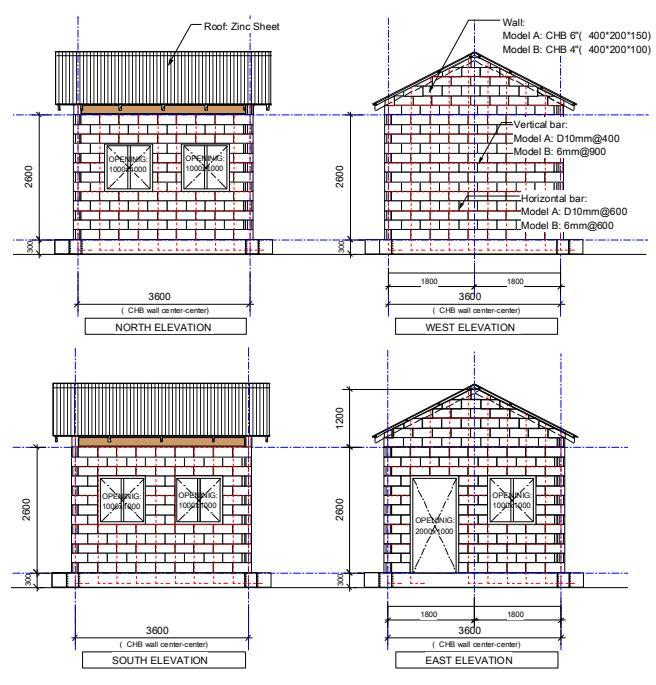
Figure 3. Elevations (N,S,W,E) of two models

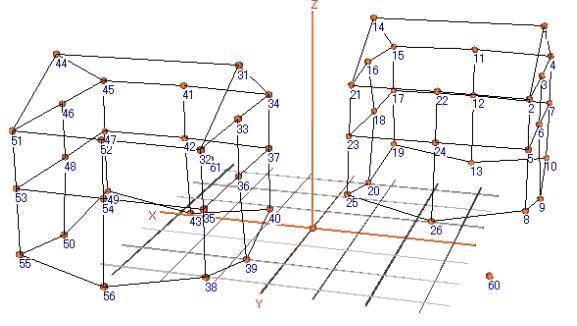
Figure 3. Location of maker for 3D measurement (Left: Model B, Right: Model A)

Variations in the performance of each model were measured using ground motion recorded from installed accelerometers (x10 points) and displacements of 3-D observation markers captured by high-resolution cameras (x60 points). (Fig 3)

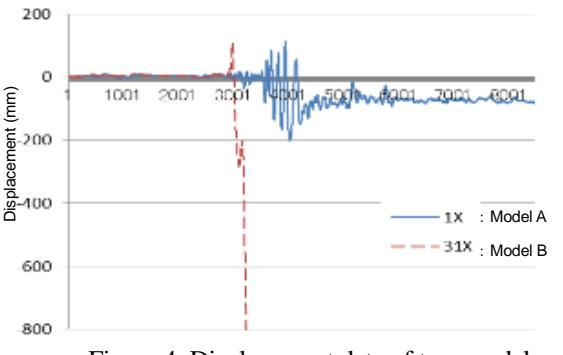
Figure 4. Displacement data of two models on input No'7

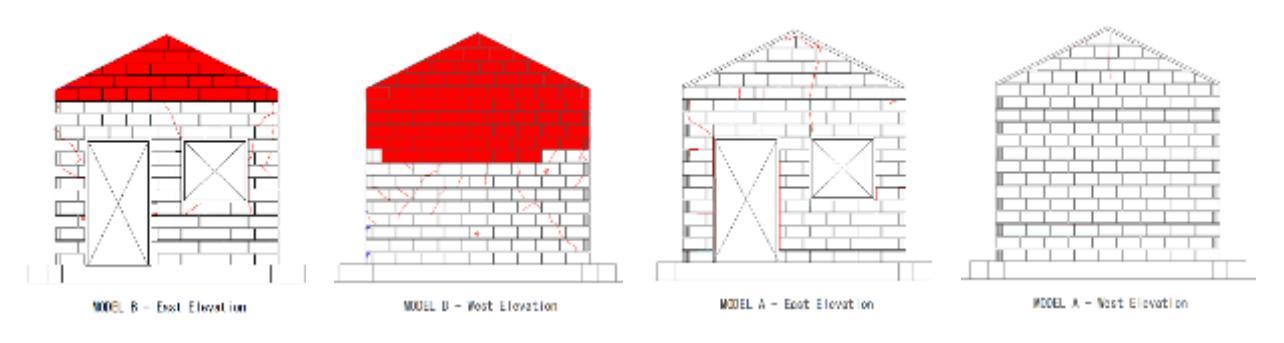
Figure 5. Cracks and fell down parts of Model A and Model B after input No'7

2.4.1. Observations on input No'7 JMA Kobe 100% (Fig.5, Fig6, Fig7) Model A (Engineered)

- East and West walls reacted to large displacement.
- · Horizontal crack was recognized on the bottom of the gable wall.
- East-South corner started to separate.

Model B (Non-engineered)

- East gable wall collapsed. The upper part of opening had large displacement.
- West gable wall and upper part of wall collapsed.

North and South wall was minor diagonal cracks started to appear.

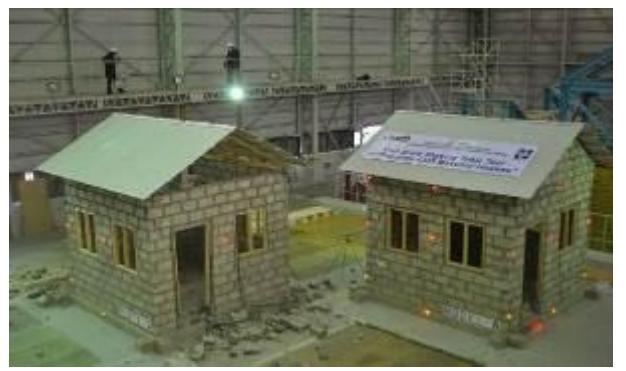
Figure 6. Two models after Input No'7 (Left side: Model B, Right side Model A)

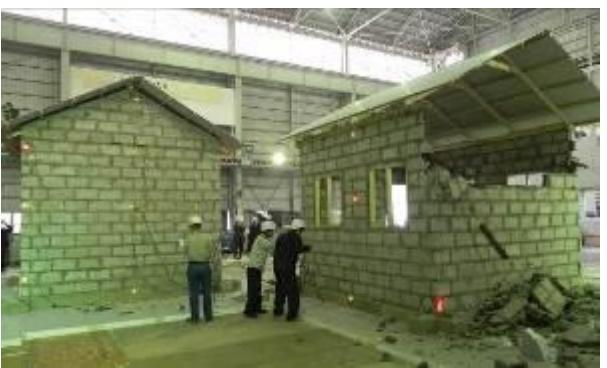
Figure 7. Two models after Input No'7 (Left side: Model A, Right side Model B)

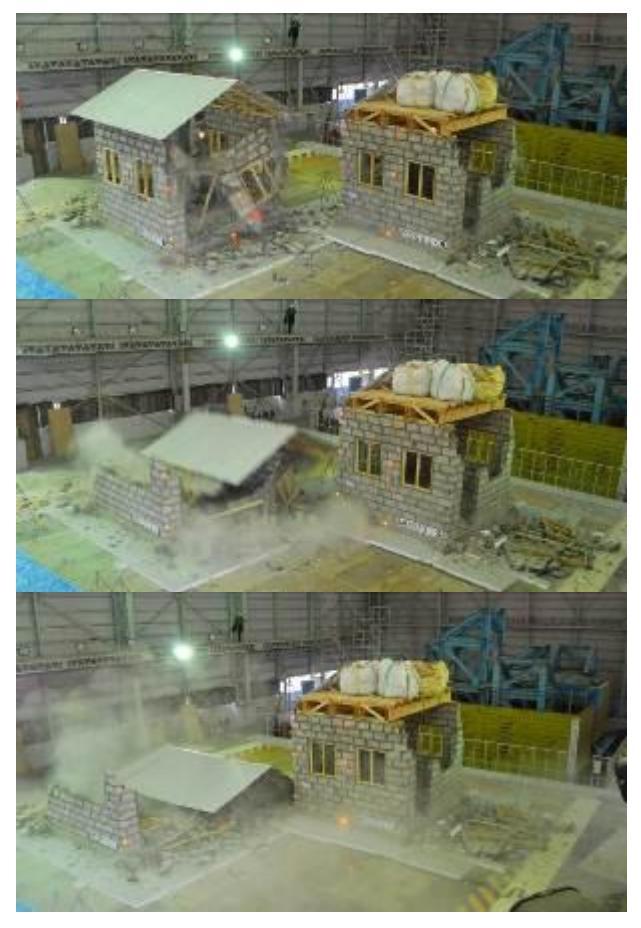
Figure 8. Behavior during collapse of Model B by Input No'19

The following findings have been drawn from the observations during full-scale shaking table experiment.(Fig.8):

- · Gable walls of Model B (Non-engineered) collapsed easily, and poses danger to its residents.
- Gable walls of both models are the most vulnerable part of the structure, showing strong movement compared to other parts
- The gable wall of Model A (Engineered) did not collapse for input No. 7; using the correct size and spacing vertical steel bar for this model may have a significant effect against bending failure of gable wall.
- Model A survived 100% of JMA Kobe input motion with only minor damage; good compaction of mortar filling improved CHB-mortar bonding and the use of standard size and spacing of steel reinforcement bars improved wall strength and ductility.
- Model B showed consistent failure between joint and upper fill mortar on the next upper level of CHBs, indicating poor bonding in the joints.

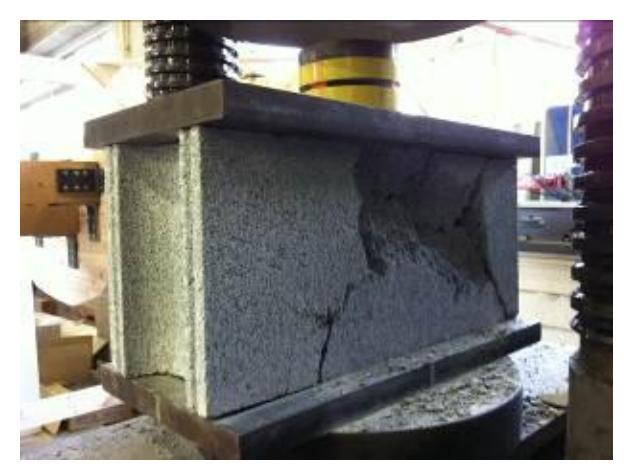
Figure 9. Compressive test of FULL BLOCK

were subjected to compression strength tests at Mie University (Fig. 9 and 10) and were compared to Japanese concrete blocks. Results reveal a relatively low compressive strength for these Philippine CHB samples, less than 10% of that of Japanese concrete blocks as shown in Table 4, 5 and 6.

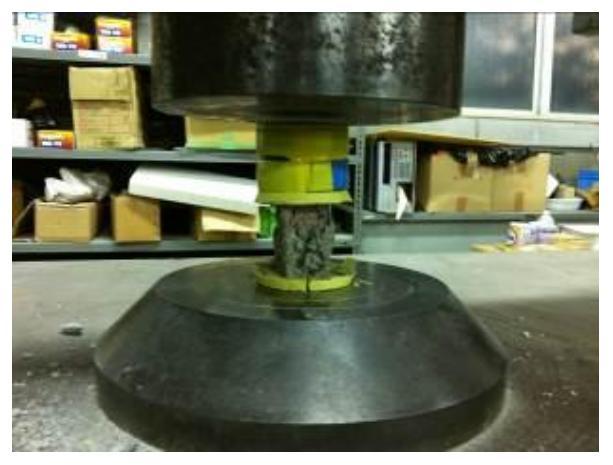
Figure 10. Compressive test of CUT-CHB
