PERFORMANCE ASSESSMENT OF UPPER STORIES IN AN OPEN GROUND STOREY BUILDING WITH RETROFITTED GROUND STOREY

Keywords: retrofitting; open ground storey; damage distribution

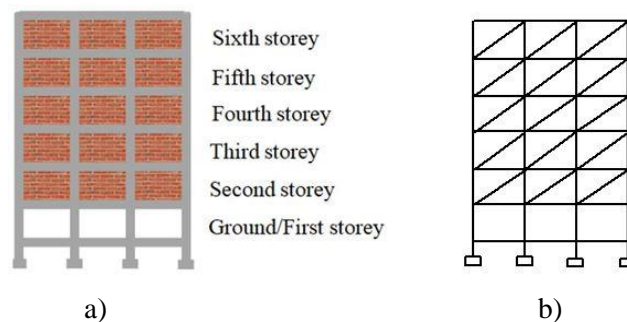
Fig. 1 a) Open Ground Storey b) Equivalent SAP model in 2D

Mass of all structural and non-structural components are included as the dead load on the building. Live load of 2.5 kN/m² in rooms and 1.25 kN/m² on roof slab and floor finishes of 1 kN/m² as per IS 456 : 2000 [4] are considered. Load combinations for building design are also considered as per IS 456 : 2000 [4]. The building is modelled in 2D for pushover analysis in SAP2000 for performance assessment after retrofitting as shown in Fig. 1 b).

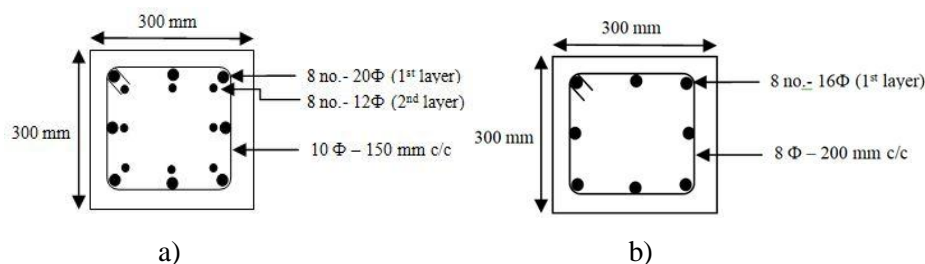
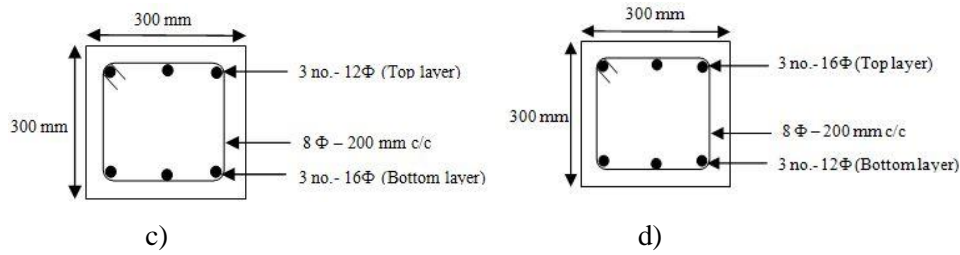
Fig. 2 Cross-sections of Open ground storey a) Ground storey column b) First storey column c) Beam mid-span cross-section d) Beam support cross-section

Three bay G+5 open ground storey building with foundation at 1.5m below ground level is taken up for this study. The building is assumed to lie in zone V city say Guwahati or Darbhanga in India. The building is assumed to be a lifeline building. It is designed as a special moment-resisting frame per IS 1893 (Part 1) : 2016 [2] and ductile detailing is provided as per IS 13920 : 2016 [3]. Elevation of the assumed building is presented in Fig. 1 a). Grade of concrete and steel used are M30 and Fe415 respectively. Beam and Column cross-sections of OGS building are shown in Fig. 2 and slab thickness is 150mm.

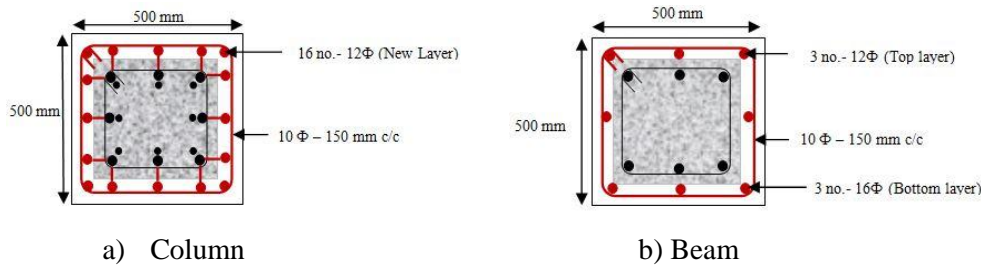
Fig. 3 Cross-sections of retrofitted column and beam

Local retrofitting techniques of column jacketing and infill wall addition as suggested in the technical document by Vijayanarayanan *et al.* [1] are adopted. As per Goud *et al.* [13] building retrofitted with both column jacketing and infill wall addition gives better performance after retrofitting. Therefore, adopting column jacketing and infill addition both for OGS retrofitting. Concrete jacketing is done as per code IS 15988 : 2013 [14]. Column and beam sizes are increased from 300 to 500 mm. Cross-sections of retrofitted column and beam are shown in Fig. 3.

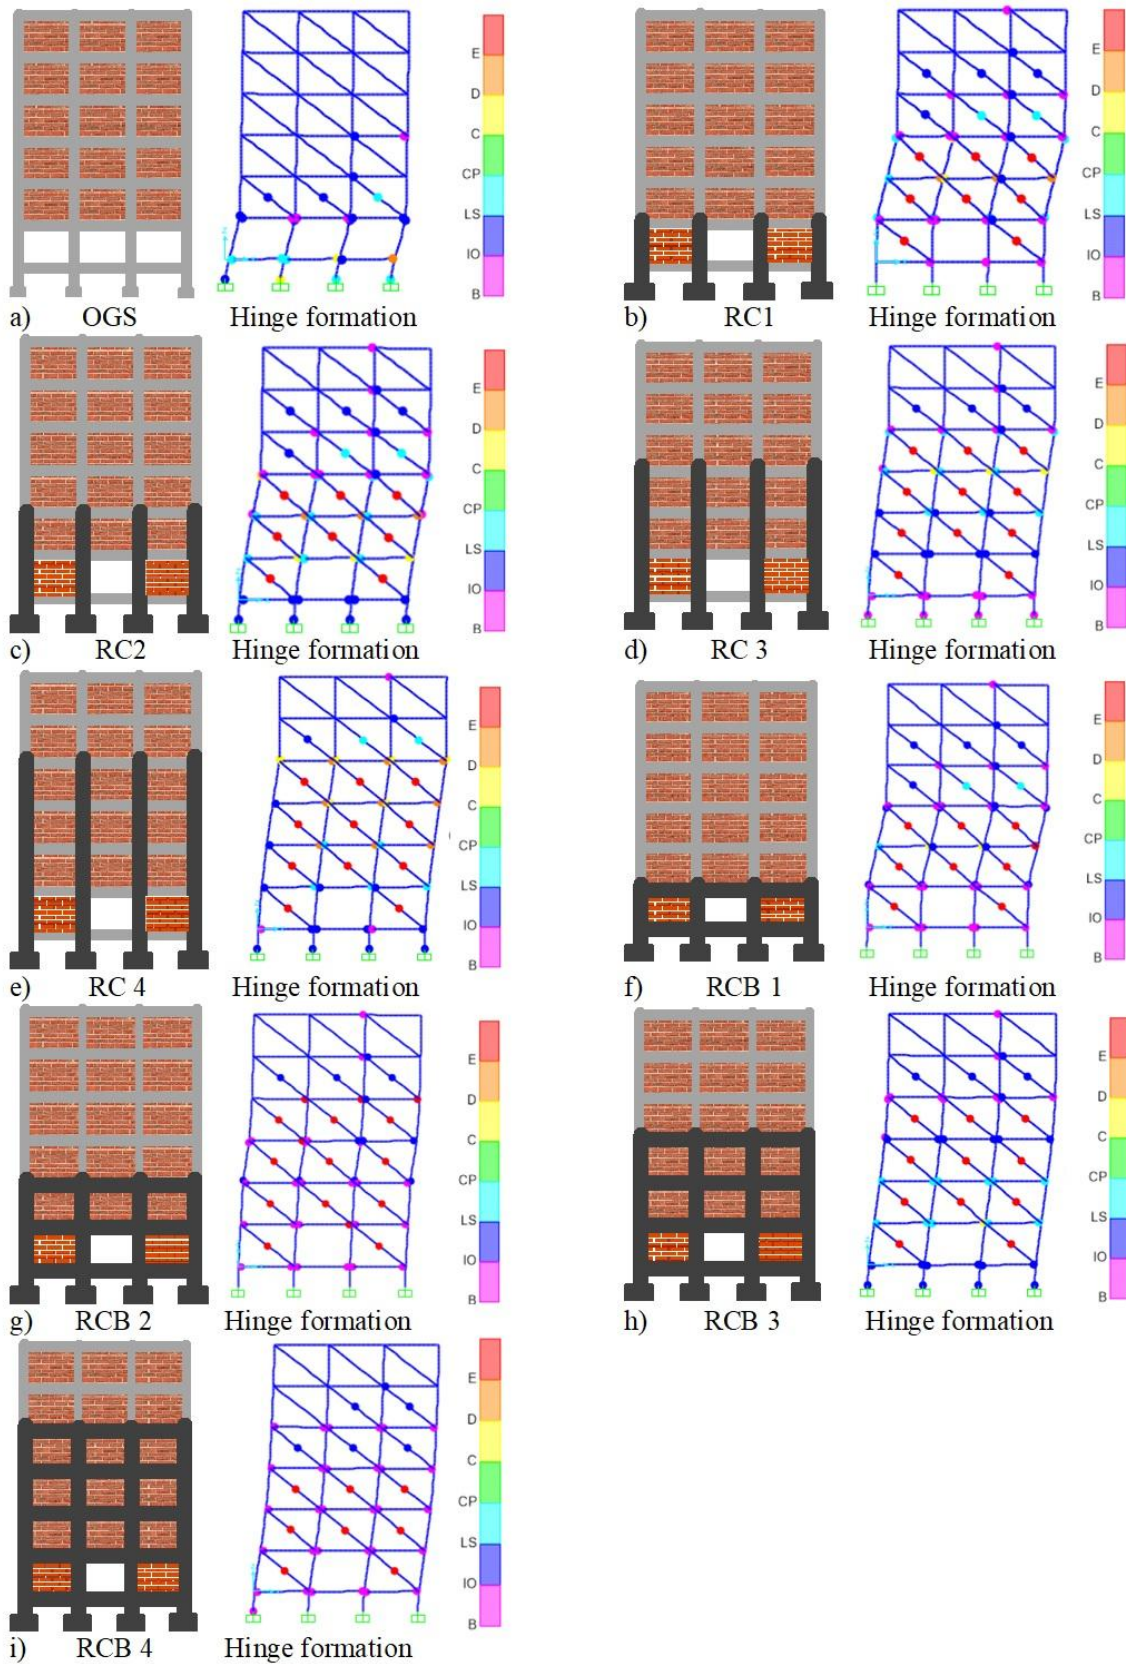
Fig. 4 Retrofitting schemes along with their hinge mechanisms

Fig. 4 (a) and (b) show the hinge mechanisms of OGS and OGS retrofitted with retrofitting scheme RC1. Comparison of hinge states of OGS and RC1 highlights the shift of collapse state hinges in the first storey of OGS to the second storey after its retrofitting. This indicates a shift of damage from first storey columns to second storey columns on retrofitting of columns of OGS. Infill wall damage persists in both cases. If building capacity required in any earthquake-prone area isn't met with RC1 retrofitting scheme, further retrofitting is required which can be planned as per the damage propagation observed from hinge mechanisms. One way is retrofitting of only columns of a storey presented in Fig. 4 by RC series. Another way is the retrofitting of columns and beams of a storey presented in Fig. 4 by RCB series.

POA is again performed for each retrofitting scheme and the capacity curves are obtained and plotted in Fig. 5 Comparison of hinge formation pattern is done. Fig. 4 (c) presents the hinge mechanism of RC2 which is retrofitting of only columns of the second storey. It is observed that hinges are now forming earlier in the third storey column than first and second storey columns. Therefore, second storey column damage has been shifted to third storey columns after retrofitting of the second storey. Similarly, damage propagates to fourth and fifth storey columns as observed in Fig. 4 (d) and (e) on retrofitting of third and fourth storey columns respectively. A similar trend of damage shift of beam and column to upper storey beam and column is seen in Fig. 4 (f), (g), (h) and (i) which present retrofitting schemes RCB involving both column and beam at each storey. Therefore, retrofitting of an OGS building doesn't mean retrofitting of just open ground storey, retrofitting of all damage potential elements shall be done to achieve minimum damage and maximum capacity.

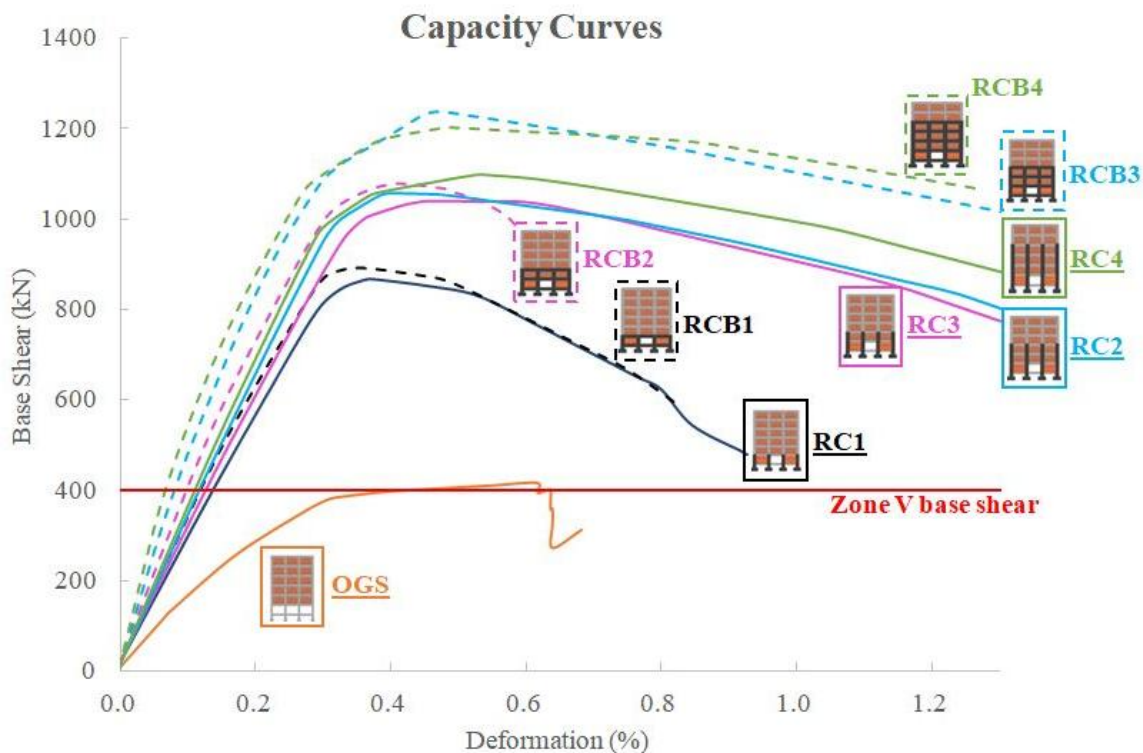
Fig. 5 Capacity curves for retrofitted buildings

Damage to a building is dependent on the expected earthquake in that region. Therefore, the capacity of the retrofitted building obtained from the POA is compared with the base shear expected in Zone V in India. As per the equivalent static method analysis, base shear attracted by the building during an earthquake ground motion is calculated as per IS 1893-2016 clause 7.6 [2]. Seismic weight of the 2D building is 2964 kN and the seismic coefficient for the current study is 0.135. Therefore, the base shear calculated is 400 kN. Same is plotted in Fig. 5 for the comparison.

Capacity curves obtained from POA of building retrofitted as per various schemes are used for comparison as shown in Fig. 5. The capacity curve for each storey retrofit is assigned a different colour. Black colour is assigned to ground storey retrofitting, pink, blue and green colours are assigned to first, second and third storey retrofitting respectively. The capacity curve with solid line represents retrofitting schemes where only columns are retrofitted and are named as RC series. The dotted line represents retrofitting schemes involving both beams and columns and is named as RCB series.

Capacity curves of retrofitting schemes RCB2 is compared with RC2, RC3 and RC4 as shown in Fig. 5. It is observed that the capacity of the scheme involving retrofitting up to the second storey beam and column, i.e., RCB2 is at par with the scheme involving only column retrofit up to the fourth storey, i.e., RC4 along with lesser deformation in the former case. Therefore, it is better to retrofit beam and column of up to the first storey rather than retrofitting upper storey columns first. However, the RC series, i.e., column retrofitting case is easier to carry out practically than the RCB series, i.e., beam column retrofitting case.

Also, it is observed that all dotted lines have lesser deformation than their corresponding solid lines. This indicates that the building deformation is less where both beams and columns of a storey are retrofitted than the case where only columns of a storey are retrofitted.

For this case study, as per the expected base shear, ground storey column retrofitting is sufficient to avoid collapse and to get minimum damage in the building. There is no need for further retrofitting. Therefore, in the same way, location and amount of retrofitting required in a building shall be selected as per the expected base shear in that region after comparison from capacity curves as shown in Fig. 5.
